THE SURFACE CONSERVATION PROJECT OF THE ACROPOLIS MONUMENTS: STUDIES AND INTERVENTIONS

ABSTRACT:

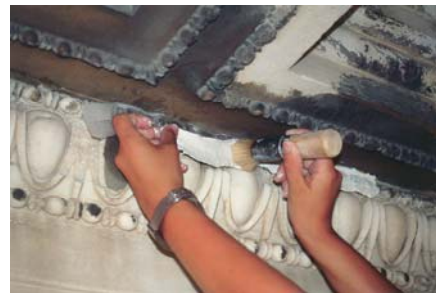
Figure 1: Consolidation of the surface

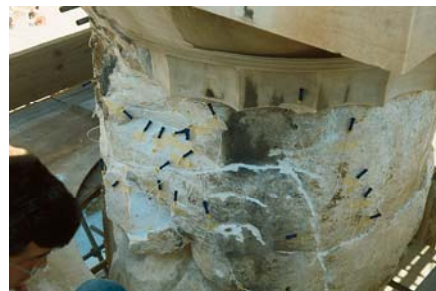
Figure 2: Injection of grouts

They are then filled by injecting according to the strength required, cement, cement-lime or hydraulic grouts of high injectability consisting of white Portland cement, fine-grained pozzolana (Santorin earth) and water in a ratio of 75:25:80 (Figure 2). The grout is stirred in an ultrasonic agitator and applied to the cracks through small tubes. The large fragments that had become loosened or detached from some blocks, are reattached with white cement and reinforced with titanium dowels wherever this is considered necessary. When small flakes are to be attached, a mortar of reduced strength is used consisting of cement and lime with the addition of calcium carbonate in order to accelerate the hardening of the mortar (Figure 3). For shallow cracks as well as after attachments or injection grouting, the joint is sealed with a mortar made of cement, lime, quartz sand and iron oxides as pigments for the chromatic harmonization with the ancient marble. The mortar is in a ratio of 1:3 binder to aggregate. The brass pins are removed and replaced, if needs be, by new pins made of titanium. The old mortars were removed using masons' and dentist's tools. The whole process is well documented through a series of photographs and graphic mappings before, during and after treatment of individual areas.

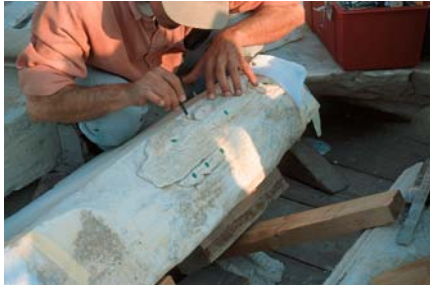
Figure 3: Reattachment of fragments

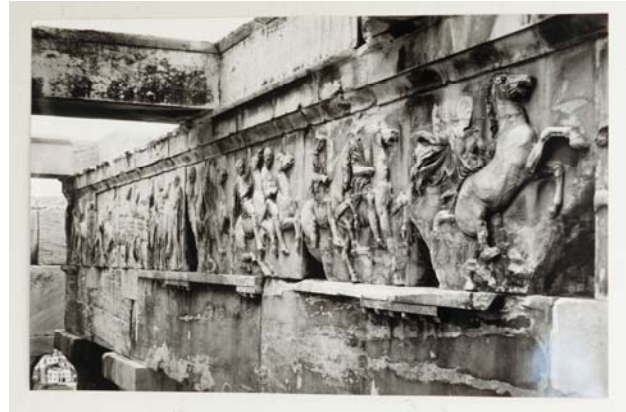
Figure 4. The Parthenon West Frieze on the monument

The Parthenon West Frieze, thought to be sculpted by Pheidias during the period 442 – 438 B.C. It was placed above the architrave of the opisthonaos and consists of sixteen blocks depicting the beginning of the Panathenaic procession which is the start of the Athenian cavalcade. The first two blocks are among the parts dismantled by Elgin, now in the British Museum. The fourteen blocks remained *in situ* until 1992 – 93 when they were removed during the restoration carried out on the temple. Two monochromatic surface layers are preserved and cover the 33 % of the sculptured surface of the West Frieze. These layers are distinguished as a) the lower orange-brown layer with a thickness of around 30 – 100 μm is well-adhered to the marble surface (Galanou, 1994). Its main components are calcium oxalates, calcium phosphates and iron oxides and it is described as the “epidermis” (skin) or “patina” encountered on many Classical and Roman monuments and b) the outer beige layer covers the epidermis and is described as the ‘coating’ (Kouzeli, 1989). According to this analysis, it is a thin artificial layer (about 80 – 120 μm thick), composed mainly of calcium carbonate. Both of these surface layers preserve original tooling traces and relief details which are observed to indicate the original surface. Thus, they document and are characterized as part of the original historic fabric and were not to be removed during the cleaning process. The presence of sulphur dioxide (in the atmosphere) led to the formation of a gypsum layer, which up to a certain thickness preserved details of the relief and it was important that it was not removed during the cleaning process.

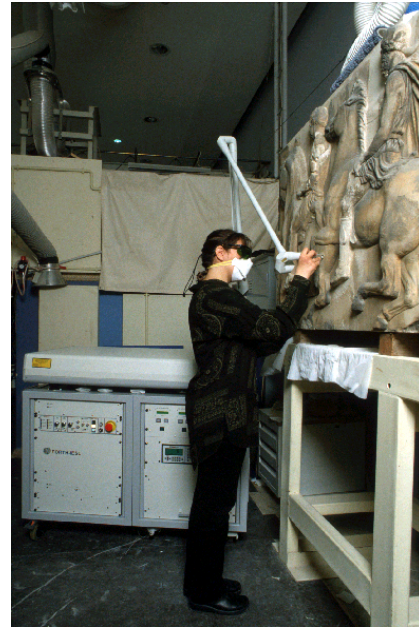
After experiments to all the possible substrates and encrustations present on the surface of the Acropolis monuments, the IESL-FORTH research team suggested combining the action of the two discrete laser ablation mechanisms. This was accomplished by the simultaneous use of two laser beams of different wavelengths, whose pulses were temporally and spatially overlapped. According to this scheme, a prototype hybrid laser system was developed by the IESL-FORTH (EP1340556A2) which in its initial state was tested successfully on the Acropolis site (Figure 6). The laser system developed was a Q-switched Nd:YAG system emitting at the fundamental (1064 nm) and the third harmonic (355nm), with

the option of using the two laser beams individually or in combination and in various ratios of energy densities. This made possible to combine different cleaning methodologies to adjacent areas of the surface to be cleaned with no profound colour or structural differences.

Figure 6. The laser system

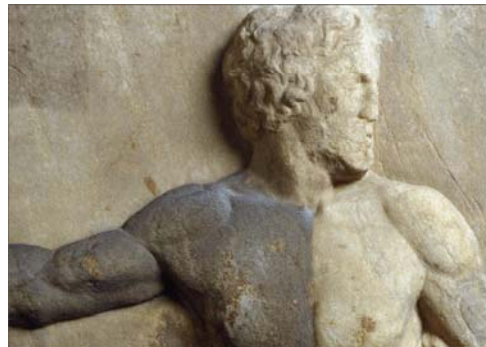
The combination of the infrared and ultraviolet radiation at relatively low energy fluences ($F_{IR} = 0.3 - 0.5 \text{ J/cm}^2$ and $F_{UV} = 0.08 - 0.2 \text{ J/cm}^2$) on loose deposits was successful without any discoloration to the underlying marble surface (Figure 7). However, in some cases, where the substrate is non-homogeneous due to deterioration, loose deposits remain among the marble crystals. In these cases, infrared radiation alone at higher densities about $0.6\text{-}1 \text{ J/cm}^2$ was applied selectively on the non-cleaned areas.

Figure 7. Detail during the laser cleaning

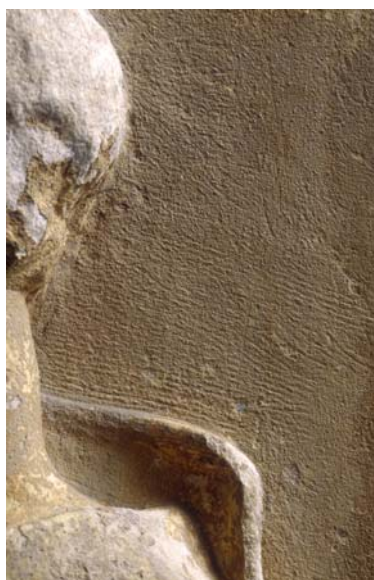
The cleaning process revealed the precious details of the sculptures and traces of ancient tools and colours (Figure 11,12).

Figure 10. Ancient tools' traces

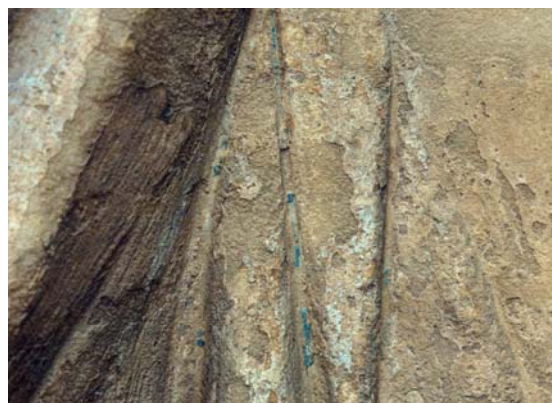
Figure 11. Ancient colour traces
