STS-122/1E

FD 08 Execute Package

MSG INDEX

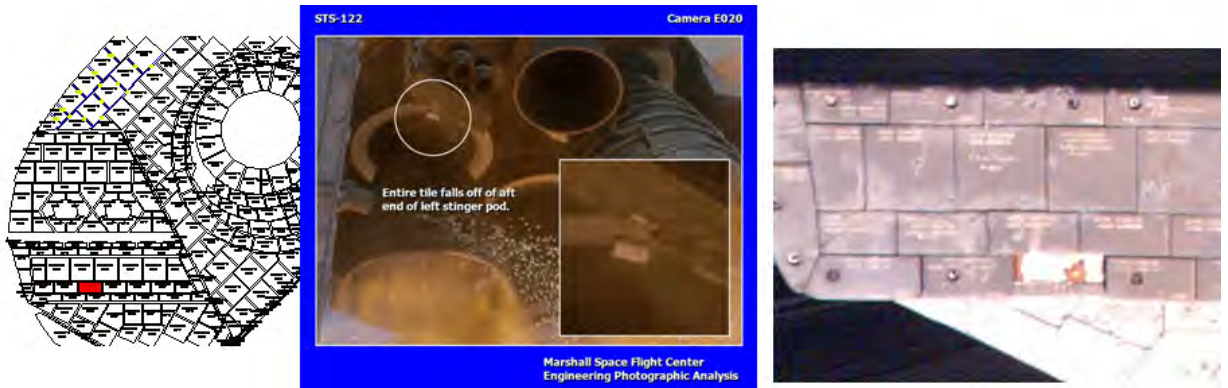
Figure 1 Location of the missing tile on the LOMS Stinger

19 **LOMS Stinger Tile:** The missing tile on the LOMS Stinger (figure 1 & 2) has been cleared
20 for entry. Both ascent and descent effects were considered and the thermal results showed
21 that the OMS pod stinger structure and the systems inside of the stinger compartment do
22 not exceed their certification limits. The stress assessment also shows that sufficient margin
23 is maintained at the tile loss location.

3 The MMT met today to review mission progress, orbiter systems status, and TPS inspection
4 results. The analysis for the Left OMS Stinger tile was completed and, as expected, was
5 cleared for entry. As a result, all of the orbiter TPS has been fully cleared for entry pending
6 Late Inspection. The MMT also decided to extend the mission by an extra docked day in
7 order to assist with Columbus outfitting.

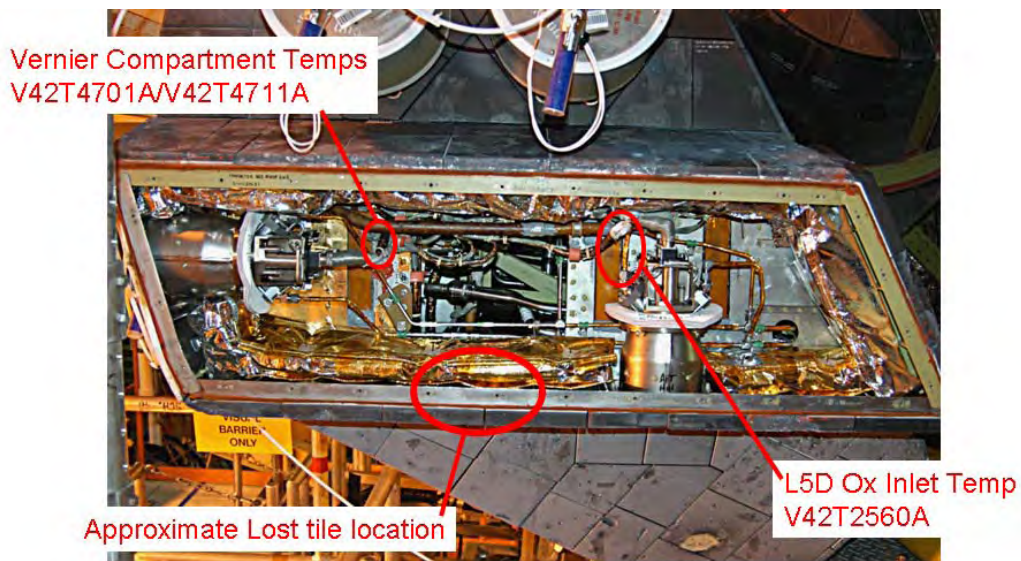
A TCS blanket is installed on back of (removed) vernier compartment door
 Figure 2 Hardware locations in the stinger in proximity to the missing tile

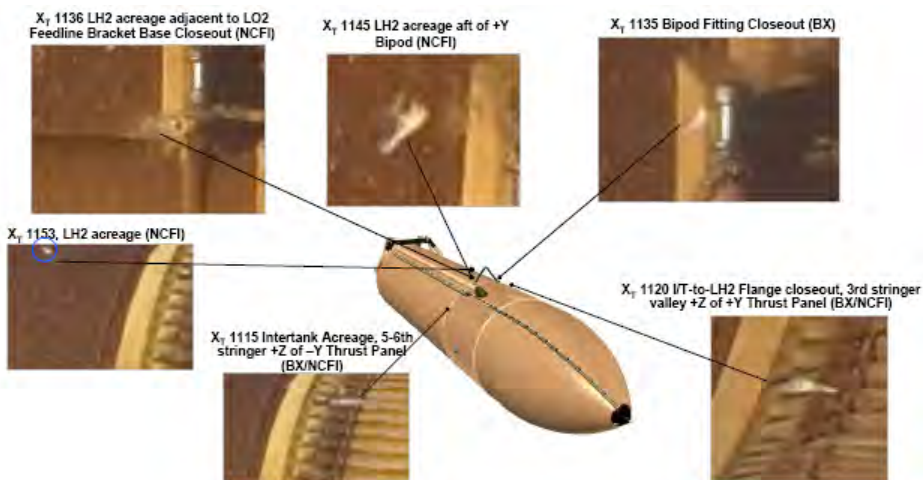
Figure 3 ET Foam loss locations

30 **ET Final Report:** The tank performed very well for it's third tanking with 10 prepress cycles
31 (LCC limit is 13). The preliminary ET foam loss assessment indicates no new failure modes.
32 (Figure 3)

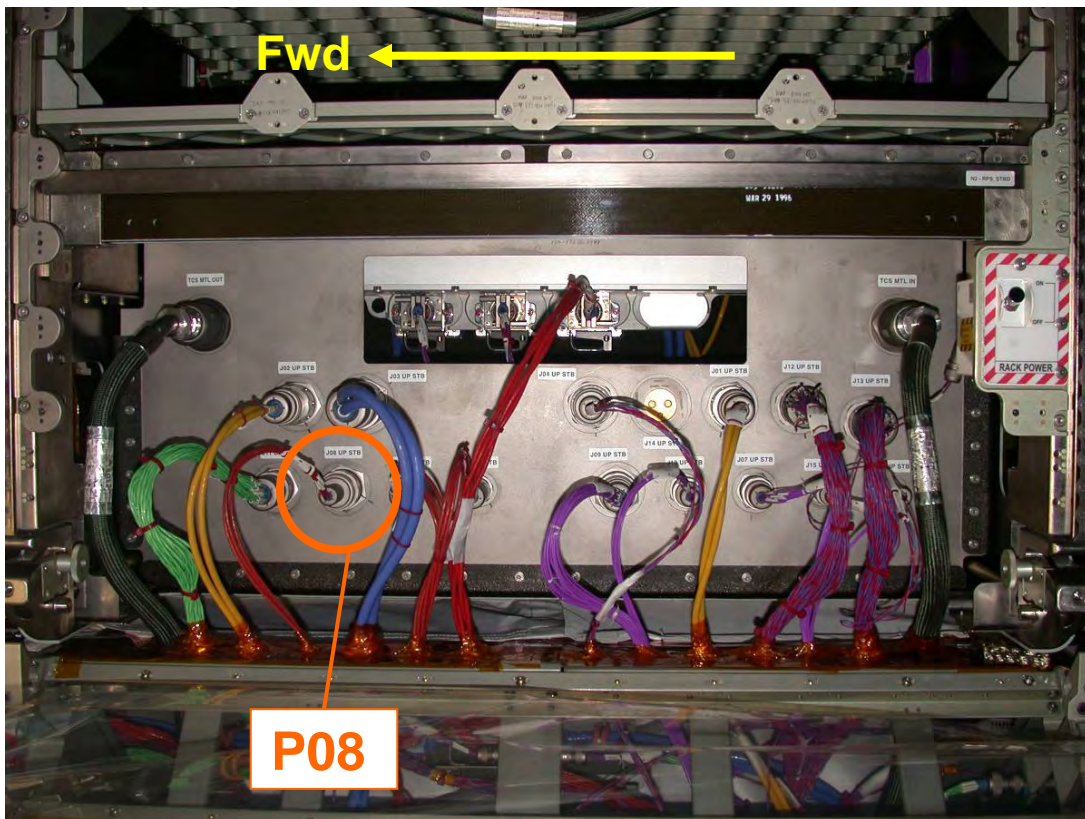
Figure 1. - Connector Cover Assembly

- NOD2S4
- 1.1 Remove/relocate any stowage from the base of NOD2S4 rack to gain access to rack Utility Interface Panel (UIP).
 - 1.2 Loosen NOD2S4-02 closeout panel fasteners (four) and remove closeout (5/32" Hex Head, Driver Handle, 1/4" Drive)
Temporarily stow closeout panel

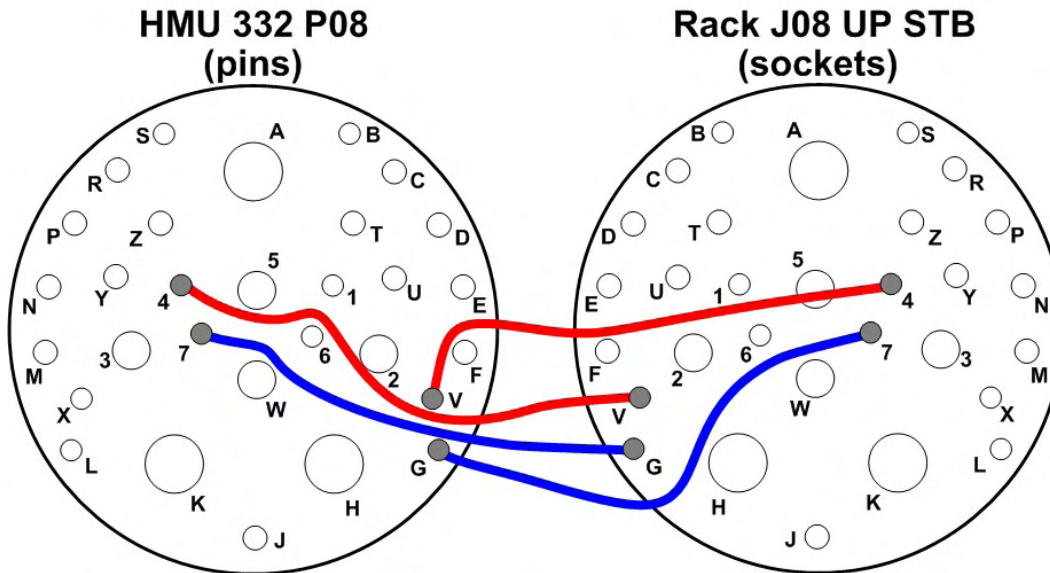
Figure 2. - Crossover Jumper Arrangement (HMU 332 P08 to rack J08)

Pin/Socket #	Function
V	RF Video PMA 2 (Orbiter) to CVIU 10
G	RF Video Return PMA 2 (Orbiter) to CVIU 10
4	RF Video CVIU 10 to PMA 2 (Orbiter)
7	RF Video Return CVIU 10 to PMA 2 (Orbiter)

NOD2S4 2.2 Install 20 Ga. Pin/Socket Test Jumper Leads, 24 in (four) between HMU 332 P08 connector and rack J08 UP STB connector to swap the forward and return video lines.

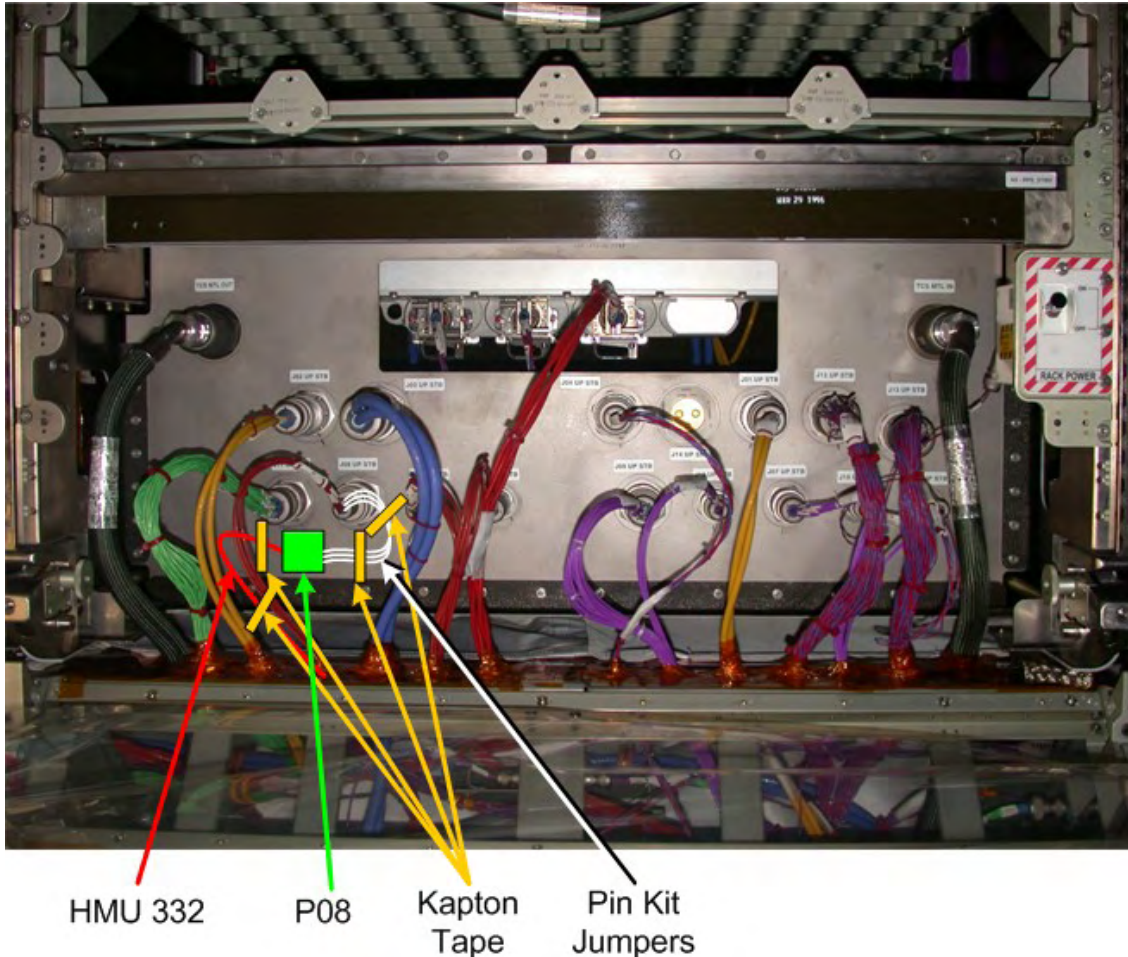
Figure 4. - Permanent Configuration of HMU 332 P08 in UIP area with Jumpers installed.

4.4 Tape HMU 332 P08 connector to NOD2S4 UIP (Kapton Tape) near J8.

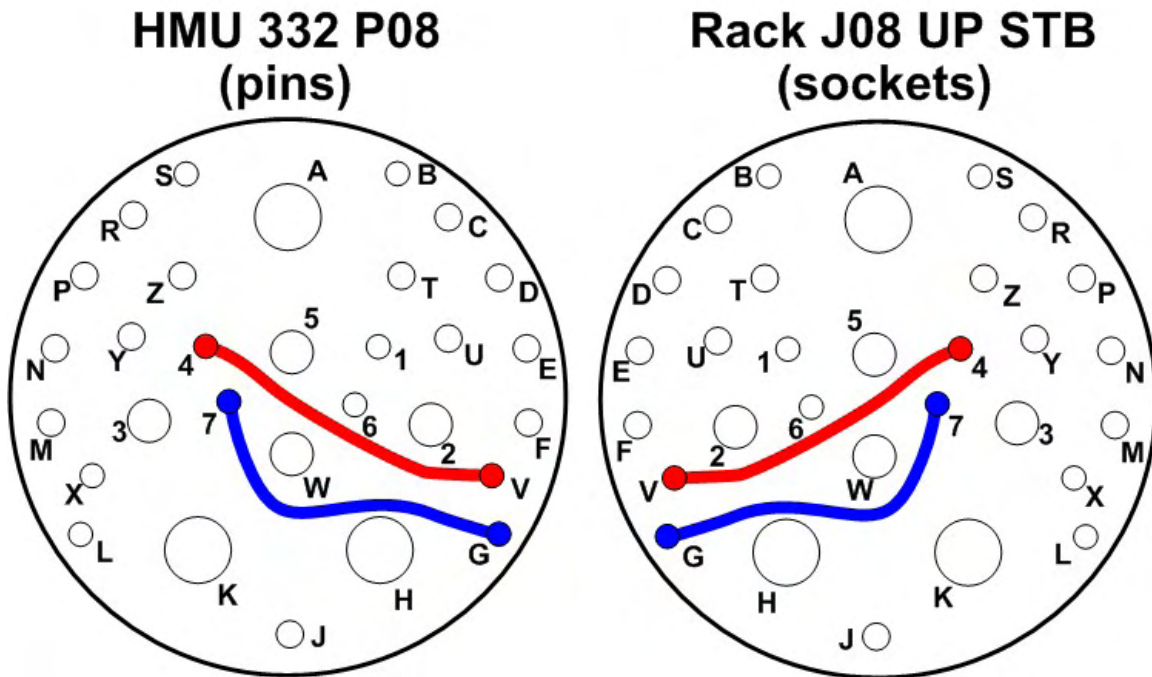
This step installs jumpers at the NOD2S4 Rack to allow CVIU 10 output video to be returned to the CVIU 10 input channel. The Orbiter video coming through PMA2 will be returned back along the same path to be monitored on the Flight Deck. This test will verify both CVIU and Orbiter video system functionality, independent of each other.

Figure 5. - Loop Back Jumper Arrangement (for both HMU 332 P08 and rack J08).

- NOD2S4
- 5.1 Remove previously installed jumpers, temp stow.
 - 5.2 Install 20 Ga. Socket/Socket Test Jumper Leads, 5 in (two) onto HMU 332 P08 connector to create Orbiter loop back.
 Jumper →|← pin V and pin 4
 Jumper →|← pin G and pin 7
 Refer to Figure 5.
 - 5.3 Install 20 Ga. Pin/Pin Test Jumper Leads, 5 in (two) onto NOD2S4 rack J08 UP STB connector to create CVIU loop back.
 Jumper →|← socket V and socket 4
 Jumper →|← socket G and socket 7
 Refer to Figure 5.
 - 5.4 Photo document jumper configuration (DCS 760 Camera).
 - 5.5 Notify **MCC-H** when complete with installation of both loop back jumpers.

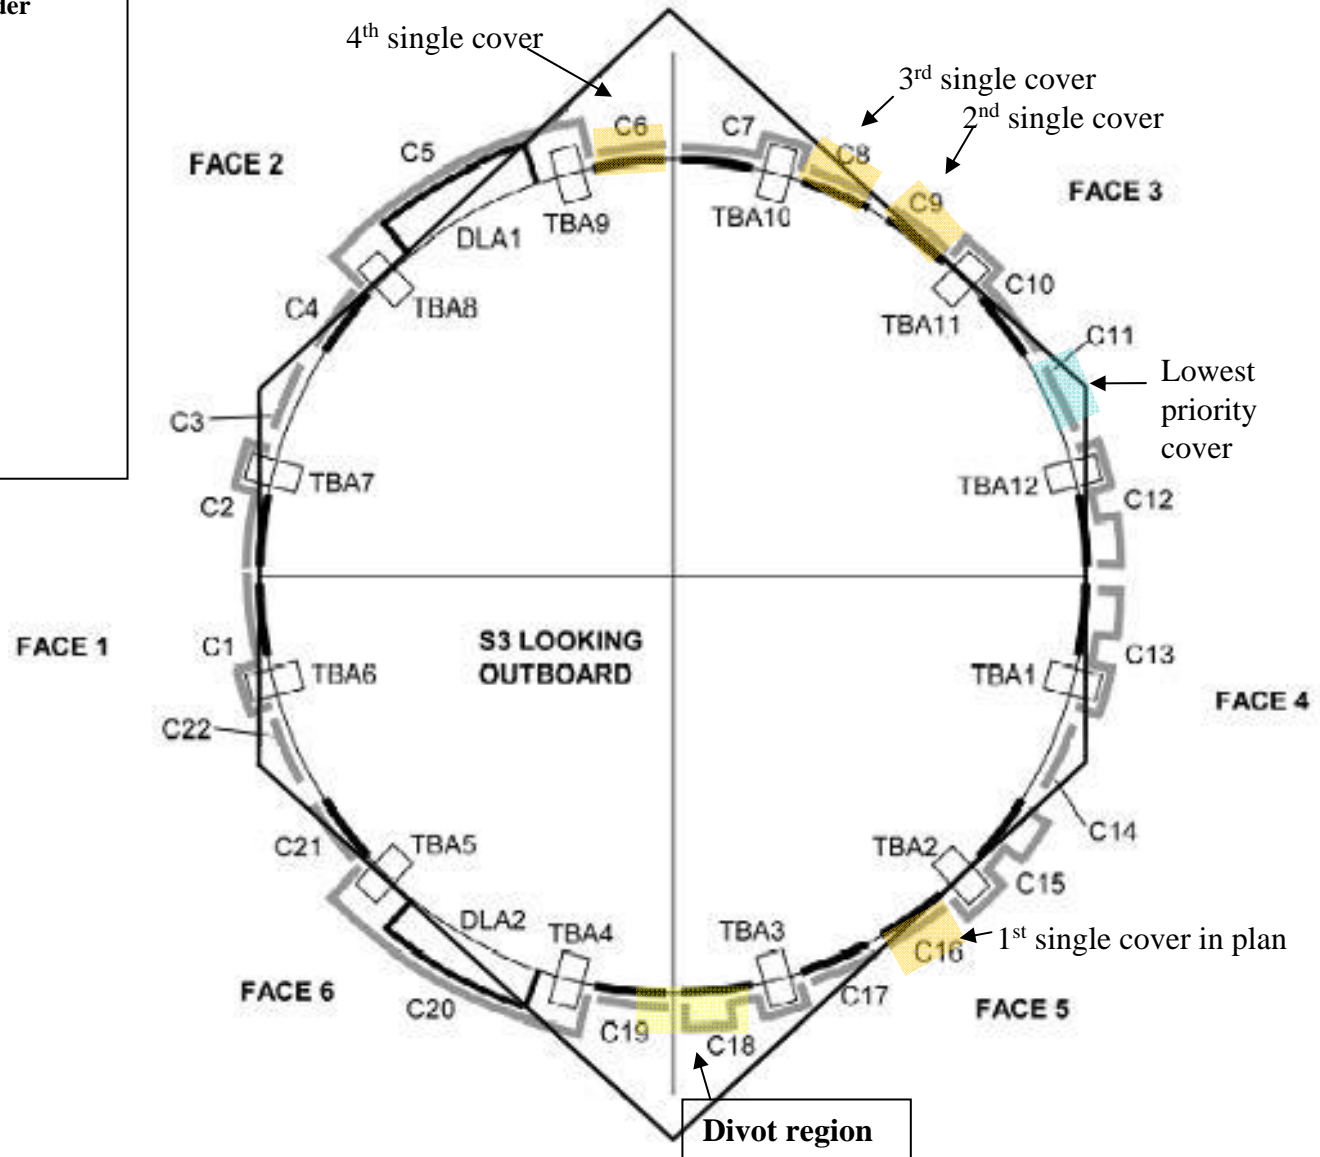
- The SARJ inspection during EVA 14 provided images of potential damage to the outboard race ring Datum A surface. The imagery is not conclusive as to whether it is damage (a divot) or debris buildup. We will be adding a SARJ Get Ahead to EVA 3 to be performed after you stow everything back at the A/L. This is the highest priority get ahead after the 1J/A tool relocations. You will revisit the divot location, take pictures, and attempt to remove the spot with an EVA wipe. In addition to this task, you will inspect and photograph the remaining single covers (5) that have not yet been inspected. 4 of the 5 covers will require taking a tape sample on the outer canted surface.
- A DOUG state file can be provided if you would like.

SARJ Terminology Refresher and Divot Location

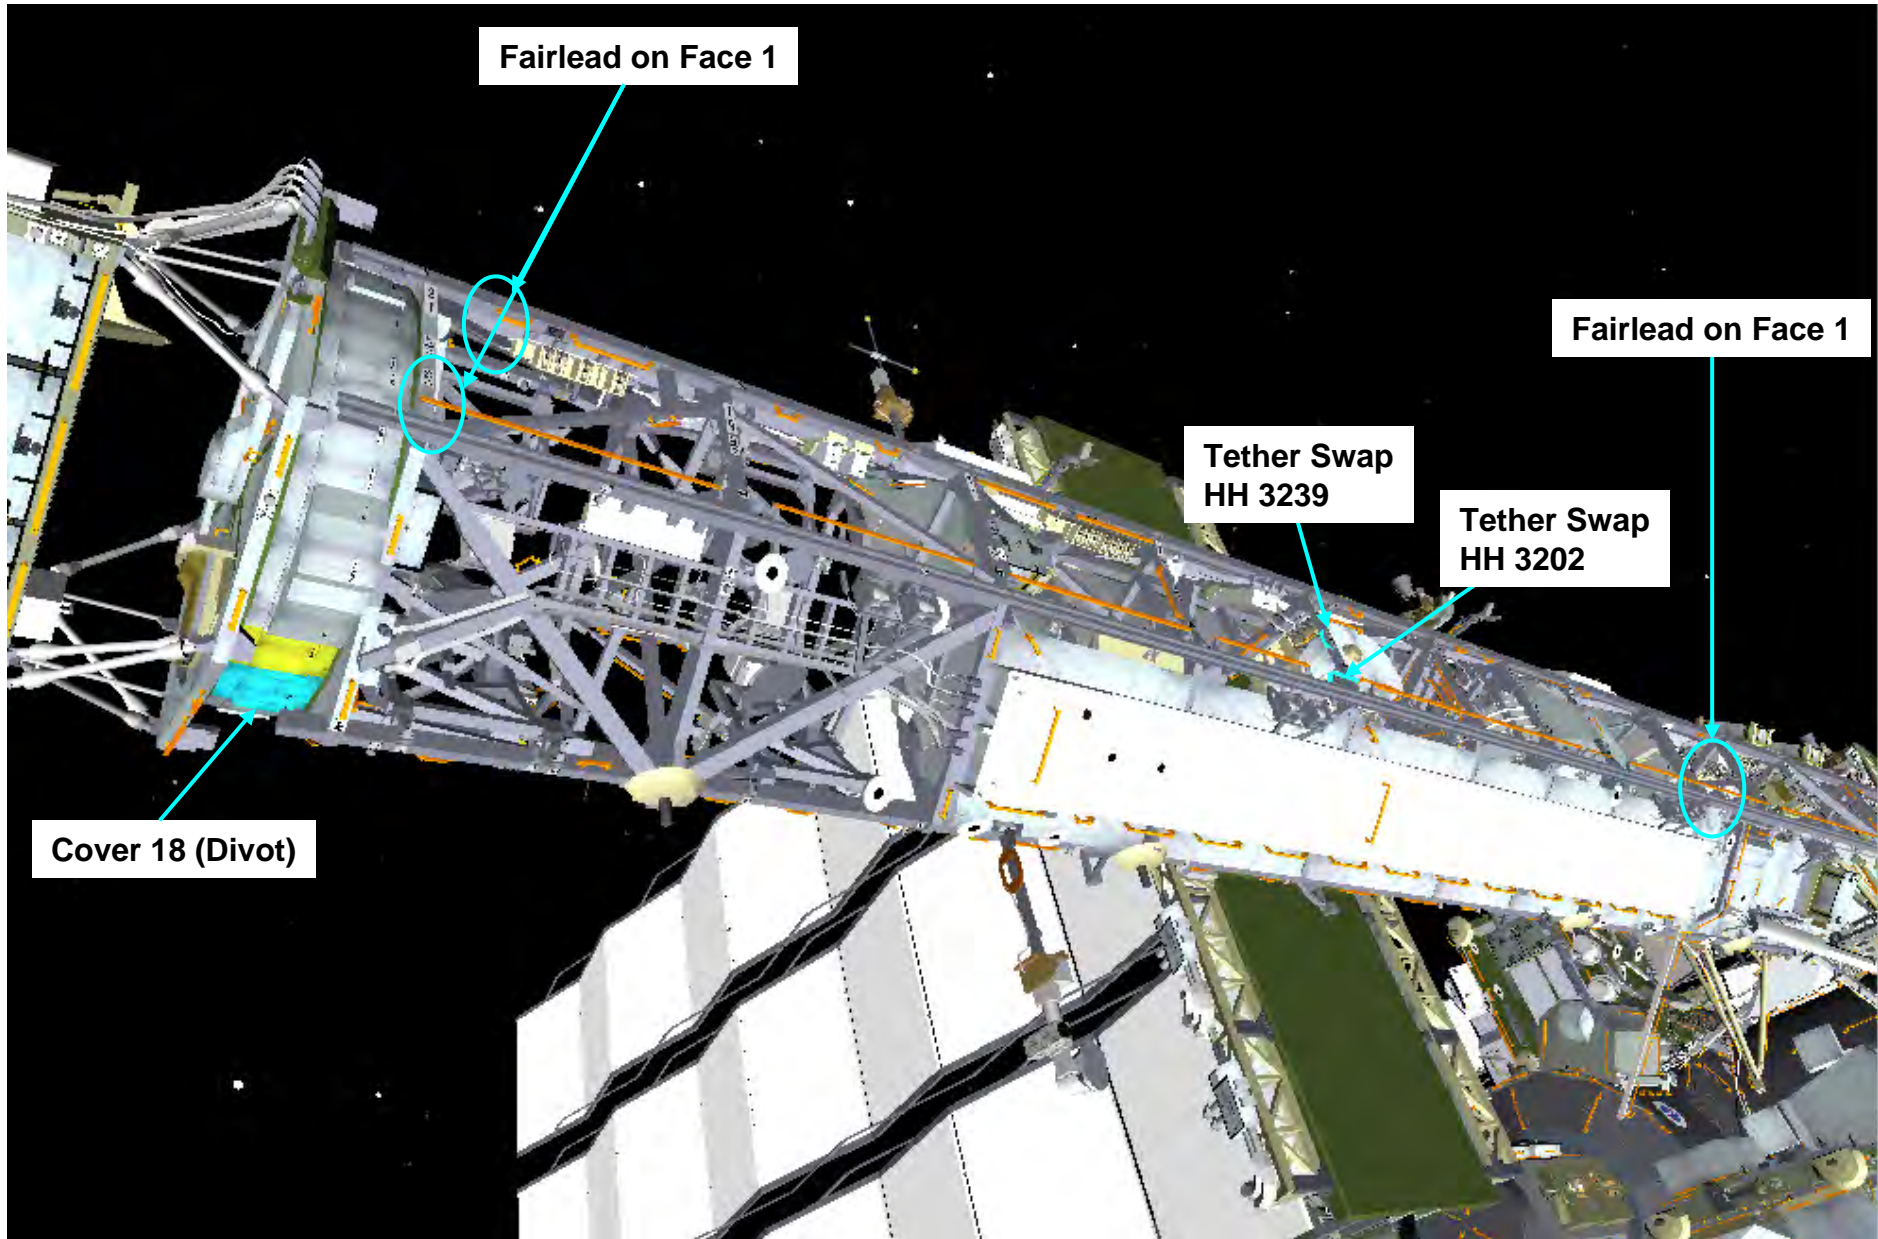
Expected Location of Divot

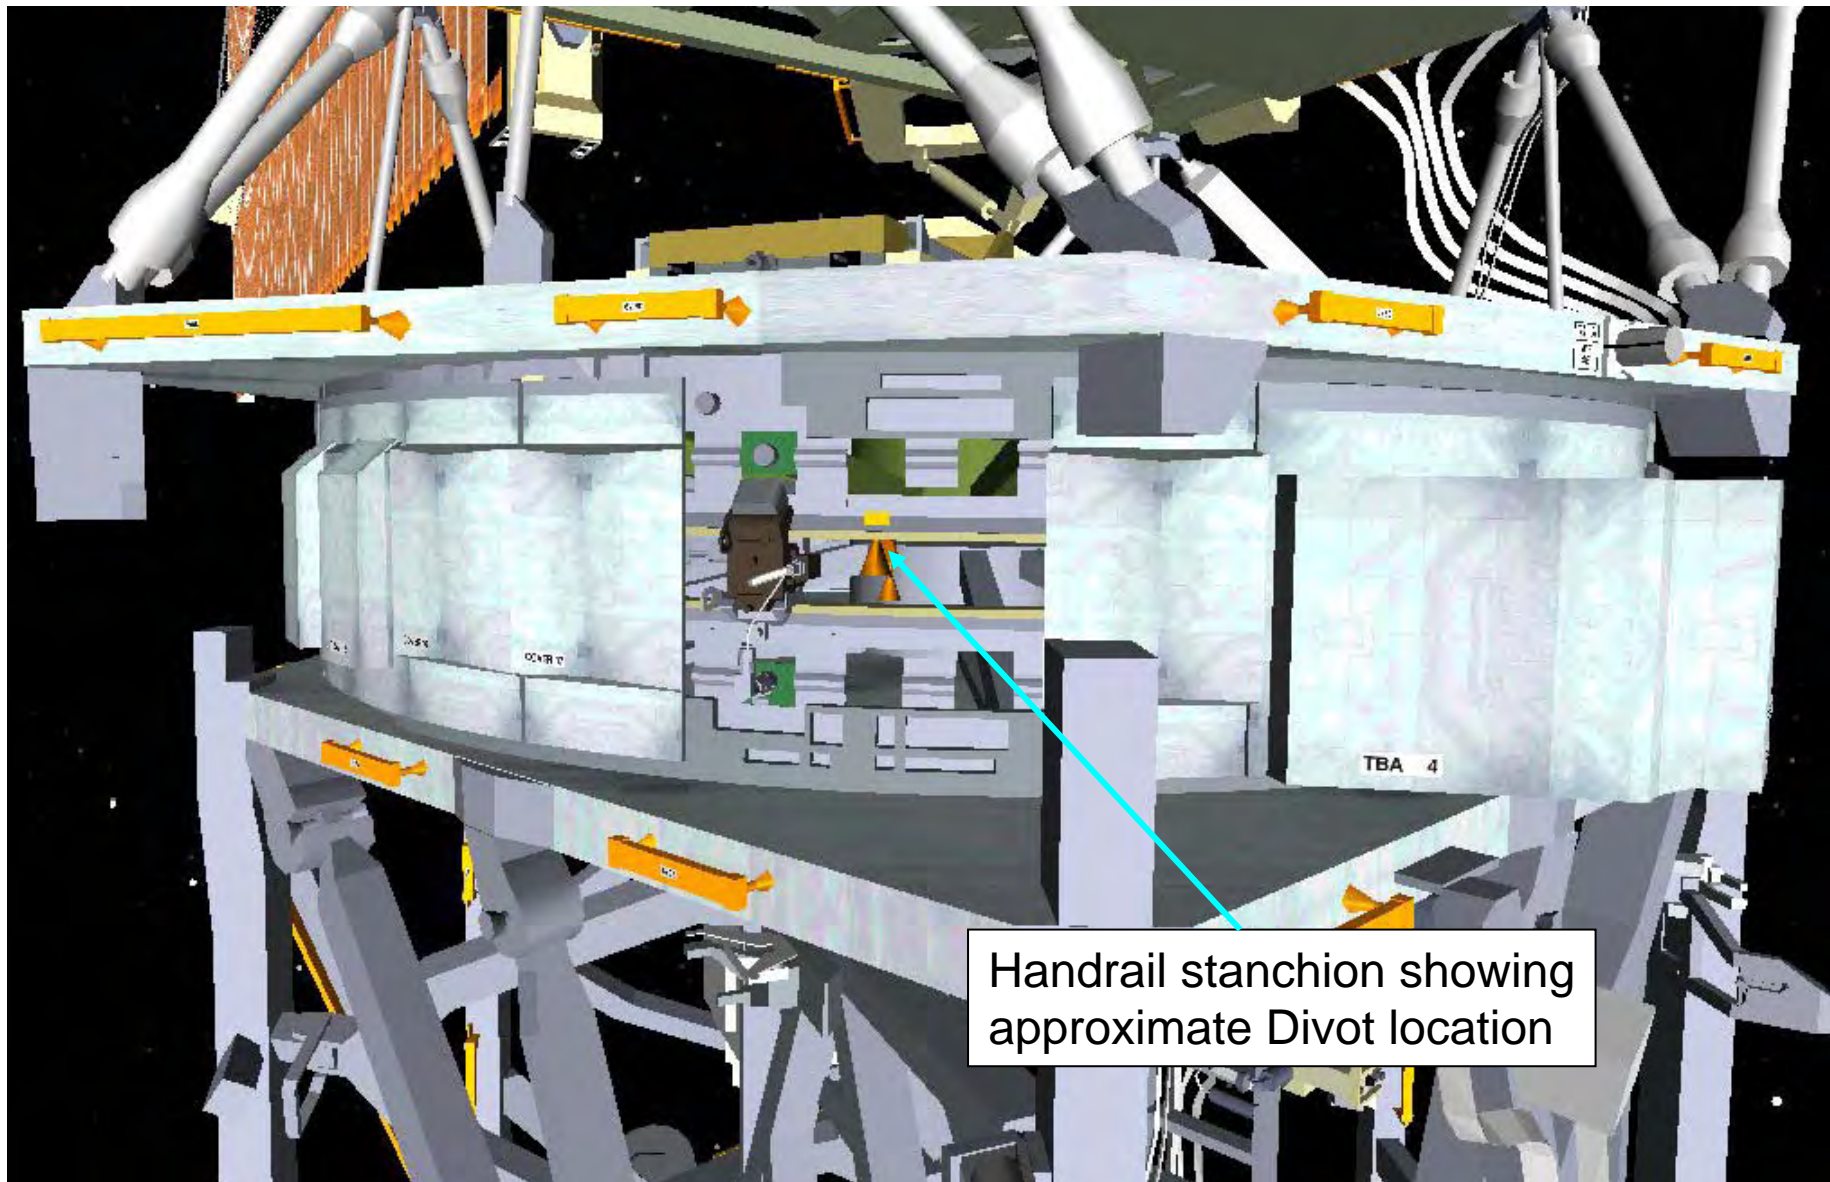
Handrail stanchion showing approximate Divot location

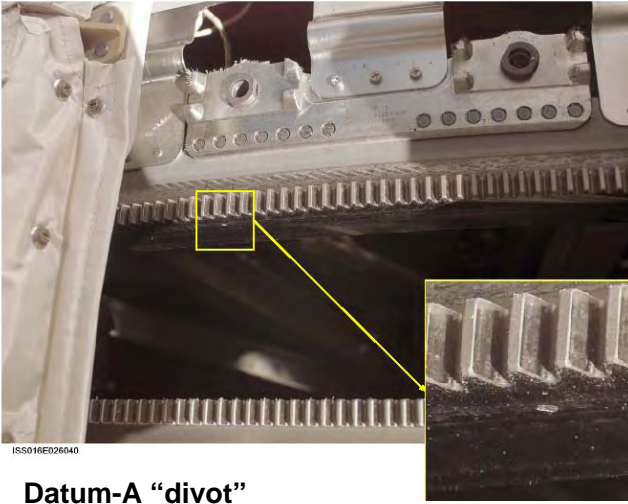
IV	EV1 & EV3
<p style="text-align: center;">NOTE</p> <ul style="list-style-type: none"> • First priority: Datum A divot inspection (divot is expected to be under cover 18) • Second priority covers 16, 9, 8, 6 • Third priority: cover 11 • Cover 18 is a double wide cover (6 inboard bolts) • Covers 6, 8, 9, 11, 16, 19 are single wide covers (4 inboard bolts) • For single cover inspections, perform best effort visual assessments of all adjacent structure • Because STBD TRRJ will continue to rotate, tether line fairleads are required on face 1

<p style="text-align: center;">Datum-A “divot”</p>	<div style="border: 2px solid black; padding: 5px; margin-bottom: 10px;"> <p style="text-align: center;">WARNING</p> <ol style="list-style-type: none"> 1. Sharp edge - spring loaded captive EVA fasteners (SARJ MLI cover bolts); ends of springs may protrude 2. Avoid contact with any exposed sharp edges during cover removal and SARJ inspection </div> <div style="border: 1px solid black; padding: 5px; margin-bottom: 10px;"> <p style="text-align: center;">CAUTION</p> <p>The following precautions should be taken to prevent loss of inboard MLI cover fasteners during removal:</p> <ul style="list-style-type: none"> • Limit turn count to minimum required for fastener release • Minimize side loading of bolt head • Maintain axial force on fastener to compress spring during rotation </div> <p>SARJ INSPECTION SETUP</p> <ol style="list-style-type: none"> 1. At airlock, stow APFR w/ 55 ft tether (A/L STBD Toolbox WIF) and COL crewlock bag; keep spare 85 ft tethers 2. Retrieve SARJ crewlock bag with camera and flash from airlock 3. Translate up CETA spur; fairlead on face 1 4. Translate to S1 HH 3202 (EV1)/HH 3239 (EV3) (face 1 CETA rail) 5. Tether swap to spare 85-ft safety tether on S1 HH 3202 (EV1)/HH 3239 (EV3) <ul style="list-style-type: none"> □ Verify hook locked, reel unlocked 6. Translate to S3/S4 interface, fairlead on face 1 in-board of SARJ 7. Translate to SARJ cover 18 (face 5, nadir) <p>DATUM-A OUTBOARD RACE RING INSPECTION</p> <ol style="list-style-type: none"> 8. Inspect gloves; status MCC on RTV and Vectran state; remove overgloves as required 9. RET MLI cover 18 to adjacent cover 10. PGT[A6 (8.3), CCW2, 30.5] 6-Ext 7/16 release inboard cover fasteners, 9 turns only (add single turns incrementally as required for release) 11. Remove MLI cover 18; temp stow w/ previously installed RET and adj eq tether on adjacent cover <ul style="list-style-type: none"> □ Inspect backside of cover, both MLI and frame 12. Perform search on outboard race ring for ‘divot’ on Datum A surface (should be centered between adjacent covers) 13. Perform visual inspection of the ‘divot’ and report conditions to IV 14. Attempt to remove debris from Datum A surface with EVA Wipe 15. Report success of debris removal to IV 16. If debris can be removed, stow EVA wipe (inside-out and rolled up) with debris in crewlock bag for return to ground

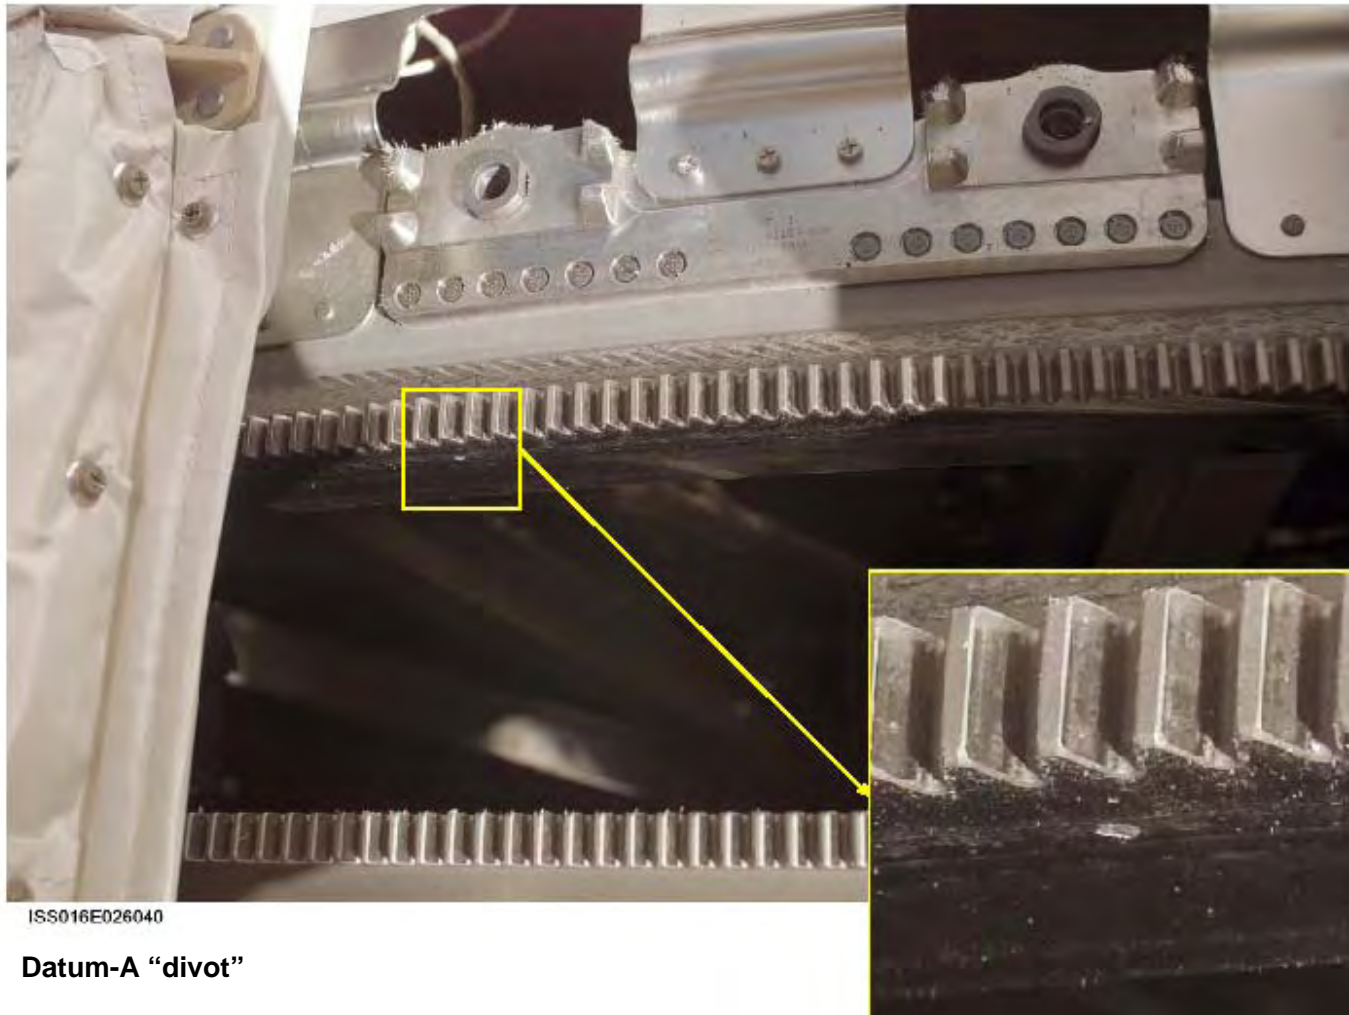
ISS016E026040

Datum-A "divot"

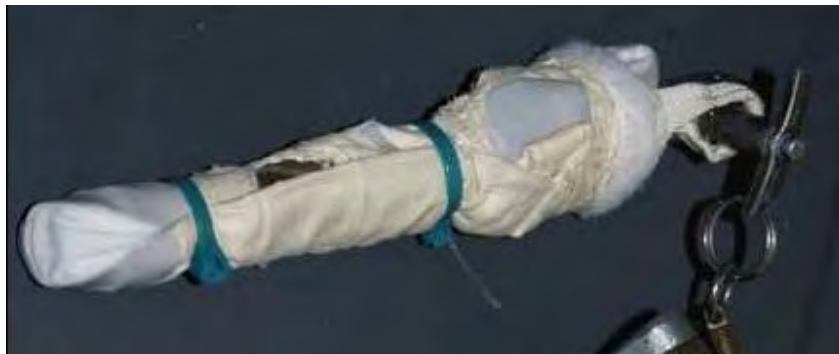
Figure 1. - Final swatch tool configuration

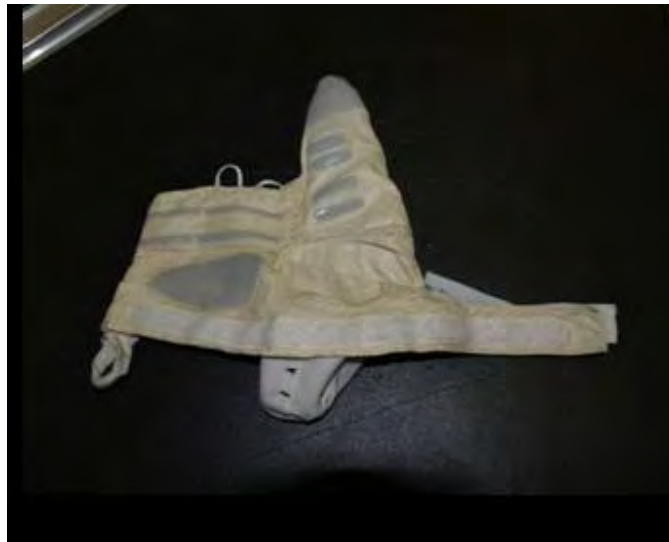
Figure 2. - Step 4.

1. Remove any loose or hanging RTV pads from overgloves.
2. Photograph condition of both overgloves to document pre-test status.
3. Set aside one overglove (dominant hand) - it will be donned during EVA to perform swatch test.
4. With other overglove palm facing you, turn overglove thumb inside out (Fig. 2).

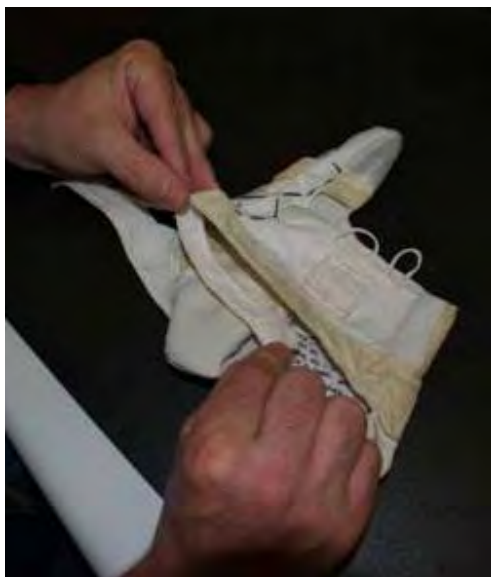
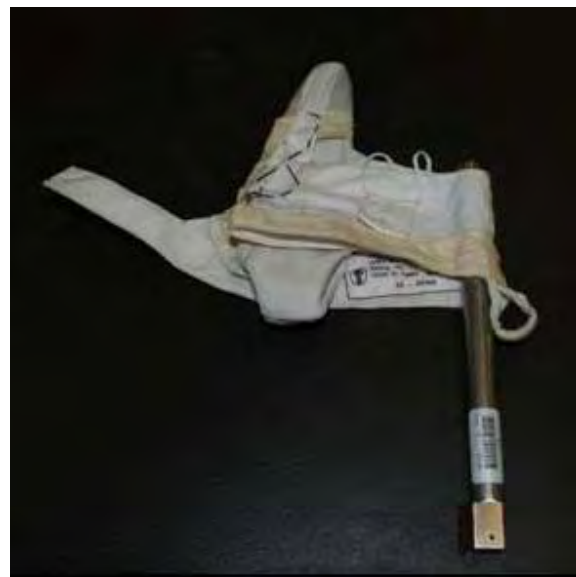
5. Fold velcro wrist strap to backside of overglove (will end up inside of the swatch tool, out of the way).
6. Insert socket into pinky side of overglove until tip just protrudes (Fig. 3).

Figure 3. - Steps 5 & 6 - Laced overglove shown, recommend non-laced ones.

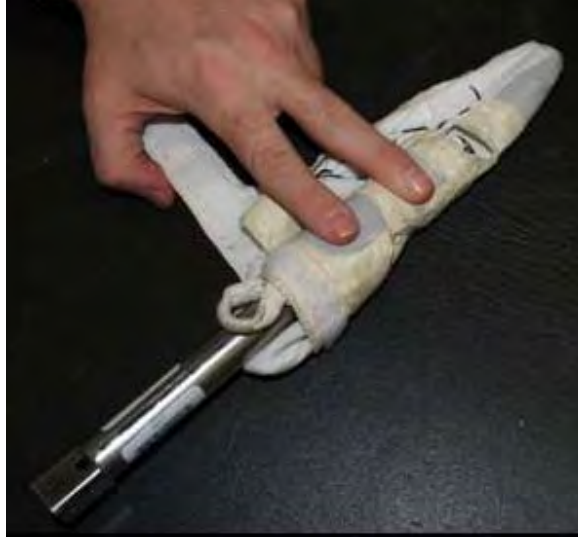
Figure 4. - Step 7.

7. Roll overglove tightly around socket until tip of socket aligns with opening into overglove forefinger (Fig. 4). Ensure overglove tether point is accessible.

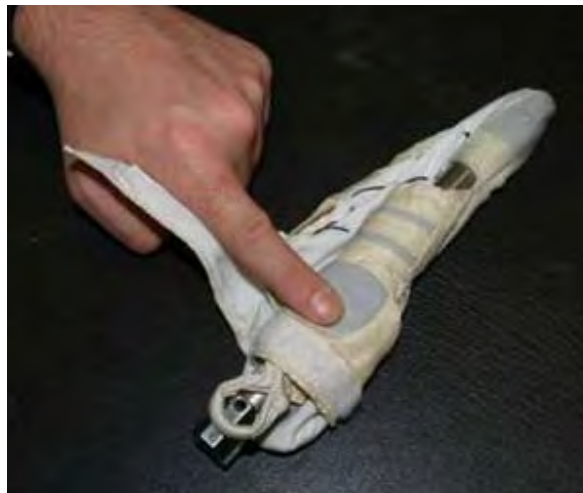
Figure 5. - Step 8.

8. Insert socket into overglove forefinger; align overglove tether loop with pip pin hole in socket (Fig. 5).

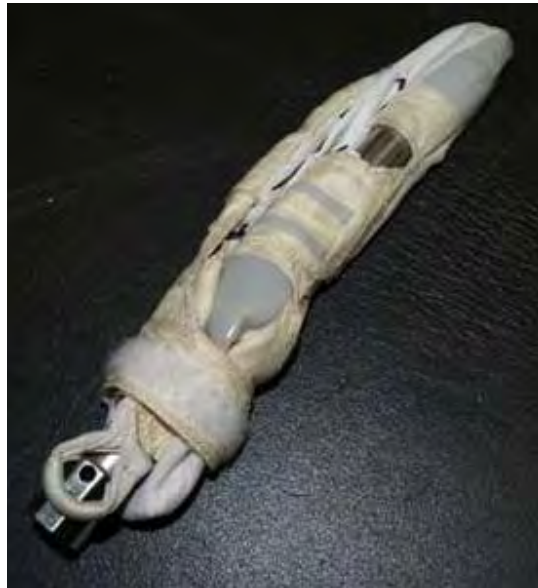
Figure 6. - Step 9.

9. Wrap Velcro strap tightly around base of tool (Fig. 6).

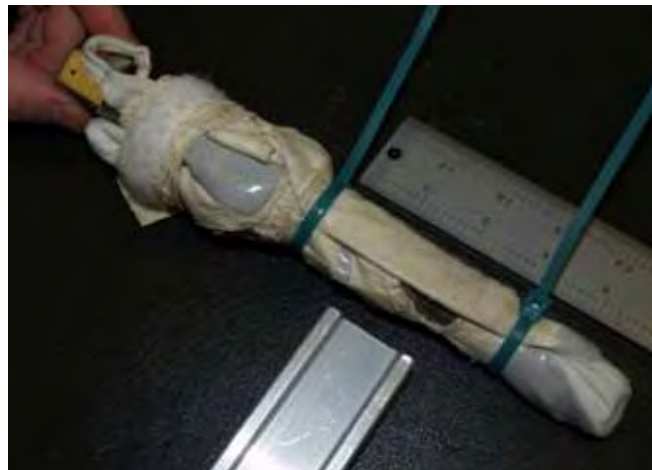
Figure 7. - Step 10.

10. Install Zip Ties (2) approximately 3-in apart, folding excess material under zip tie as required to keep the roll tight (Fig. 7).

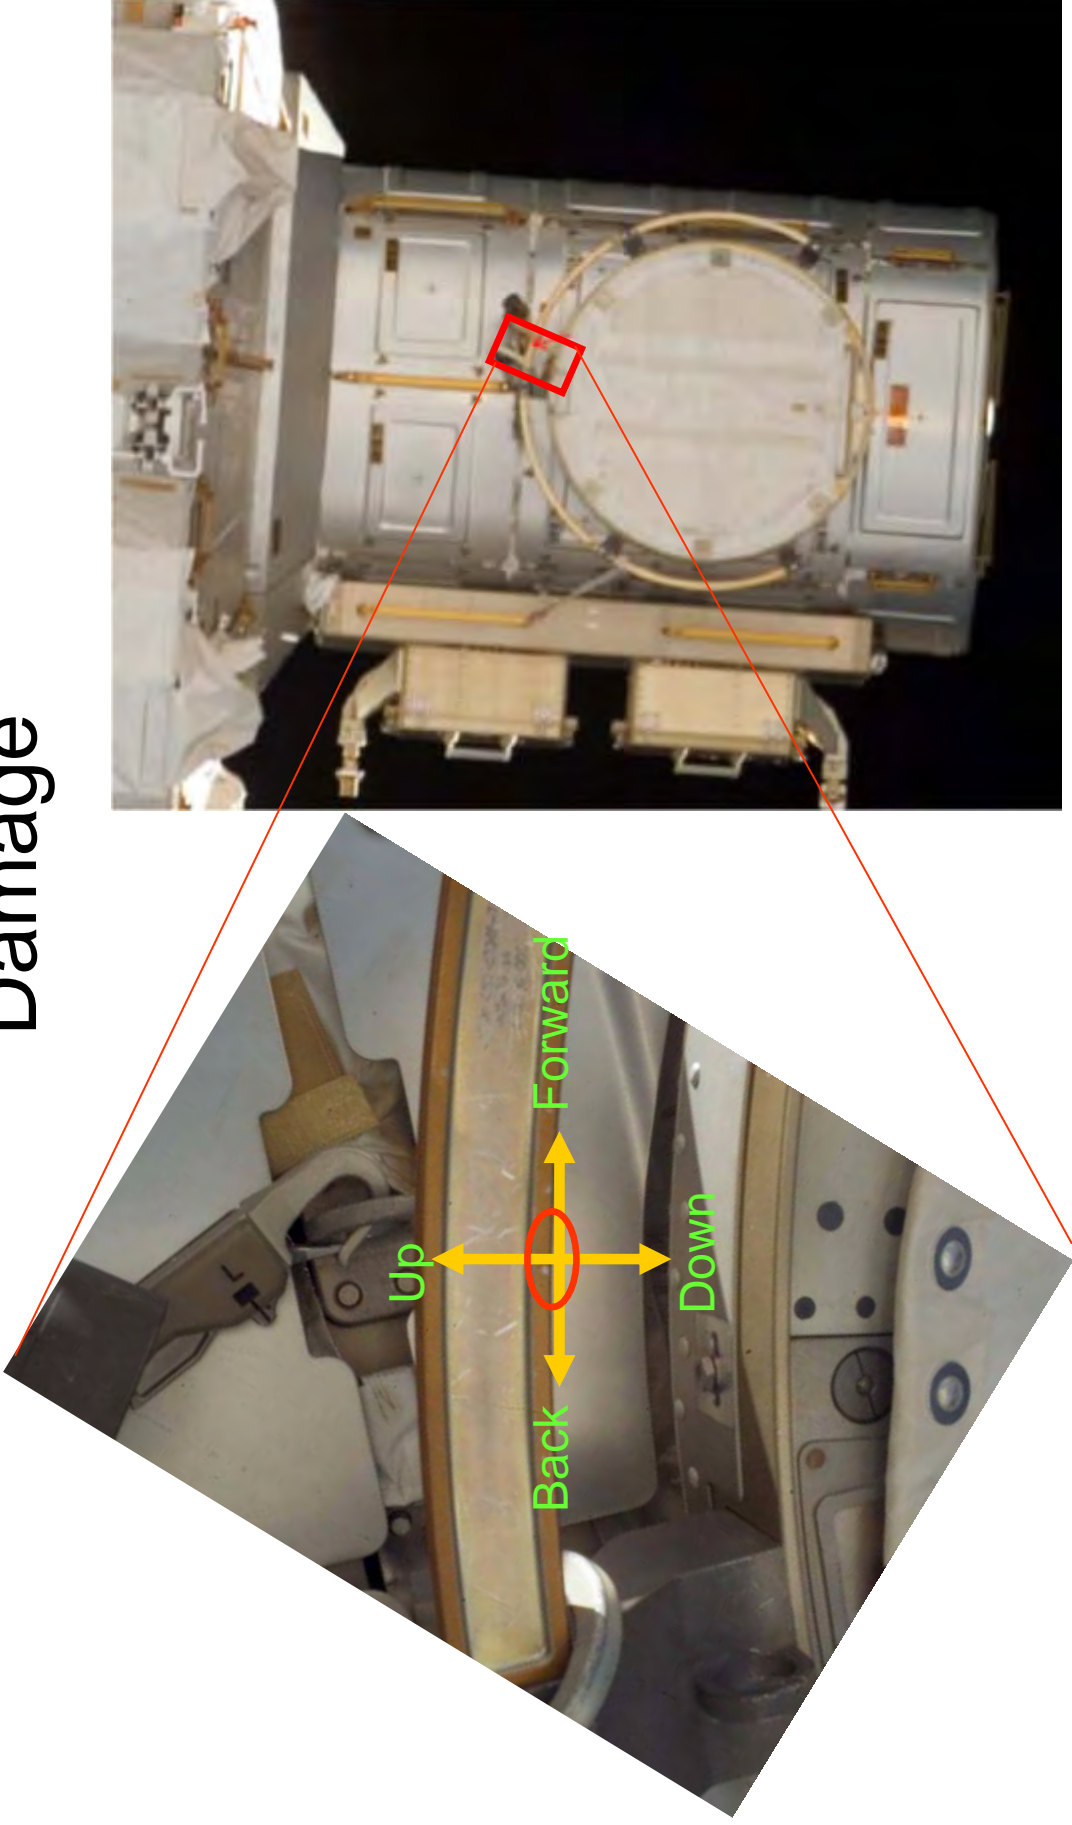
Figure 1

Figure 1. Orientation for Inspection of Handrail Damage

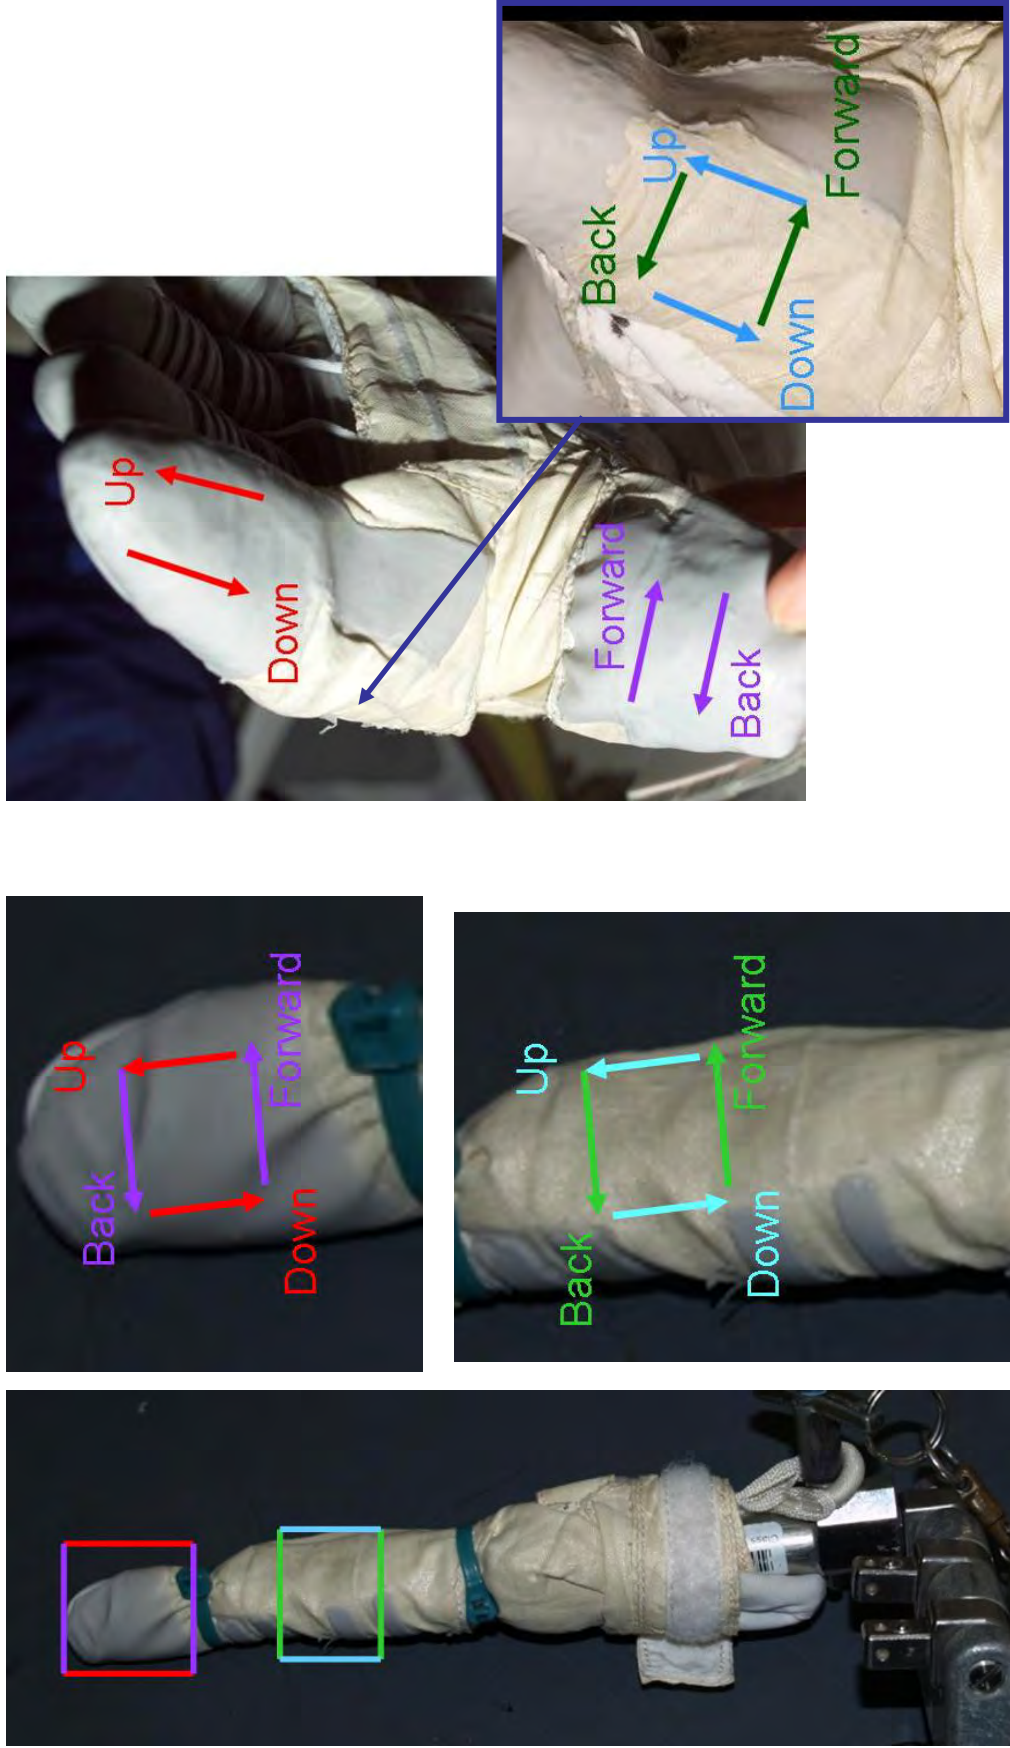
Figure 2. Sample locations
