Transport and Works (Inquiries Procedure) Rules 2004
Proposed London Underground (Victoria Station Upgrade) Order

APPENDICES 1 – 2 TO REBUTTAL PROOF OF EVIDENCE of
TIM CHAPMAN of ARUP

PREVIOUS EXAMPLES OF JET GROUTING

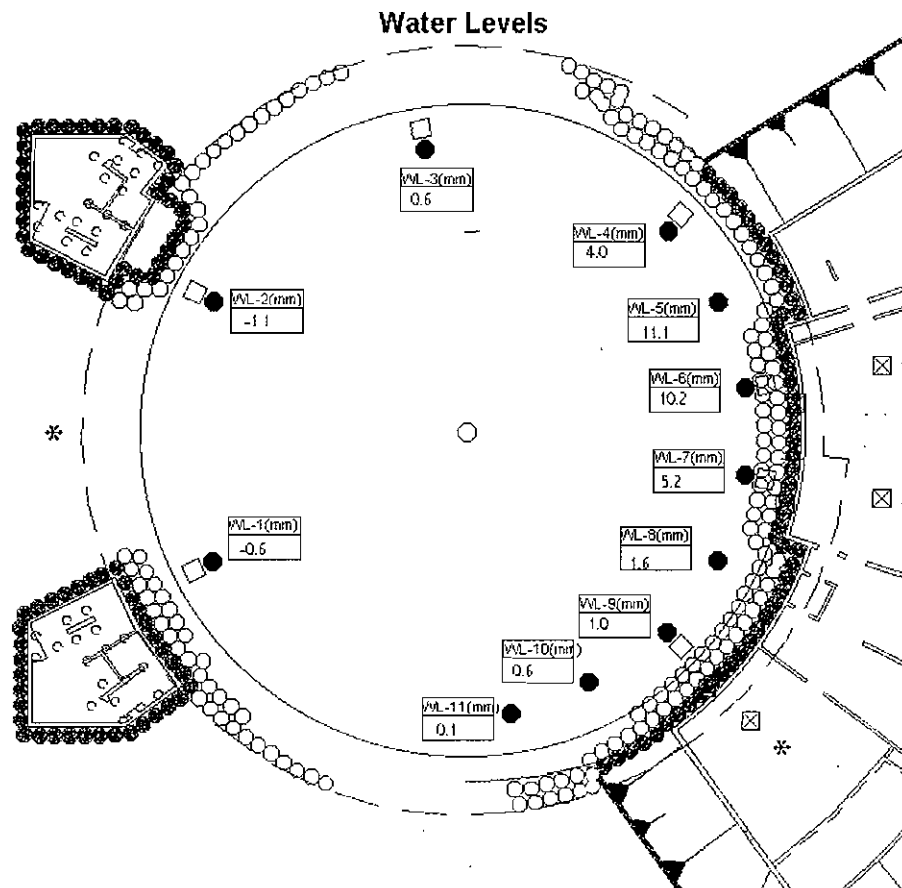
Figure 4 Typical computer presentation showing water cells

- Green settlement less than or equal to the finite element prediction.
- Amber settlement over the predicted value but not exceeding the actual limit.
- Red exceeds the actual limit for that given construction stage.

By “clicking” with the mouse on any one of the water cell points a second presentation was given showing settlement changes over the previous five days for the individual water cell. Figure 5 shows a “five day” water cell presentation for all the cells on site.

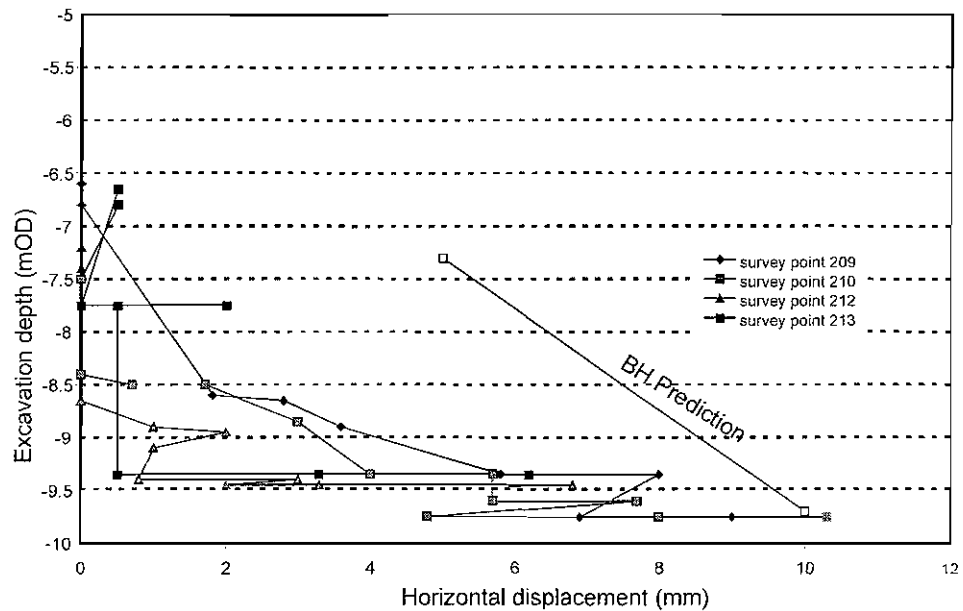
Figure 7 Precise surveying – lateral movements

Comparison between predicted lateral movements during basement excavation and observed performance of a number of surveying points is given in Figure 7. It will be noted that movement continued subsequent to the full depth of excavation having been reached, due to continuing "elastic" displacement and the removal of the berm (see Section 6) during wall construction. Inclinator displacements are given in Figure 8 for the period when the full depth of excavation had been reached but before lateral movements had stopped; unfortunately a review of subsequent data showed inconsistency in the readings. Both cases show good agreement with predicted values with a variance of about 1 mm for both the lateral and vertical movements (See Table 2).

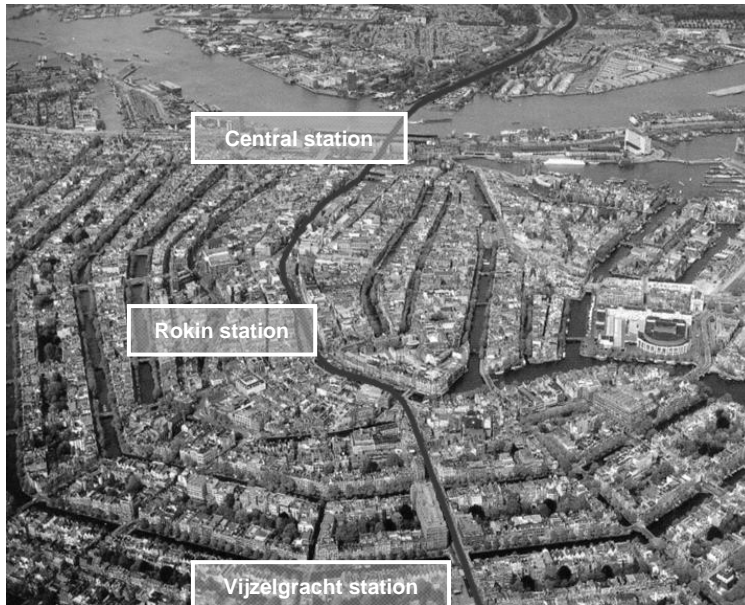
Fig. 1: Aerial view of the North-South Line in Amsterdam.

As shown on the photograph, the line starts in the north part of the city, then crossing the river IJ, the Central station, followed by the old city centre. At the end the North-South Line is connected to the existing metro line at Amsterdam South – World Trade Centre. Figures 2 and 3 show maps of Amsterdam with the metro line and the stations.

it possible to realise the wish of the city of Amsterdam to construct a metro line in the old city centre without removing buildings in the proposed alignment. By the end of the century the design of the line was finished and in the period of 2000 to 2002 several contracts were signed with different contracting companies to start building the metro tunnel and its stations. Figure 1 shows the alignment of the North-South Line.

Figure 1 shows the alignment of the metro line from the north to the south. As shown on the photograph, the line starts in the northern part of the city, then crosses the river IJ, crossing the central station, followed by the old city centre. After the old city centre the new North-South Line is attached to the existing metro line at Amsterdam South – World Trade Centre. Figure 2 shows the map of Amsterdam with the metro line and the stations.

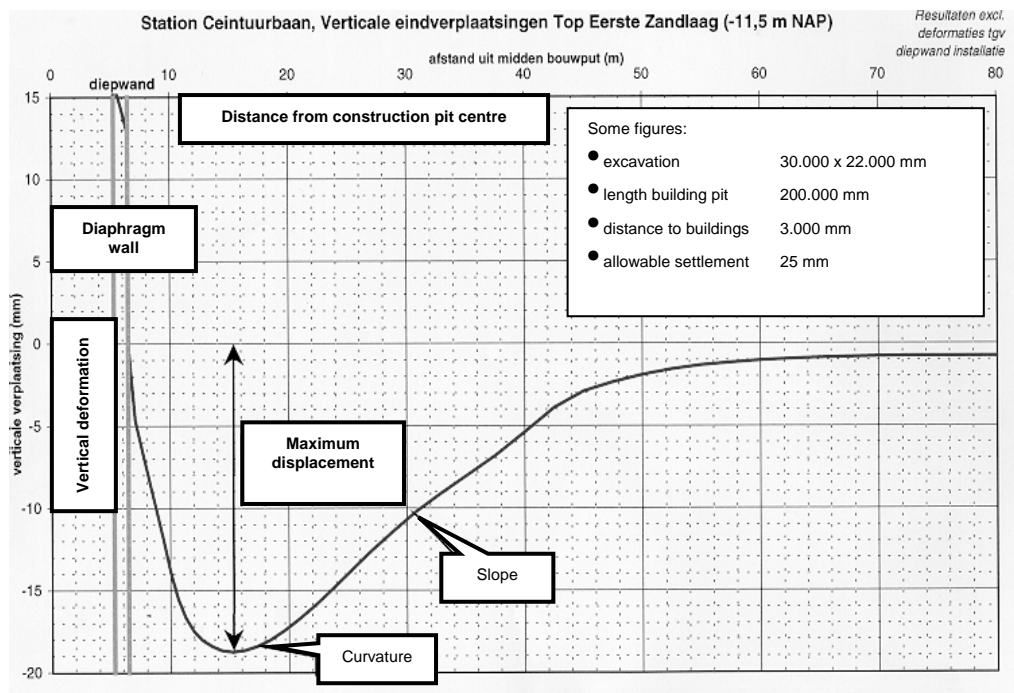
Fig. 5: Representative prediction of settlement of the first sand layer.

Based on these assumptions the contractual design was made. The constraint of a maximum settlement of 25 mm is based on the assumption that settlements within this limit should not lead to major damage to the surrounding buildings. FEM calculations using Plaxis showed that with the design parameters described above the settlement of the first sand layer stayed within this limit. See Figure 5 with the results of the FEM calculations.

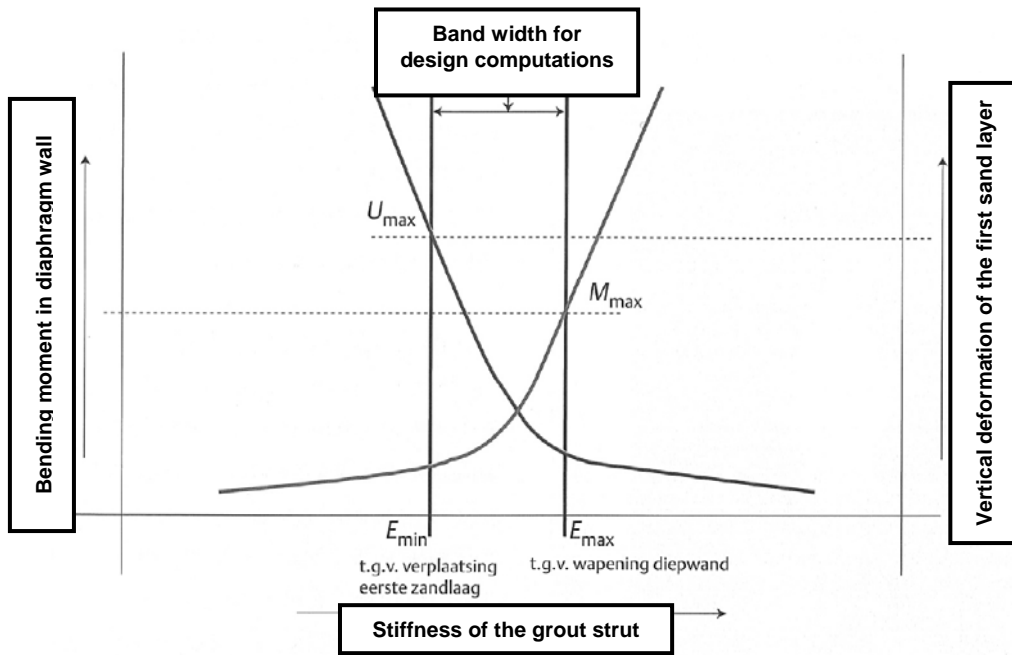
Fig. 13: Band width for the stiffness of the grout strut.

The initial stiffness of the individual grout columns, and therefore of the complete grout strut, however remained an uncertain parameter in the design process. This was further complicated by the uncertainty about the creep of the material. To control the upper boundary of the stiffness the idea was raised to introduce holes in the middle of the grout strut. See Figure 9 where a part of the grout strut applied with these holes is inputted in an FEM program. A new design for the grout strut was made by introducing a difference in column types, the so-called red and green columns. Green columns were columns to be made without restriction. The red columns were optional. If the stiffness of the grout columns to be produced should prove to be low the red columns had to be made. Red columns could be left out if the stiffness of the grout columns should prove to be high. Through this observational method a controlling tool was created to keep the cumulative stiffness of the grout strut within the narrow allowable boundaries as shown in Figure 13.

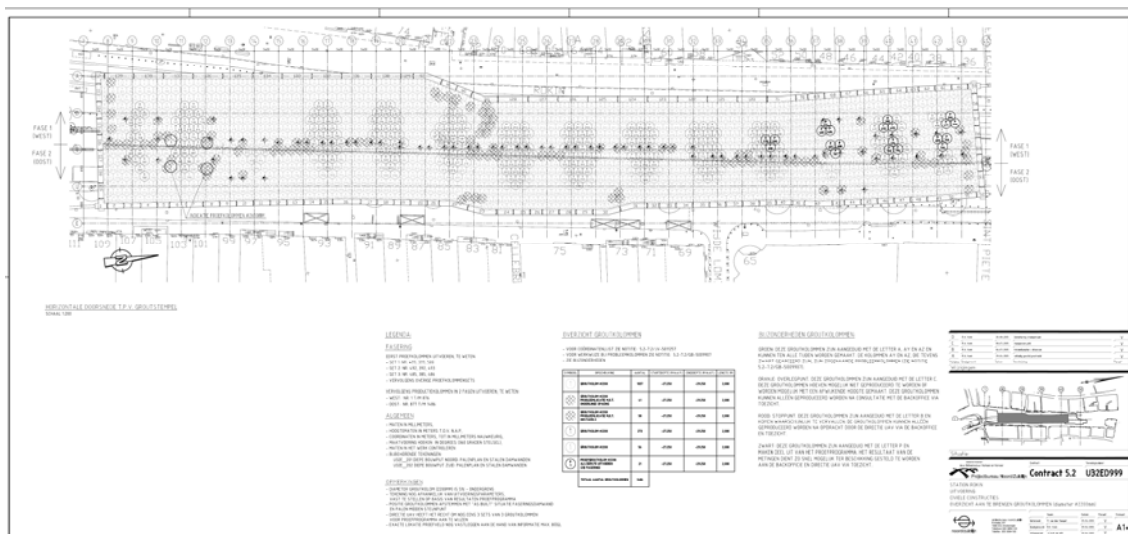
Fig. 14: Amended lay-out of the grout strut at Rokin with green and red columns.

This observational method obliged the contractor as well as the designers to have detailed information on the stiffness and strength of the grout columns in an early stage of the project. For this reason the contractor made core borings and took samples from the first columns to be tested in a laboratory on strength, stiffness (including creep) and cement content. On a weekly basis the contractor was informed by the supervisor if red columns had to be made or could be left out. Although the progress of the works was at risk by this method the works were not hampered. Since there were some differences in the design stiffness of the different station boxes the red columns were omitted at Ceintuurbaan and Vijzelgracht but the major part of the red columns were made at Rokin, see Figures 14 and 15.

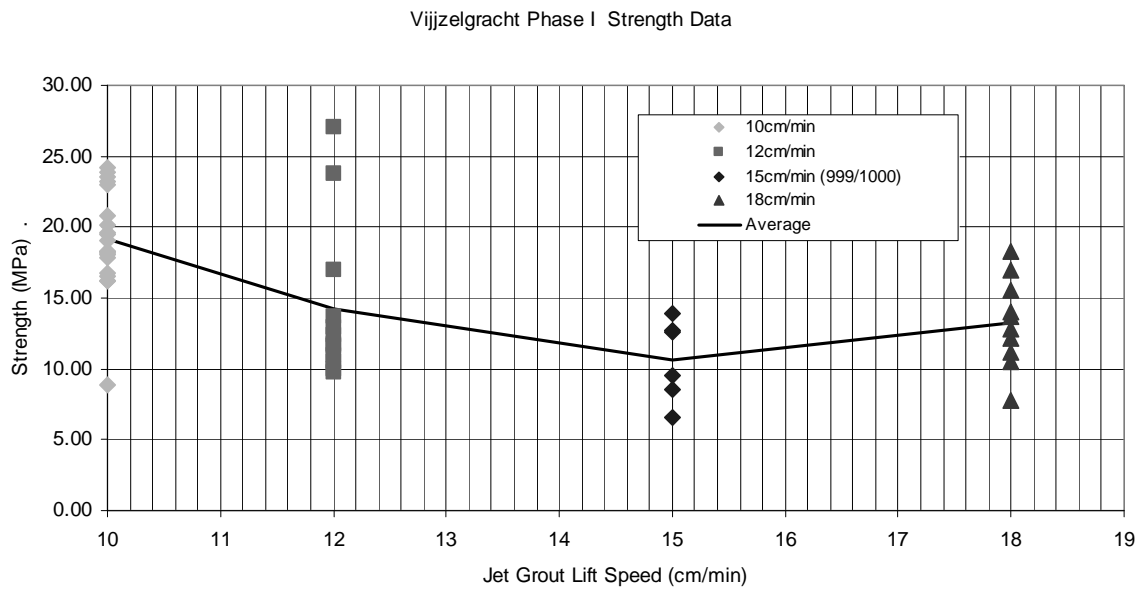
Fig. 4: Results of core strengths compared to jet grout withdrawal rate.

The results generally show a trend of decreasing strength and stiffness with increasing withdrawal rate as expected as the theoretical column cement content is decreasing. The graphs also show that the required strength and stiffness were easily exceeded.

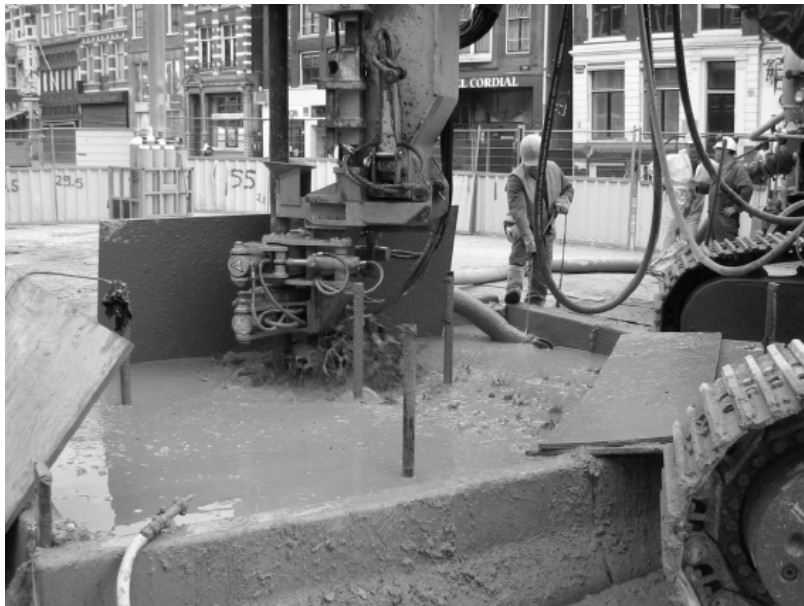
Fig. 9: Diameter measurement by Hydrophone.

For Rokin Phases 1 and 2 and Ceintuurbaan station boxes, the jet grouting was carried out by Bilfinger & Berger who had developed their own method of diameter measurement using hydrophones. This functioned by placing microphones around the perimeter of a column and then listening through microphones for the impact of the grout jets. In operation, two or three 50 mm holes were drilled to the depth of the bottom of the column and positioned just inside and outside the design column radius. In reality, because of the deviation of both column and hydrophone holes this was somewhat of a lottery and in a number of cases, the hydrophones ended up either too close or too far away from a column. Nevertheless, B&B could interpret the waveform and make some estimation of the position of the hydrophone in relation to the column diameter. Generally sets of three columns were measured which gave more chance of using the hydrophones successfully. Figure 9 shows a test in progress and Figure 10 shows the layout of column and hydrophones. The design diameter in this case was 2.2 m based on a conventional double jet grout system.
