# The Conservation of Wall Paintings

Proceedings of a symposium  
organized by the Courtauld Institute of Art  
and the Getty Conservation Institute,  
London, July 13-16, 1987

Sharon Cather, Editor

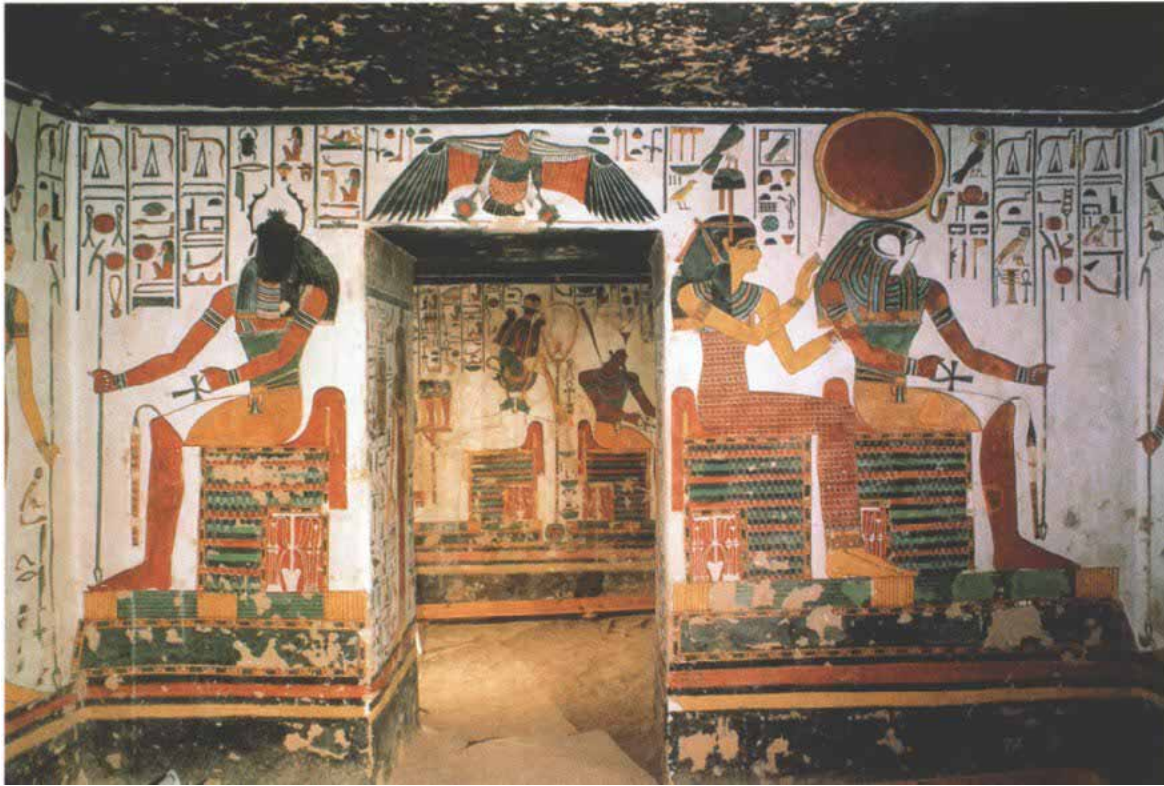
Plate 1, above. View of the east wall of the vestibule (E) with Kheperi, Isis, and Harakhty, and into the inner chamber (G). 1987.

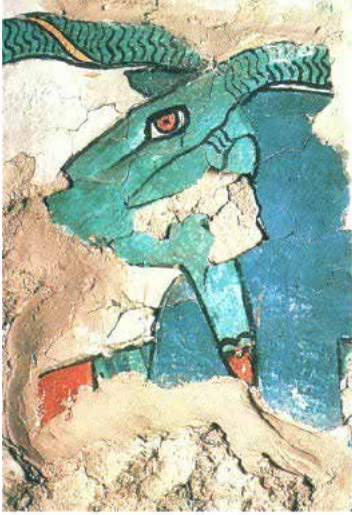
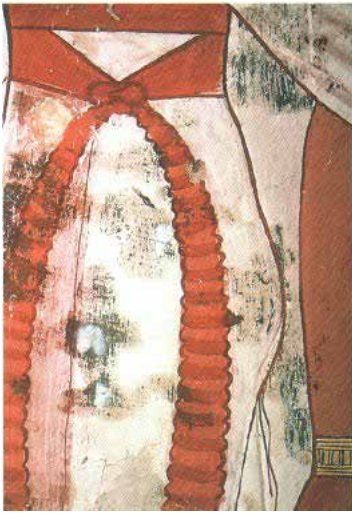
Plate 6, top. North wall in the sarcophagus chamber (K). Detail of dangerously detached plaster. 1986.

Plate 9, bottom right. North wall in the sarcophagus chamber (K). Reattachment of partially detached plaster. 1987.

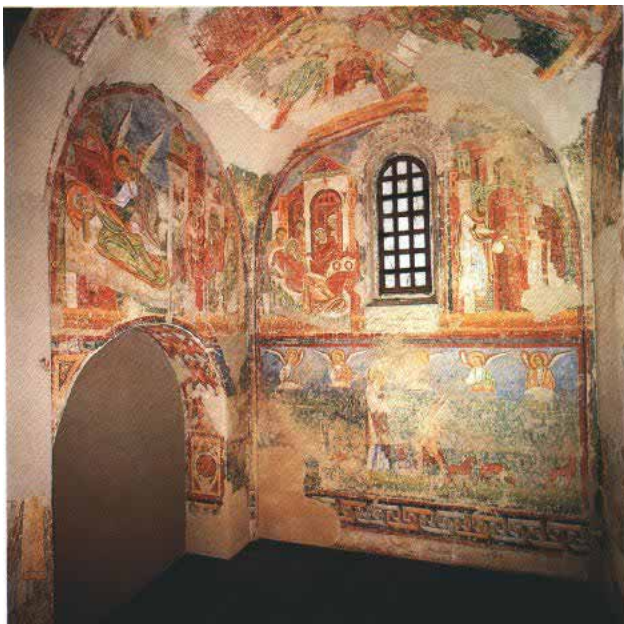
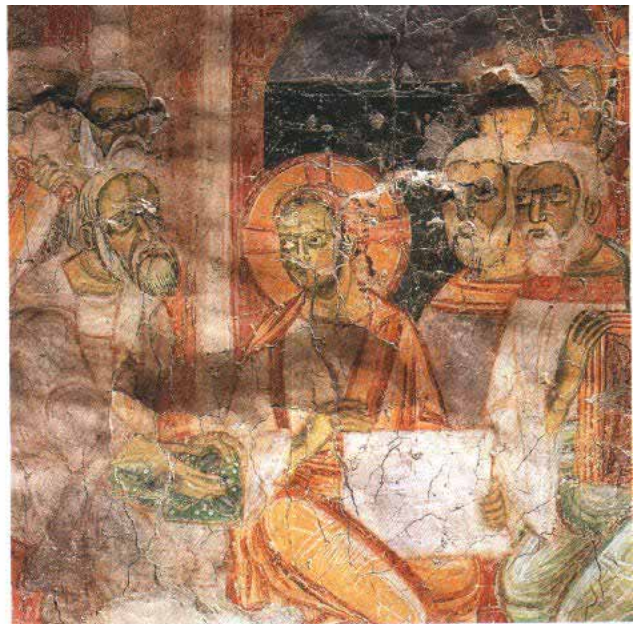
*Two-thirds of this scene was desali-  
nated and consolidated with sili-  
cates. Details show an area that  
required treatment (Pl. 26, upper  
left) and an untreated area (Pl. 27,  
upper right).*

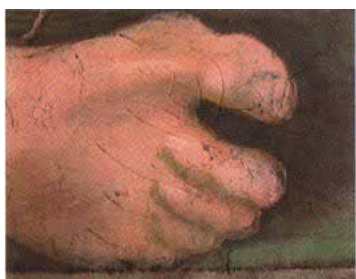
*Plate 35, below. The Creation of Adam. Detail of the foot of Adam after cleaning, showing indirect incisions, pentimento, and translucent preparatory drawing in black.*

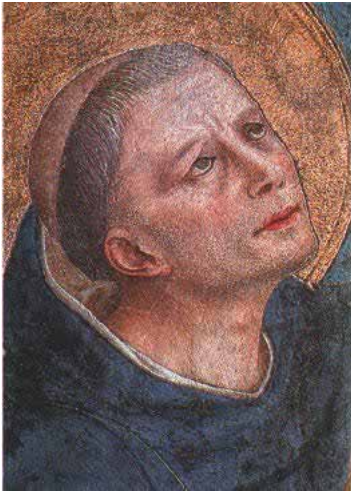
Plates 53 and 54. Fra Angelico, Christ on the Cross Adored by Saint Dominic. Florence, Convent of San Marco, Cloister. Treatment based on barium was carried out in 1973, and these details were photographed in raking light in 1987 (compare Figs. 4, 5 on p. 146).

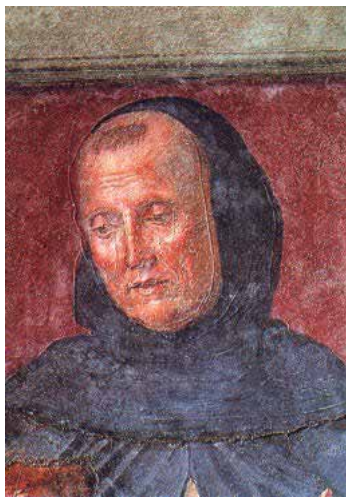
Plates 55 and 56. Giovanni Antonio Sogliani, The Last Supper. Florence, Convent of San Marco, Old Refectory. Treatment based on barium was carried out in 1975, and these details were photographed in raking light in 1987 (compare Figs. 6, 7 on p. 147).

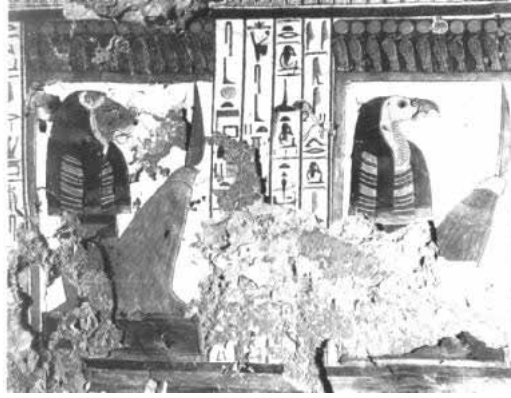
Figure 2, top. Detail of Nefertari before the First and Second Door of the Domain of Osiris. Sarcophagus chamber (K), south wall, east side. Condition when photographed by Schiaparelli in 1904-1905.

Figure 3, right. As in Fig. 2. Condition when recorded by the Metropolitan Museum of Art, ca. 1922.

Figure 4, bottom. As in Fig. 2. Condition in 1986 after emergency stabilization as part of the present program for the preservation of the paintings.

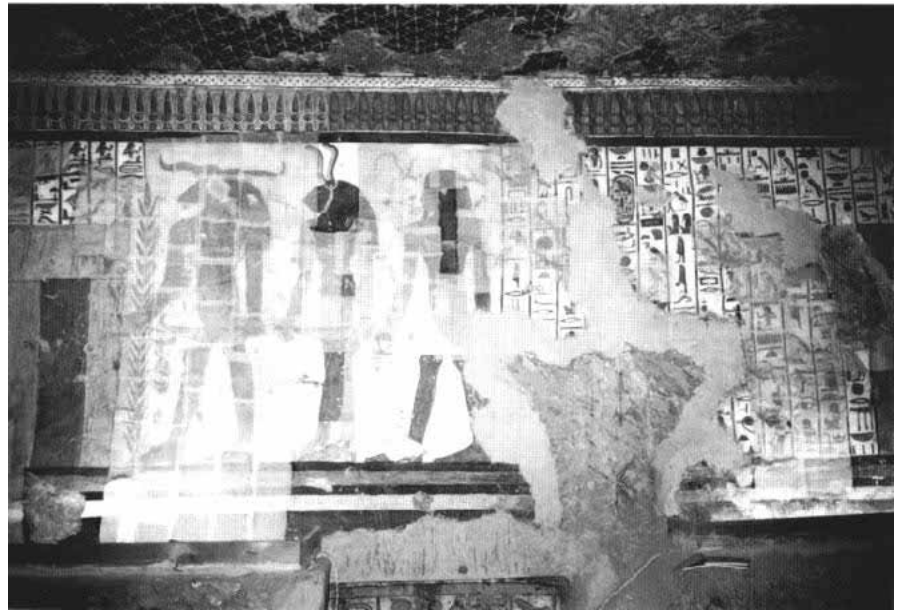
*Figure 6, top. Mechanical damage due to carelessness is evident here at the level of the ledge that runs around the sarcophagus chamber (detail of Fig. 7). 1986.*

*Figure 7, above right. Sarcophagus chamber (K), east wall, south side. Guardians of the Second Gate of the Domain of Osiris. Condition in 1987, with facings and repairs from previous interventions.*

Throughout the tomb there was evidence of previous restorations. These localized attempts had been carried out at different periods and in different techniques (Fig. 7); although a few of them are of good quality, most are aesthetically unacceptable (Pl. 8), and some pose risks for the survival of the surrounding painting.

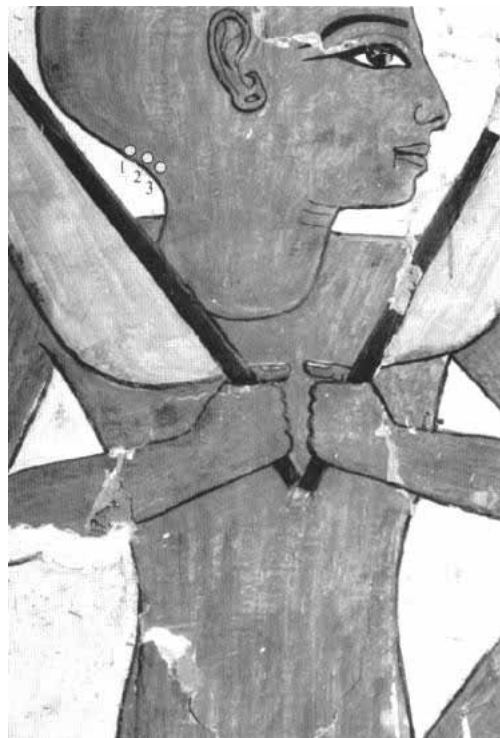
*Figure 9. An area (K-2A) on the east wall of the sarcophagus chamber (K) selected for color measurement. 1986. Data for the red is given in Table 2.*

For the recording every effort was made to select original colors, avoiding previous interventions. Seven areas of painting were chosen and documented photographically. To remove loose surface contaminations, they were first dusted lightly with a soft squirrel-hair brush while air was blown from a bulb syringe. Due to the lack of homogeneity of the painted areas, three measurements were made of each color occurring in each painted area and marked on Polaroid photographs (Fig. 9). Thus for each color there are Y x y values, the range of these values related both to the homogeneity of that color and to surface roughness (Table 2). One composition was completely measured twice in order to assess the reproducibility of the procedure.

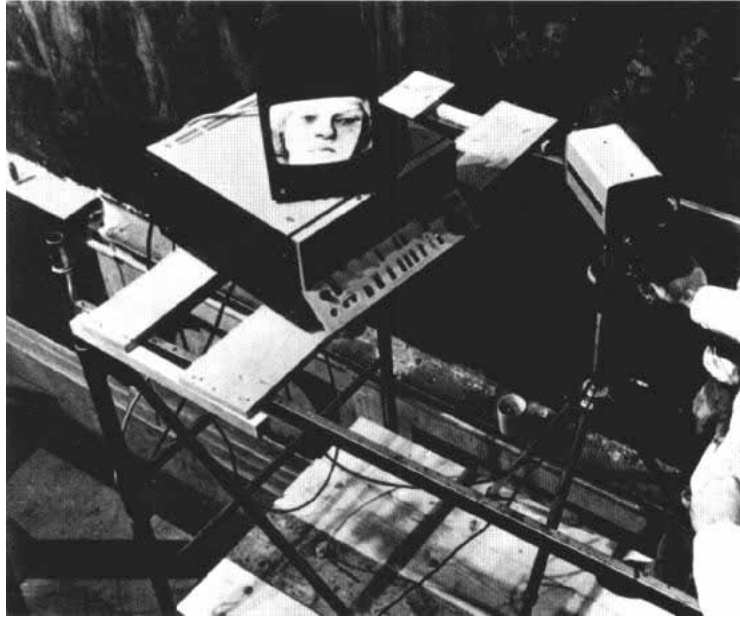
Figure 6. Infrared reflectography used for examination.

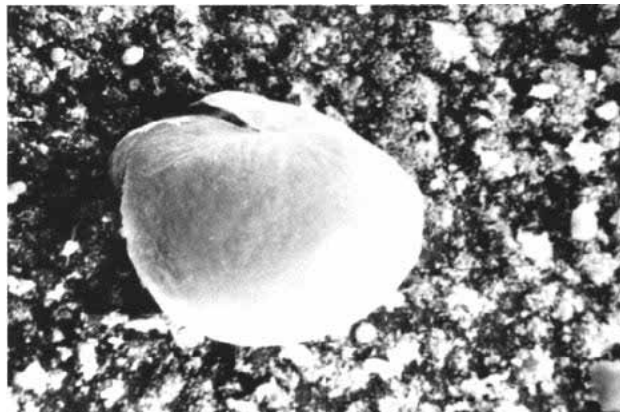
Figure 7. Study of the microenvironment included examination of the quantity and nature of the suspended particles.

Environmental causes of deterioration were assessed in terms of the microclimate and the microbiological load. Study of the environment included particular reference to the measurement of the concentration of ambient sulfur dioxide. Examination of the nature and quantity of suspended particulates (Fig. 7) indicated that they were about 80% carbon, explaining the serious deterioration of the frescoes. Microbiological activity was investigated by sampling both from the painted surface (from scrapings and wet and dry swabs) and from the

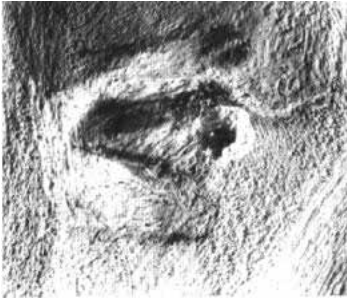
*Figure 5. A funnel-shaped loss in the render caused by the slaking of calcium oxide. Photographed in raking light. 1984.*

The next step was to assess the damage to the render. Most of the large areas of loss caused by water penetration were limited to the area above the west wall (see Pl. 16). Smaller losses occurred along the cracks, and alveolar formations caused by crystallization of salts were found in the surface. In several places, render that had been preconsolidated was flaking off. The adhesion of the two-layer render to the support was good, and there were only a few hollow spaces. Two types of crack formation were apparent: shrinkage cracks, which had formed as the fresco set, and cracks of varying depth and width that had developed later. Another type of damage consisted of small circular areas (1-7 cm in diameter) where the render had lifted off the support; in some places it had already fallen away, leaving a funnel-shaped loss (Fig. 5). This was caused by unslaked lime particles in the render; as they absorbed moisture and were converted from calcium oxide to calcium hydroxide, they increased in volume and deflected upward, leading to the loss of painted render.

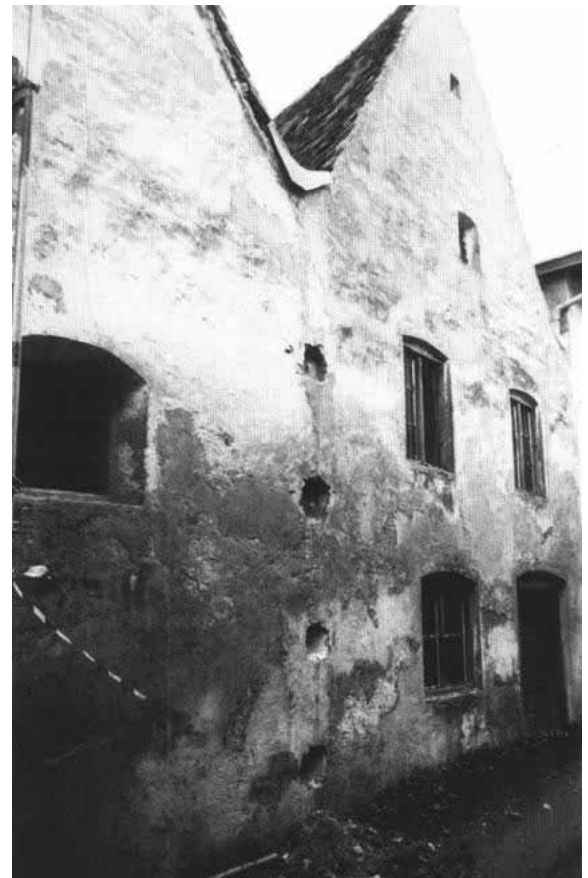
Figure 5, below right. Schloß Laupheim. Remedial structural measures involved insertion of two anchoring rods and the replacement of two columns (arrows) of the arcade with reinforced concrete columns.

Schloß Laupheim is another illustration of the effectiveness of this method of maintaining a wall in its original state without any visible interventions. Two anchors were sufficient to reestablish the shear value of this wall. Moreover they permitted the preservation not only of valuable internal wall surfaces but also of the entire load-bearing structure except for two columns replaced in reinforced concrete (Fig. 5).

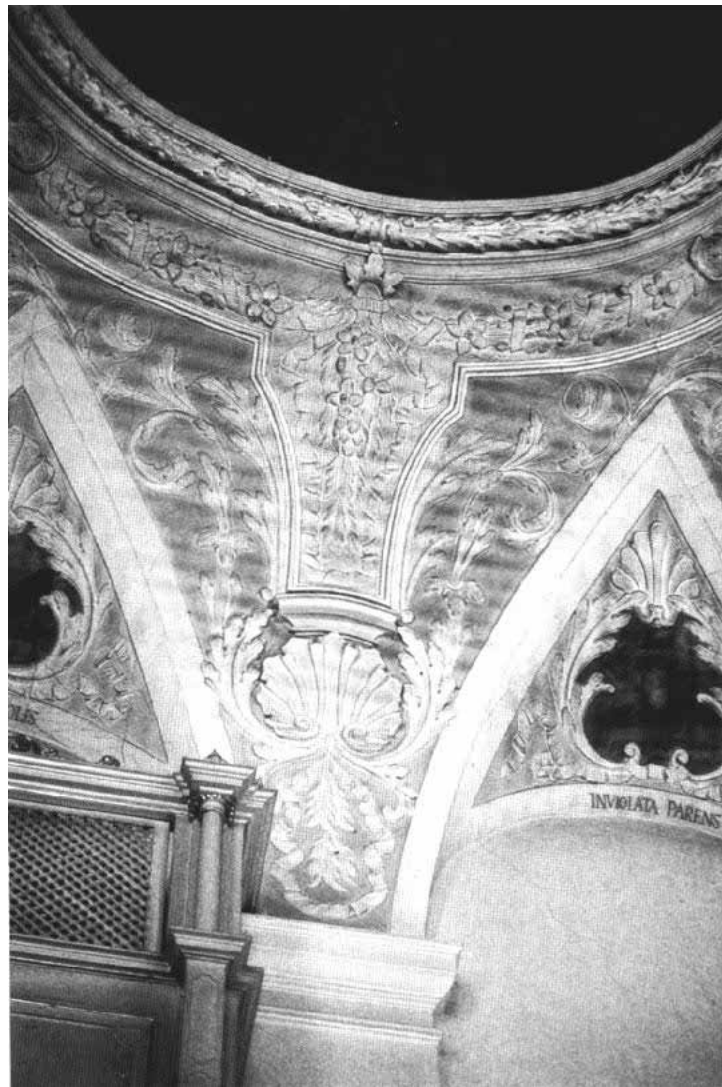
*Figure 6. Damage resulting from the different thermal conductivity of plaster and wooden lath.*

If an increase in moisture is superimposed on this effect, there may be additional dangers from algae and other organic infestations. Nevertheless, modifying thermal conductivity parameters may be acceptable, or even beneficial, to ensure the ongoing existence of paintings if the effect of thermal insulation can be spread over a large surface. In order to protect wall paintings, all localized "hot spots" are to be avoided. The application of a rock-wool insulation layer to the painted dome of a church, for example, will decrease thermal tensions within the vault without producing detrimental side effects.

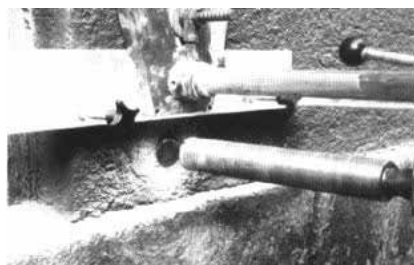
*Figure 11, right. Drilling a solid core for direct moisture measurement.*

The best method available is to drill a solid core (Fig. 11), since only undisturbed material, not drilling dust, provides information as to porosity percentages. Since it is essential to know the distribution of water within a wall, cores are segmented immediately upon drilling and the segments measured separately, so that a horizontal moisture profile results. Any core so drilled must be sealed immediately in a vapor-tight container for weighing in the laboratory. The first result obtained, the wet weight, corresponds to the weight of the material sampled including moisture. Next the sample is dried to a constant weight (Fig. 12) and re-weighed, giving the dry weight. Finally, the sample is rewetted to a constant weight and reweighed. This final result, the saturation weight, indicates the maximum quantity of water that can be absorbed by the material being tested. From these three values the extent to which any wall is already water-logged can be derived.

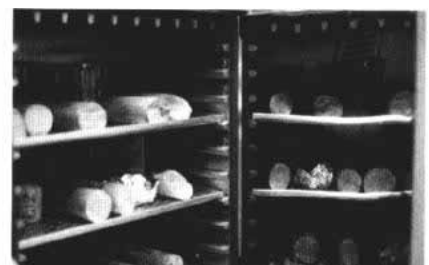
*Figure 12, far right. Drying solid cores that have been segmented to provide a profile of moisture content.*

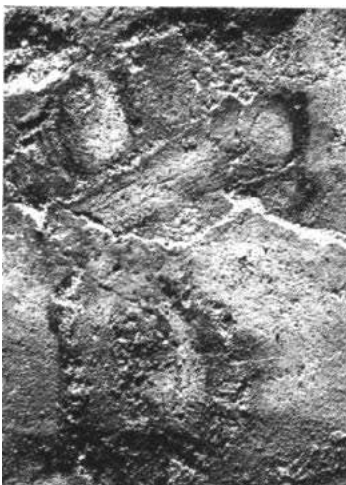
Figure 4. West wall, north bay, detail of Christ Healing the Man with the Unclean Spirit in the Synagogue at Capernaum, in raking light, showing the condition in 1979.

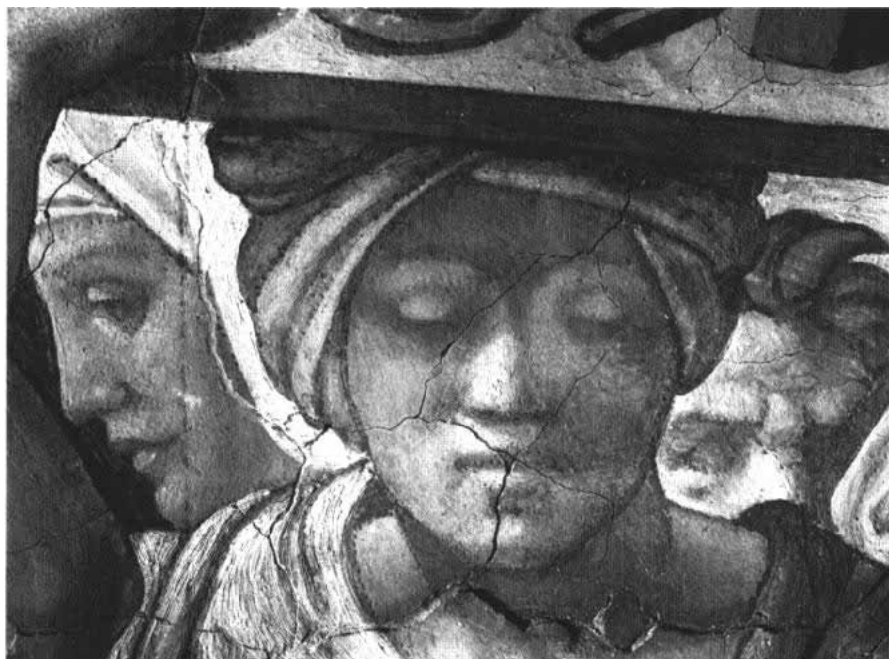
Figure 3, right. Detail from *The Flood*, after cleaning, showing the spolvero from the transfer of the cartoon, and a snapped line.

transferred the cartoons by pouncing (Fig. 3) and, more rarely, by indirect incision through the cartoon. In the second half, however, transfer by indirect incision is much more frequent than pouncing (Pl. 35). Often, the light pouncing is traced over in black with the point of a brush (Fig. 4). Sometimes within areas of flesh painting incision directly onto the fresh plaster is done with a thin point (Fig. 5). The lunettes, the nude bronze figures and others—such as Noah planting the vineyard (Fig. 6), or the sleeping soldier in the pendentive of Judith and Holofernes—are all executed *alla prima*, painted without cartoon, directly with color, at times with the aid of a summary preparatory drawing. The resulting painting is broad, almost gestural. When *pentimenti* occur in these areas they are executed during the work and therefore in fresco, but are covered by the overlying colors.

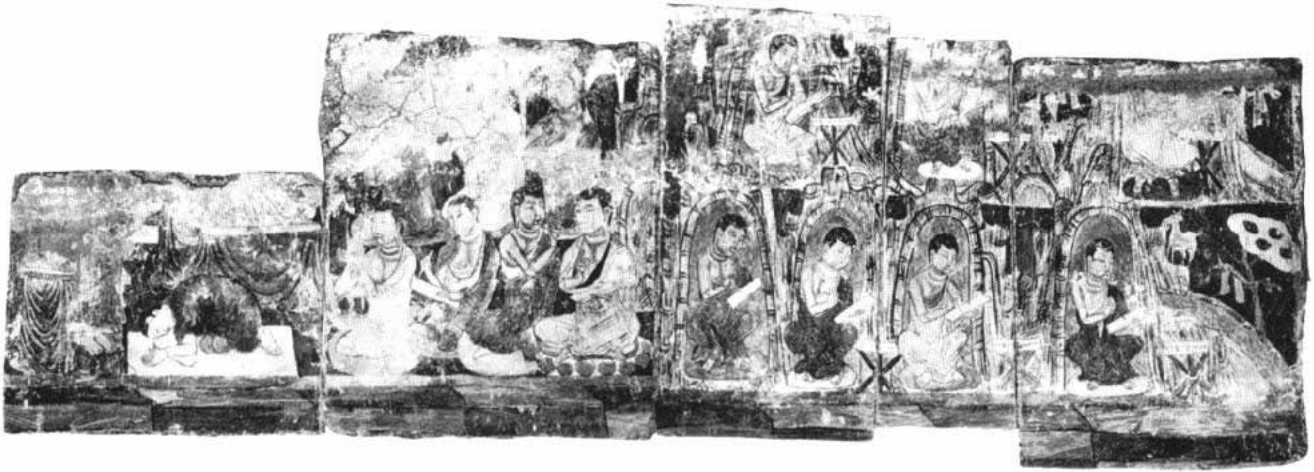
Figure 7, above. Monks Receiving Instruction. *Ming-Oi*, 8th-9th century. 77 x 223 x 0.5 cm. London, British Museum, OA Mi xiii 5-9. (Reproduced from Stein 1921: 4:CXXV.)

Cut into sections by Stein for removal and transportation, the painting arrived in the British Museum after his expedition of 1916, and was published in 1921. The illustration from that publication (Fig. 7) shows the irregularly shaped sections correctly aligned to each other. For removal from the wall, the trompe l'oeil border at the bottom was cut in a straight, but stepped line, while the tops of the sections were cut in a less even fashion, perhaps to avoid more deteriorated areas of the painting. Vertical cuts were made along the yellow band that separated the individual scenes of the monks. The original width of this band is not recorded, but traces of it remain on the edges of one section, suggesting that loss was minimal. Much of the damage and deterioration now

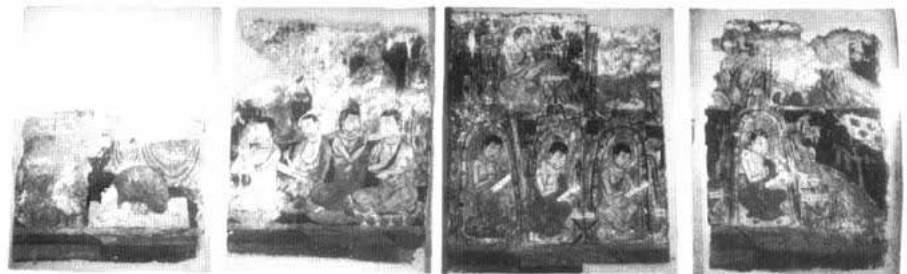
Figure 8, right. General view of Monks Receiving Instruction before conservation, 1987.

evident is visible in Stein's photographs. Loss of the paint layer and ground has occurred in a number of areas, and in others the exposed clay/straw render is disrupted and friable. There are also numerous cracks and abrasions. Deterioration may have occurred in situ in the course of the destruction of the shrine and from rainwater, which, though rare in this region, could have penetrated the ruined structure. Also, given the brittle nature of the paint and support, damage is likely to have been exacerbated during transportation to England. Finally, there are areas of lifting paint seemingly due to the failure of the bond between the paint layer and ground and the substrate.

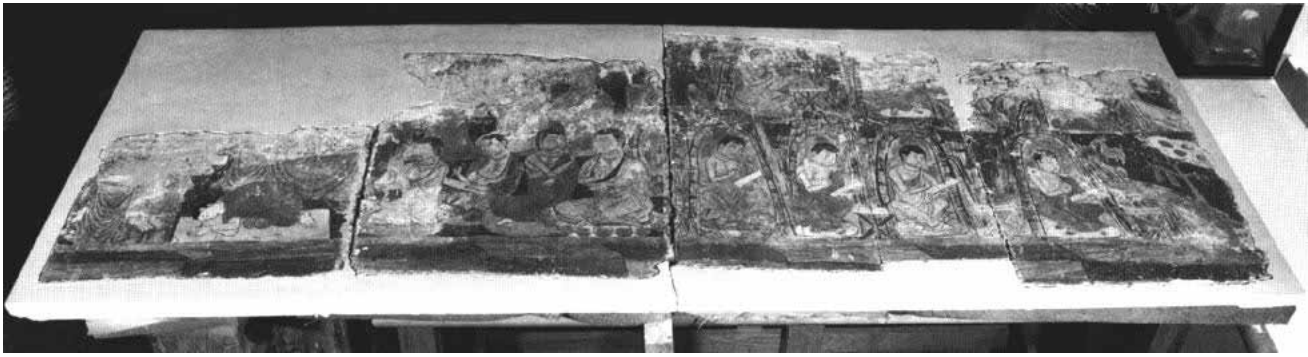
Figure 10. General view after conservation.

Once the local consolidation, gap filling, and relaying of paint flakes had been done, the five sections were ready to be remounted. By joining them in two units of two and three sections each, they could be held in position but would still be of manageable size for handling. A smooth, neutrally colored surround, level with the paint surface, was required. In addition the painting was to be placed in a glazed frame without the vertical divisions of the previous one.

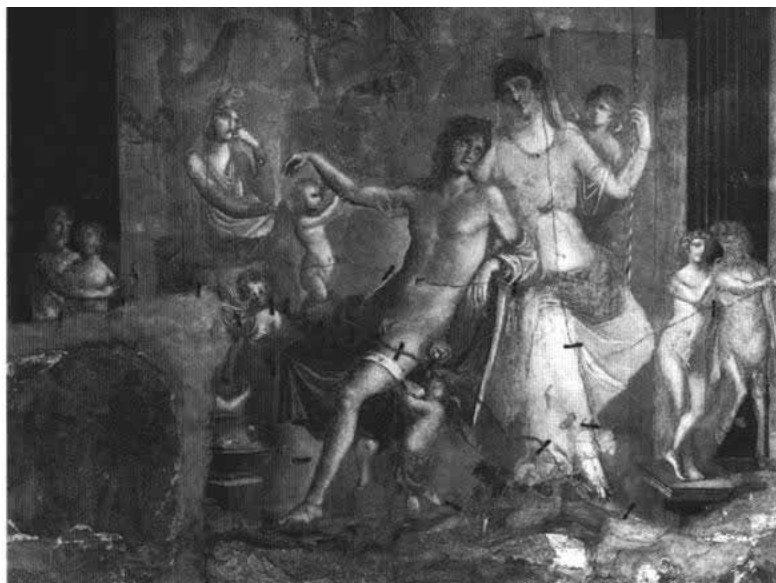
*Figure 10, right. Adonis and Venus in the Casa dell'Adone Ferito. Pompeii. Note the use of lead cramps and the mortar repairs. Photographed in 1930.*

Even more serious than the treatment with wax was the lack of shelter in most of the houses in Pompeii (see Pl. 43; Kockel 1986:503, ill. 37, 38), lamented by Winckelmann (1762, 1764), Goethe (in 1787),<sup>22</sup> and many others. Nevertheless some measures were taken and we find early descriptions of lead cramps installed to prevent the plaster layers from falling off the wall. However, many of these have gradually come away leaving holes and other damage (compare Figs. 10 and 11). Workmen smeared the edges of the paintings with ordinary mortar, which even nowadays has not always been replaced by better materials.

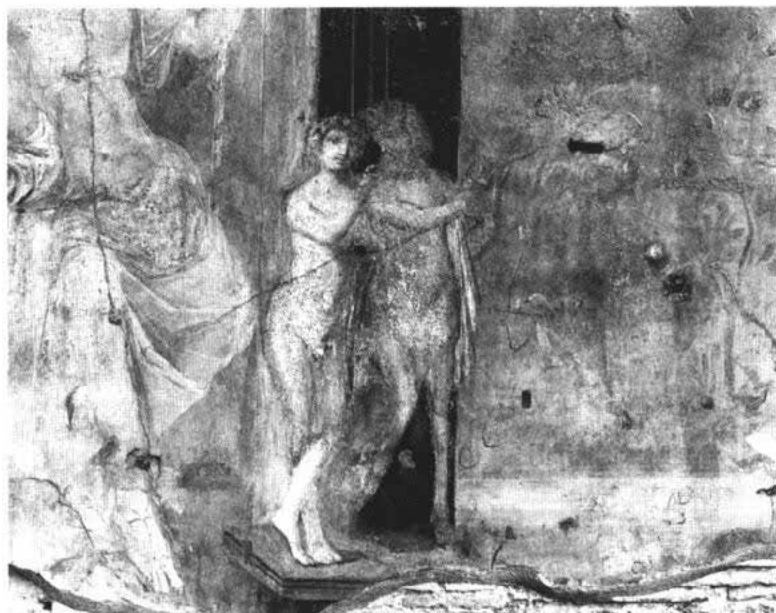
*Figure 11, below right. Detail of Fig. 10. Photographed in 1982.*

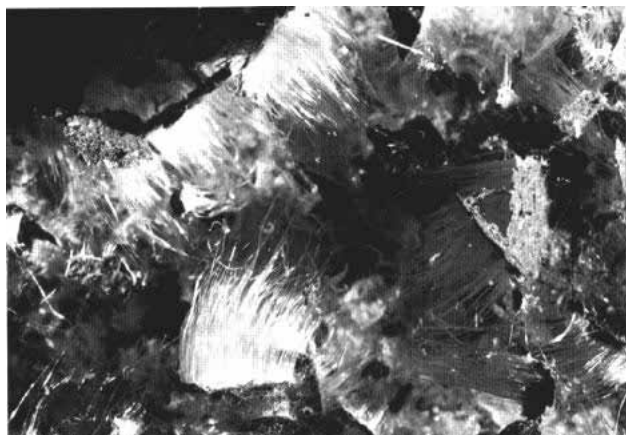
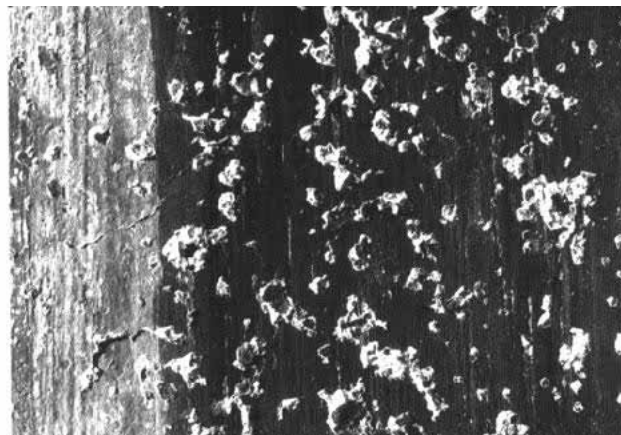
Figure 16. Relationship of the averaged daily values for relative humidity (RH) and temperature (T) to the observed salt crystallization (shown below) in the crypt of the Grossmünster, Zurich, 1986.

The crypt of the Grossmünster in Zurich (Fig. 16) is heated continuously from November to April (the convent church of Müstair will be discussed separately below). This reduces the relative humidities from values of 60-80%

to values between 40 and 60%. Nitronatrite crystallizes during late autumn, when the relative humidity falls below 60%, and crystallization continues, slowing during the following months. During the same period the crystals undergo a kind of aging, with their habits transforming from acicular to more isometric shapes. From May through June, when the relative humidity rises again to values above 60%, the crystalline salts disappear, dissolved at an air humidity above the equilibrium relative humidity.

Thus the main deteriorating events caused by crystallization occur in the crypt when the air is dried drastically by heating the room. This has accelerated the process of decay since the last restoration.

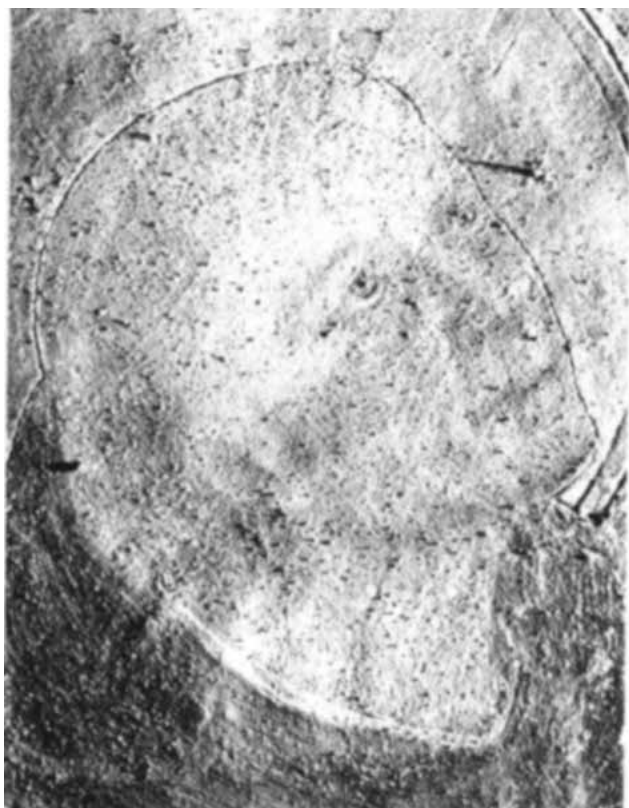
*Figure 6, facing page, right. Sogliani, The Last Supper, detail. Photograph taken in raking light before treatment with barium in 1975. Compare Pl. 55, taken in 1987.*

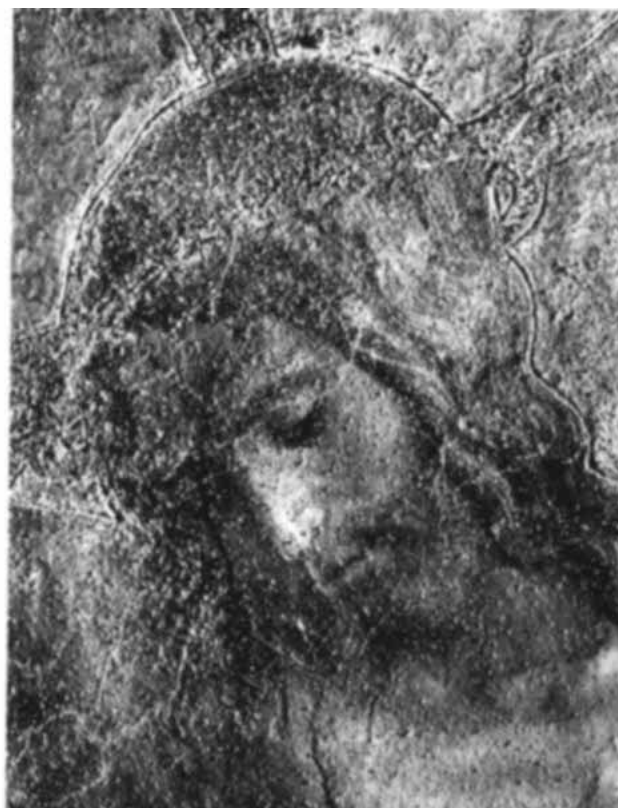
*Figure 7, facing page, far right. As in Fig. 6. Compare Pl. 56, taken in 1987.*
