I-68

# Fog Detection System

## Planning Report

Sabra, Wang & Associates,  
1504 Joh Avenue, Suite 160  
Baltimore, MD 21227

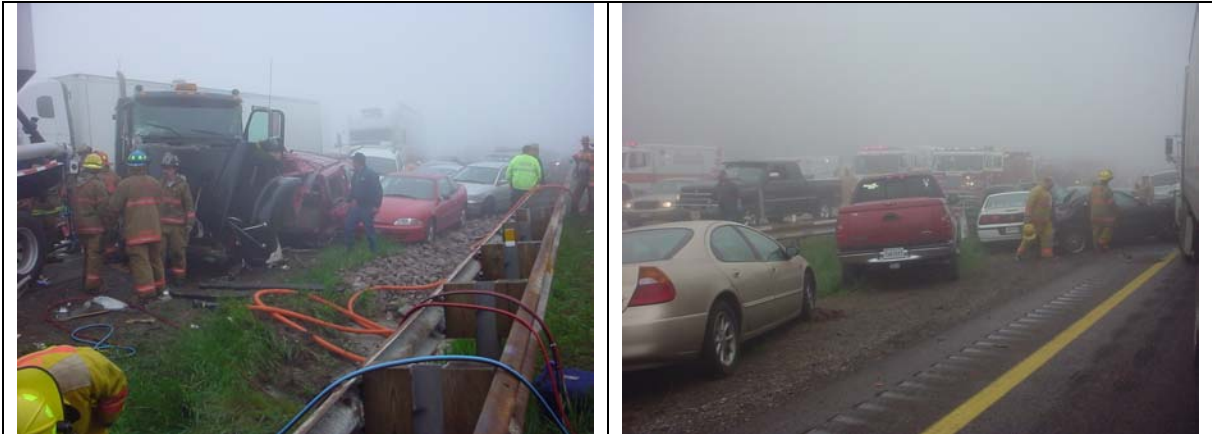
**Figure 2. Photographs From May 23, 2003 Accident on Big Savage Mountain.**

As operations wound up, the extent of the accident could be defined. Two patients died at the scene from injuries and 64 patients were transported to area hospitals. Approximately 90 vehicles were involved in both accidents, which included tractor trailers as well as passenger vehicles. Heavy fog was blamed for the accident. Interstate 68 remained closed for approximately 24 hours after the first accident occurred.

The accident location was near the I-68 cut on Big Savage Mountain which is 2,900 feet above sea level. In this area, foggy conditions are common in the spring and icy conditions are common in the fall on this stretch of road.

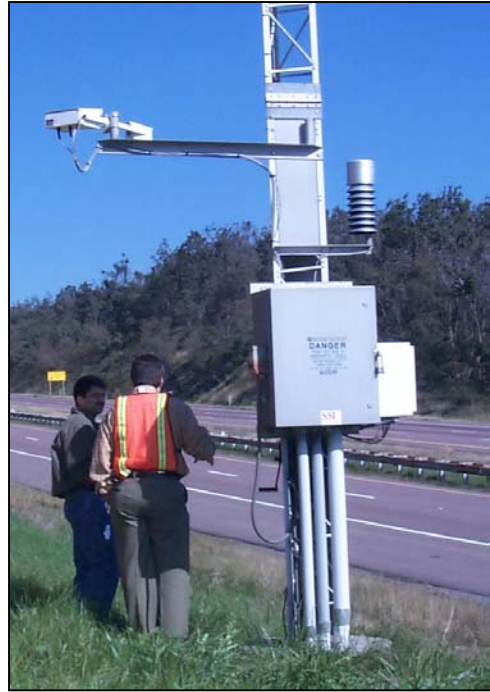
**Figure 3. I-68 RWIS Station Located Near Big Savage Mountain.**

These data are collected by sensors placed at the roadside or in the roadway itself. A Remote Processing Unit (RPU) is housed in a field cabinet and provides the initial processing of the sensor data. It also provides the communications processing necessary to transmit the information to the next level of the system. This next level is a Server located in the SHA District 6 operations center in LaVale. This Server provides communications, collection, archiving, and distribution of the data. The raw data are used directly or in coordination with a service provider to prepare weather forecasts. Forecasts can be used to predict site-specific weather and pavement conditions. The data can be used locally in District 6, but are also transmitted to the Statewide Operations Center.

The primary sensors used at the RWIS site are described below.

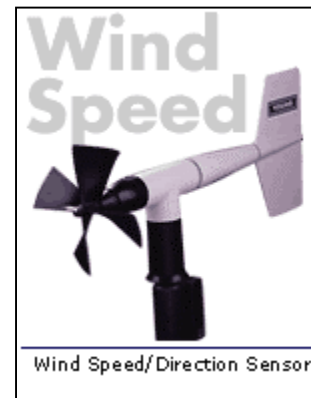
The RWIS uses the R.M. Young wind speed/direction sensor. This sensor is noted for its reliability and ease of maintenance. Mechanical sensors have been the mainstays of the meteorological community for years. Meteorologists have used two basic approaches: separate wind vane and anemometer cups or the integral wind vane and propeller. For reliability with minimal maintenance the R.M. Young has proven to be an excellent sensor.

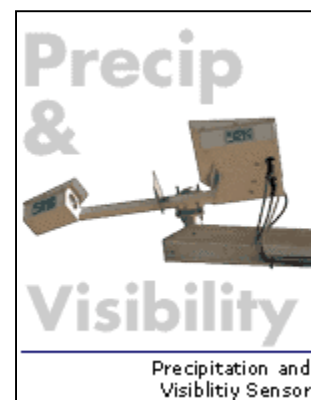
For this project, the Visibility sensor is the key. This sensor can detect the type of precipitation (none, rain, snow or drizzle); precipitation intensity (light, moderate, or heavy); precipitation rate, liquid equivalent (in actual length per time units, e.g., cm/hr) and measurement of visibility.

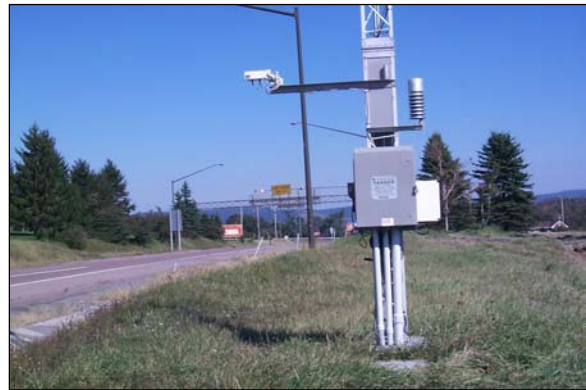
**F**  
**Figure 8. Keysers Ridge RWIS station.**

A photograph of the existing RWIS station at Keysers Ridge is shown in Figure 8.

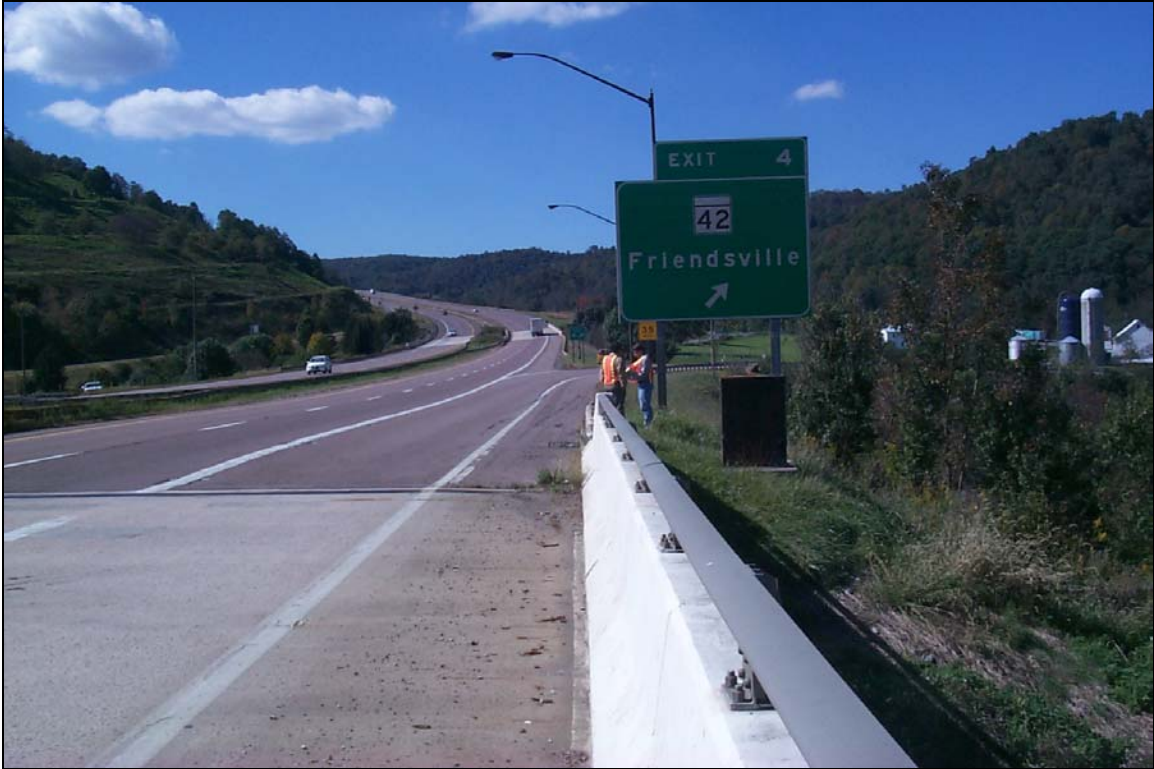
**Figure 11. Potential Location for a RWIS Station at Friendsville.**

This location differs from the others in several important aspects: the type of expected fog; the existence of existing infrastructure; the profile of the highway; and the relatively poor lines of sight, especially to the west. While the other two areas are threatened with advection fog and upslope fog that are a concern at the higher elevations, Radiation fog, also called Ground fog is the primary concern in this valley. A good potential location for the fog sensor was identified just east of the Interchange at milepost 4 on the north shoulder of I-68. A power source was located with 100 yards of the location. Although not necessary for this fog detection and warning project, it would likely be practical to install a full RWIS station similar to that located at the other two locations. The photograph in Figure 11 shows the sight looking westward from the bridge. The equipment cabinet on the right contains the power supply for the overhead lighting.

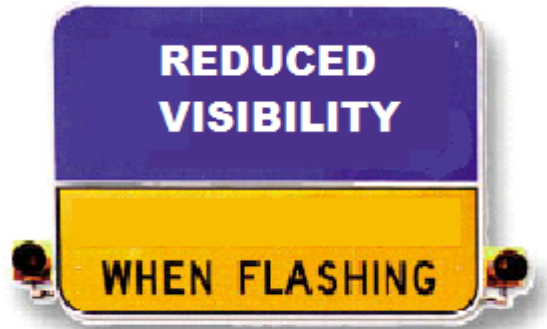
The purpose of the warning signs is to inform the motorist that there is a reduced visibility situation ahead of them. This is a task similar to the “Shazam” signs used by the SHA to inform motorists of a Highway Advisory Radio (HAR) broadcast. We recommend, therefore, that the “Reduced Visibility” sign be similar in design and operation. Flashing LED beacons will be installed at each sign, they are actuated to flash when a special reduced visibility condition is sensed at the associated RWIS. The details of the sign construction are provided in the Appendix.

**LED Displays:** The LED display beacons are a nominal 12” in size. The LED lamps are fabricated from TSiInGaP material. The LED elements shall be optimally matched and provide a uniform amber color output. The lamps incorporate multiple main circuits. All lamps use a self-regulating circuit to accommodate input voltages from 10.5 VDC to 18.0 VDC.
