Joint Verification of the location and condition of Hr.Ms. De Ruyter, Java and Kortenaer

6 to 9th of February 2017, Jakarta Indonesia

Version 09/02/2017

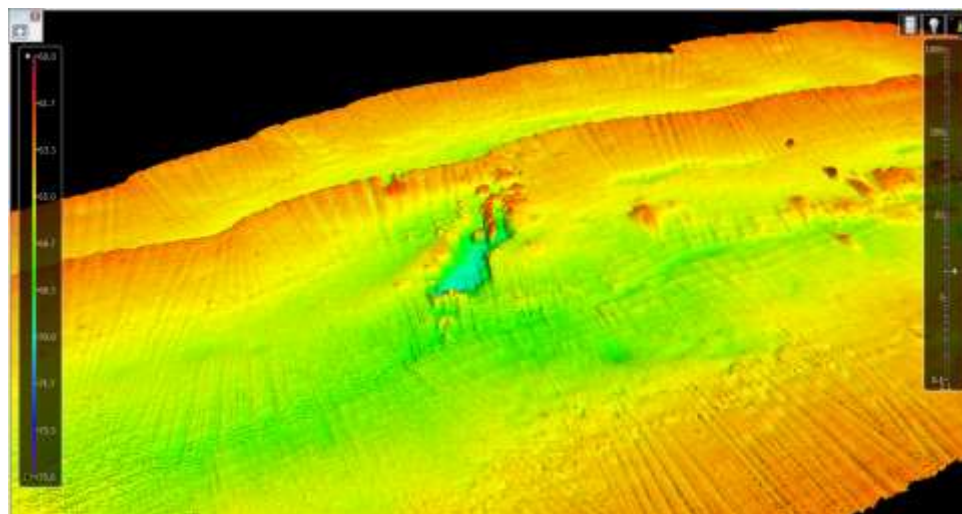
Figure 4: Surface grid 1m bin in 3D View.

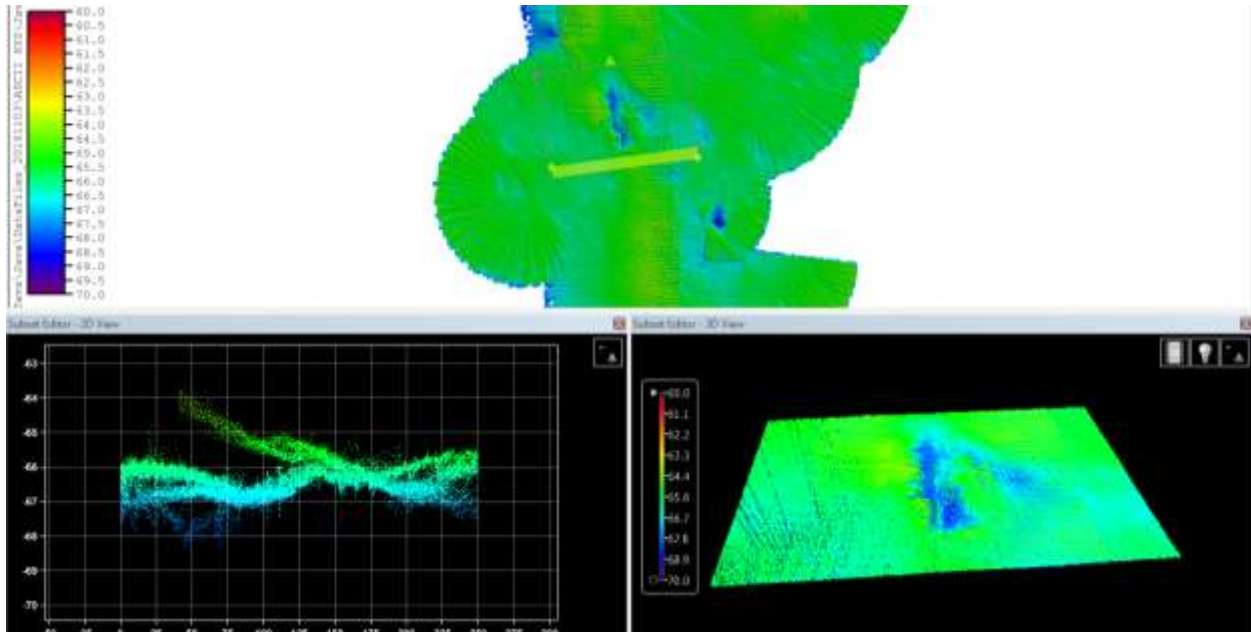
Figure 7: Examining MBES Data Surface Grid 1m bin, 3D and 2D Point Cloud.

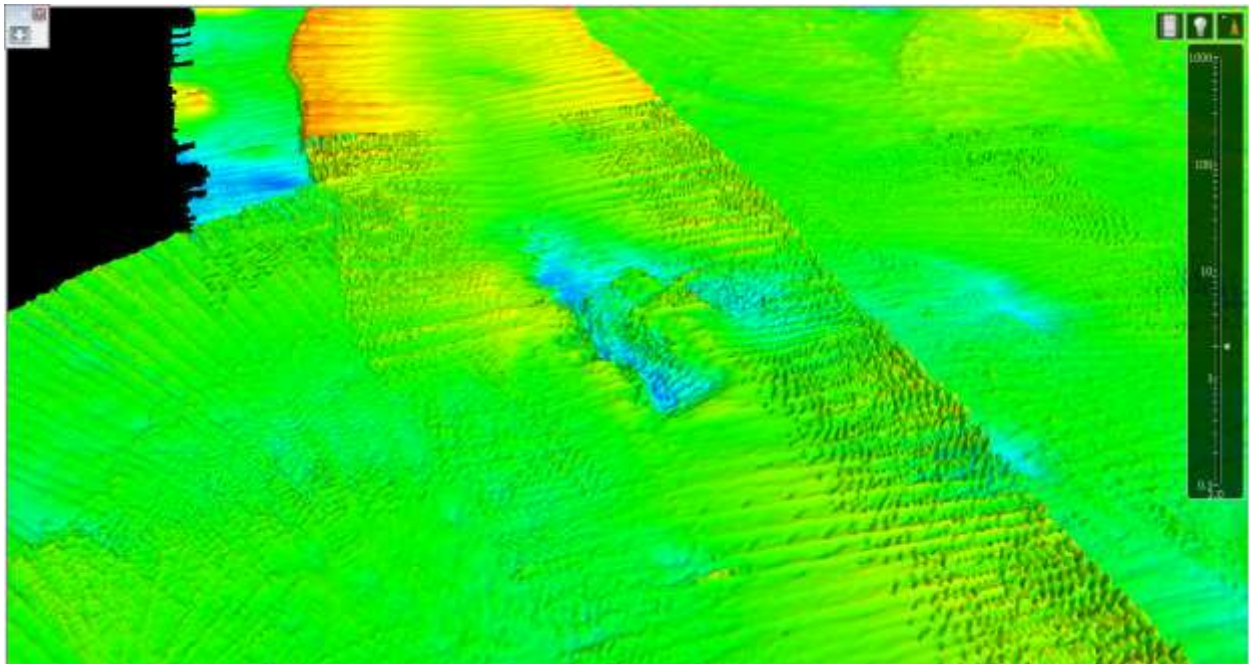
Figure 8: Surface grid 1m bin in 3D View.

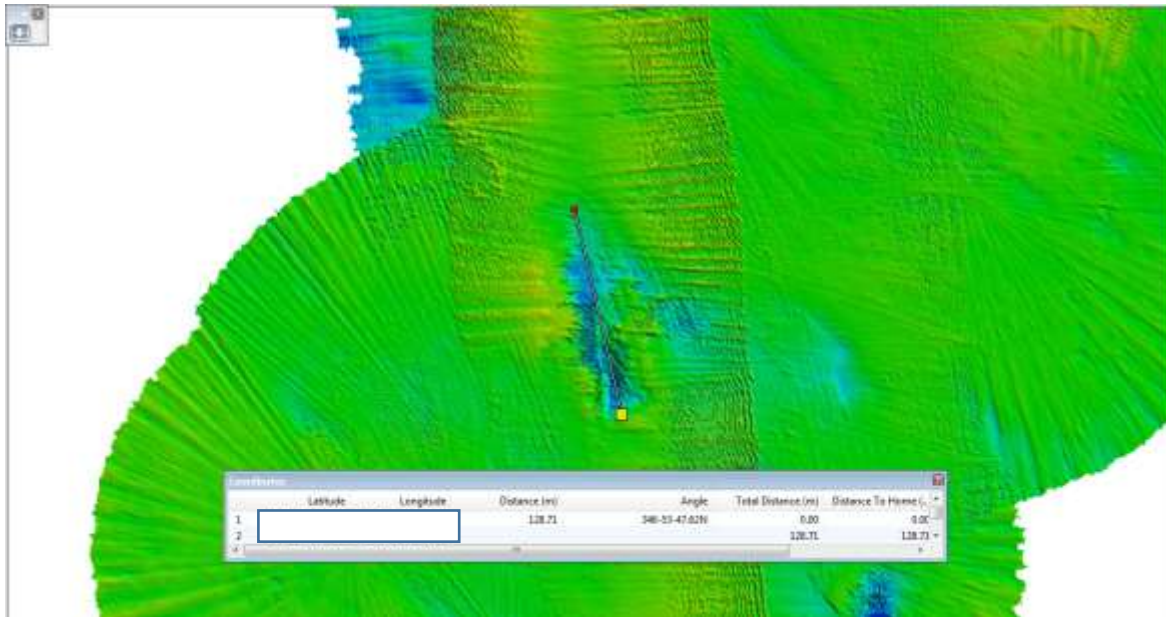
Trench wreck Site B length 128.71 meter [346-53-47.62N].

Figure 9: Trench Length Measurement.

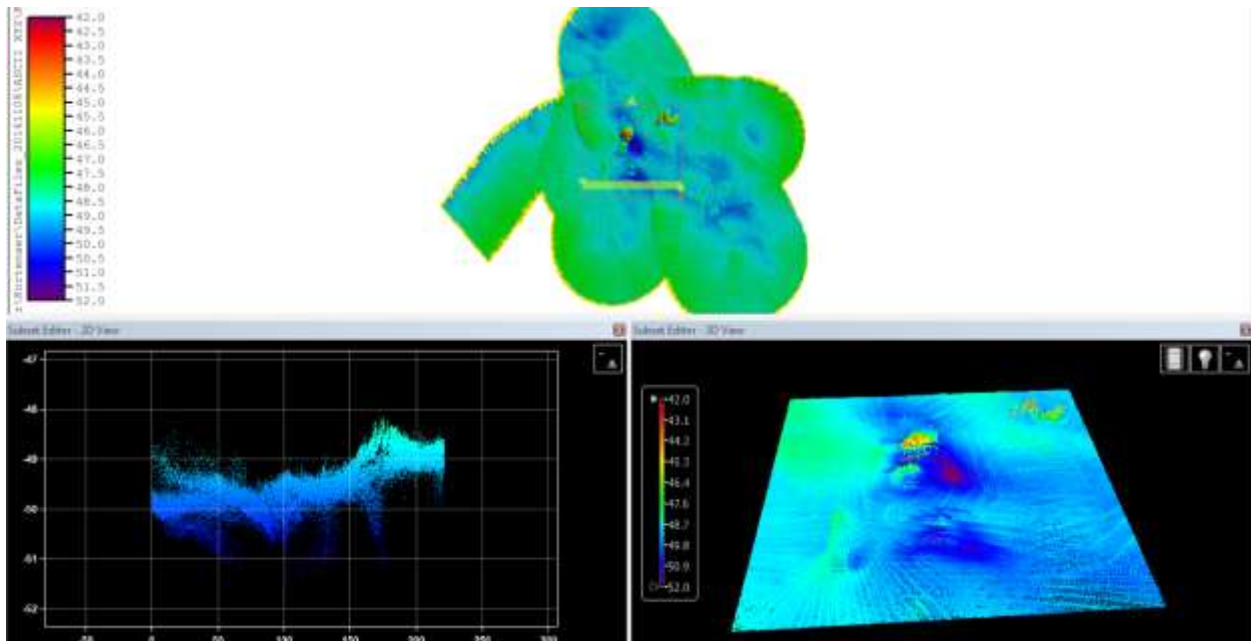
Figure 11: Examining MBES Data Surface Grid 1m bin, 3D and 2D Point Cloud.

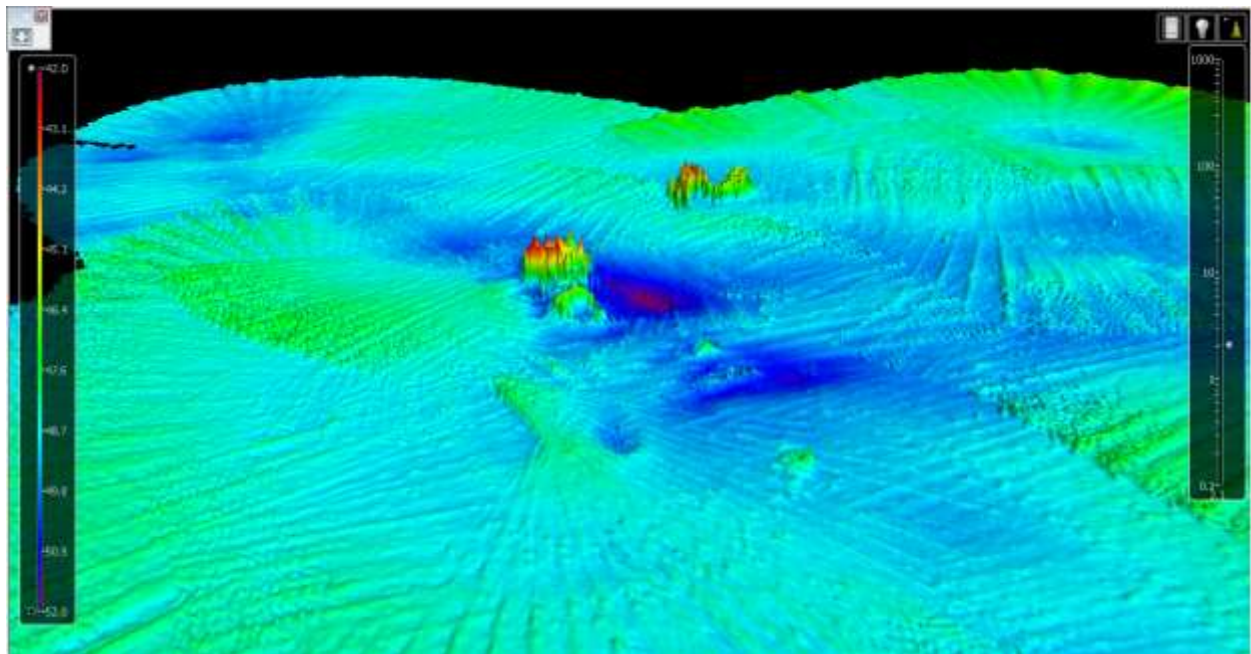
Figure 12: Surface grid 1m bin in 3D View.

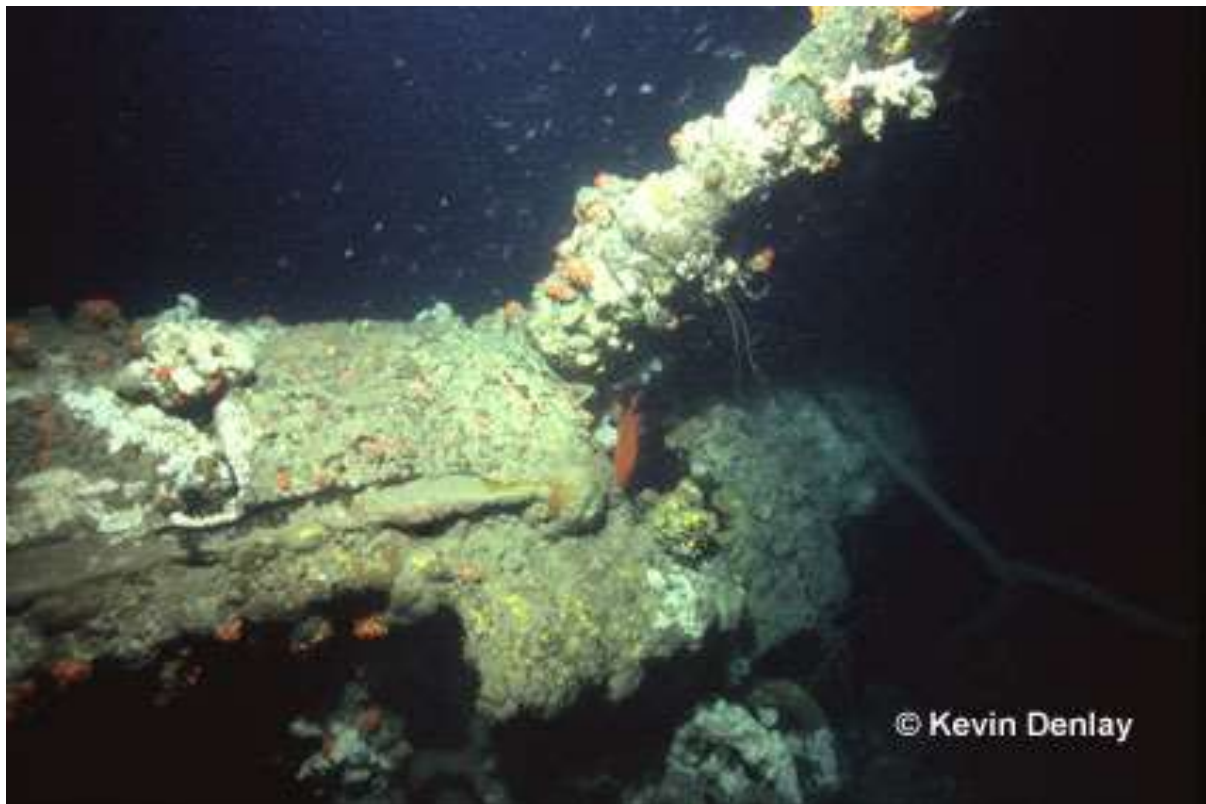
Figure 16: Looking from a lower angle at the face shields on *De Ruyter's* Bofors guns. This one is taken looking at the face from below and to the left. The twin barrels point out to upper right.

No historical photo shows the protective shields in place on *De Ruyter* and when underwater photos of these shields (see figure 16) were first seen they apparently caused somewhat of a controversy as many people were completely unaware that *De Ruyter's* Bofors were actually shielded.⁹ Originally these shields had not been installed on the ship, but historical information revealed that they were added on just right before the battle started. The details described above makes the identification of the wreck of that of the *De Ruyter* admissible.

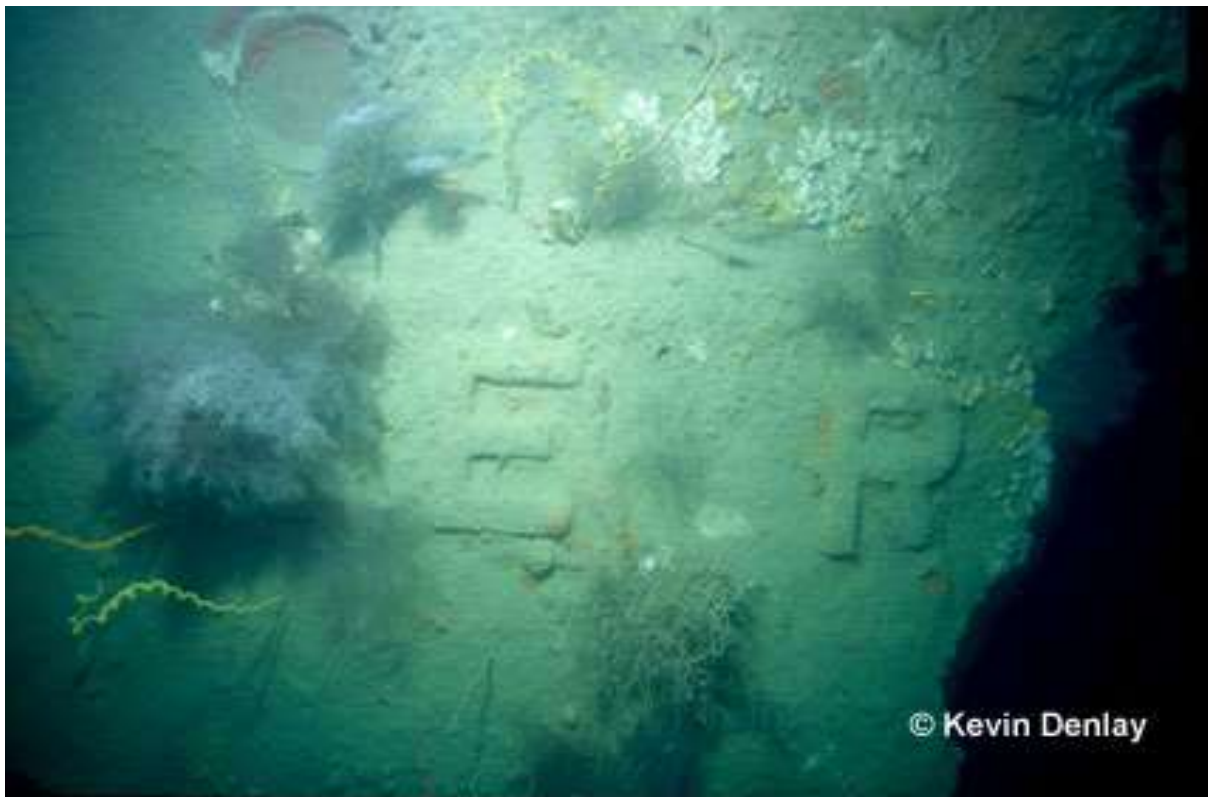
Figure 17: While the letter D is hidden by a small coral bush on left, the letters E and R of *De Ruyter's* name, as seen in historical photos on her stern, are clearly visible. A large gash or split runs down *De Ruyter's* port hull just to the right of the letter R.

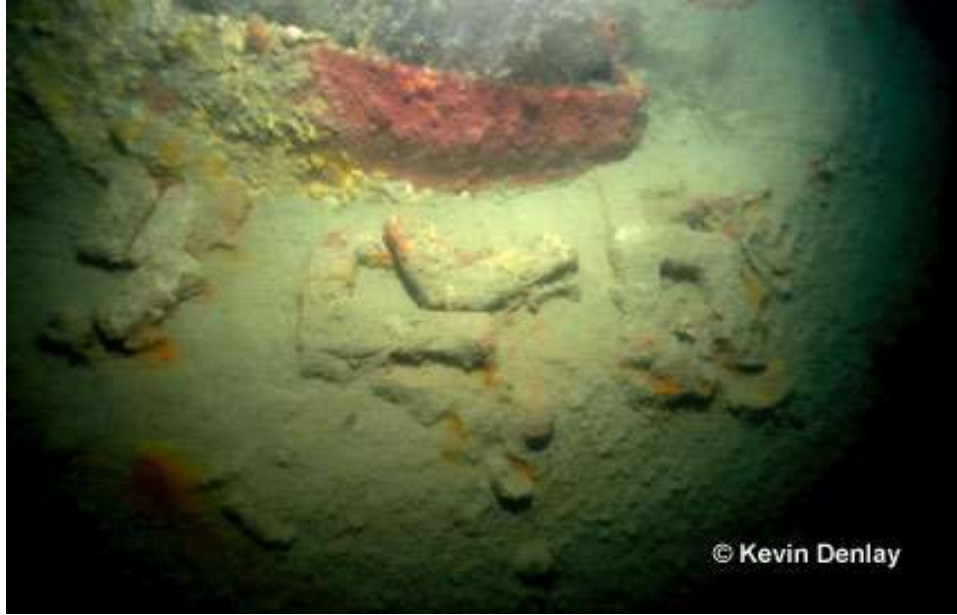
Figure 18: The remaining letters of De Ruyter's name lay jumbled.

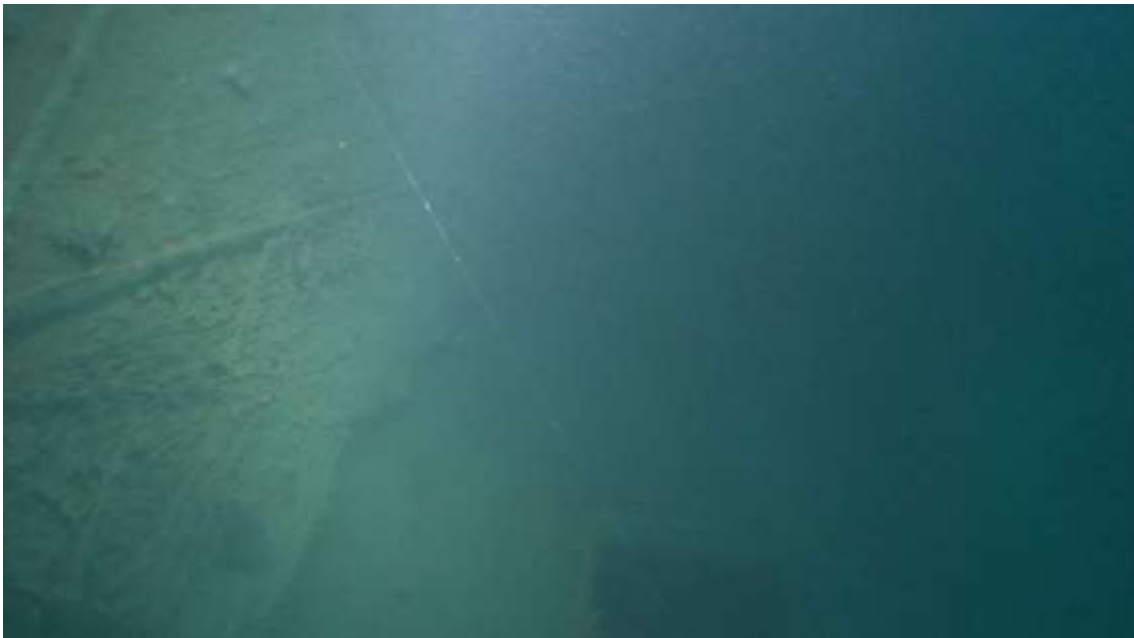
At the time of the 2008 video survey Hr.Ms. *De Ruyter* was laying intact and upright, tilted to starboard at approximately 30 degrees. The starboard guardrail was nearly at the level of the seabed. The forward rangefinder atop the bridge tower had lost its port arm. The forward gun turrets were trained to approximately Green 90. Figure 19 shows a small hatch along the side of the no. 1 turret.¹⁰

Figure 19: A small hatch (bottom middle/right) along the side of the no. 1 turret.

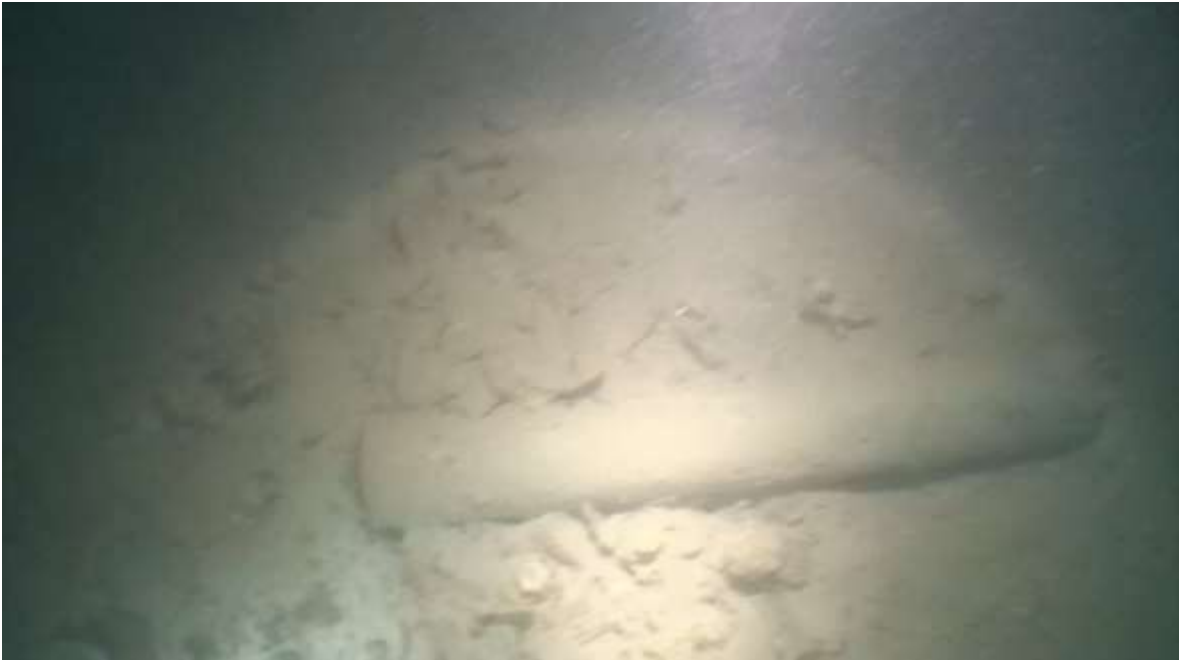
Expended 15 cm cartridge casings were found scattered around the seabed on the starboard side (see figure 20). The *De Ruyter* had seven 15 cm Bofors guns (see Appendix 4).

Figure 20: One of the 15 cm cartridge casings.

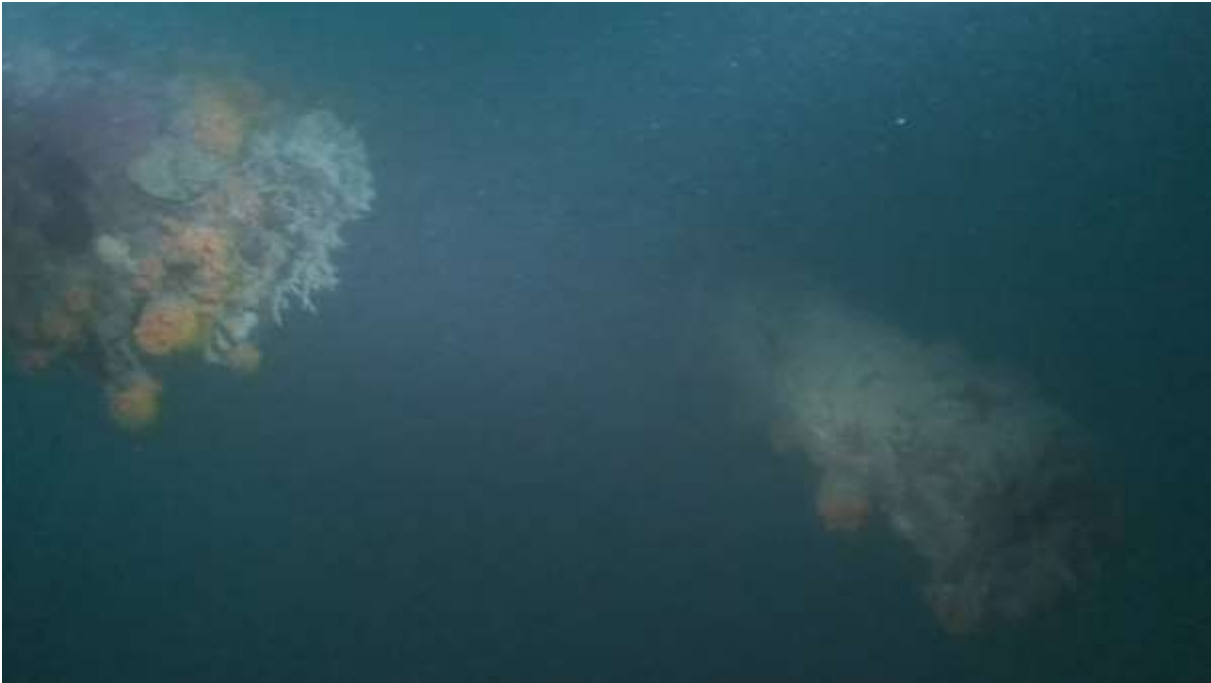
The five 40 mm Bofor guns on the aft deckhouse (above the captain's cabin) were *in situ* and demonstrated the protective shield fitted just prior to her sailing. The aft turrets were still in cruising position pointing towards the stern.

Figure 22: The aft turrets pointing towards the stern.

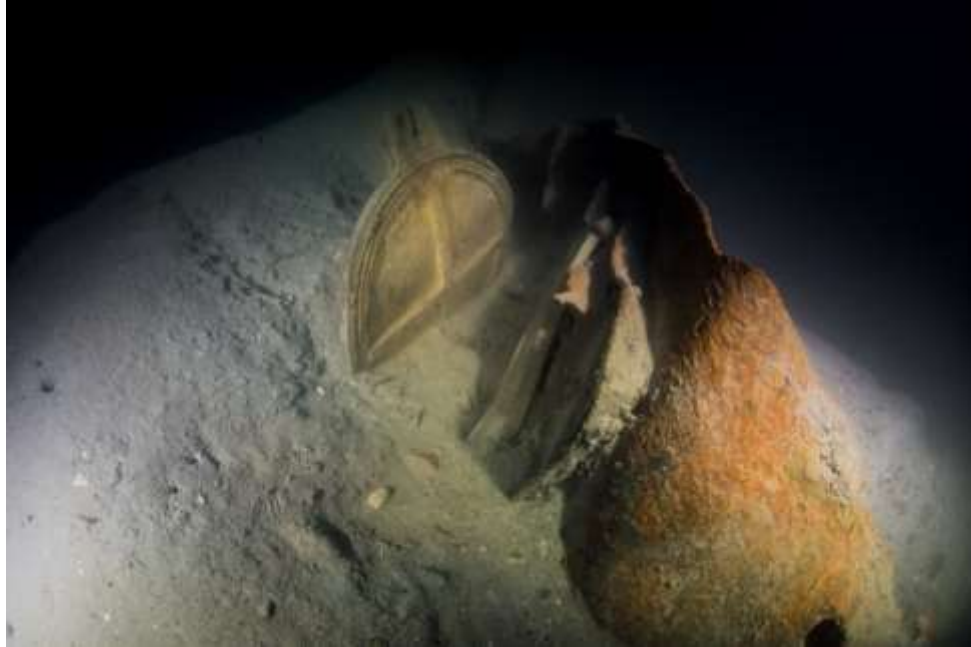
In 2016 the divers reported a large trench (170 m) lined with subsurface mud and clay. This can also be observed from the videos. This clayish seabed surface had large gouges through it, consistent with the use of a claw. Some small debris was located including a section of torn thick metal hull plating containing a scuttle. The deadlight observed and photographed was of the pattern seen on historical pictures of *De Ruyter* (compare figure 23 with 24 and 25). Preliminary research executed by the expert team could only reveal that these deadlights were used on Dutch light cruisers but it remained unclear if these were only specific for *De Ruyter* or if they were also present on the *Java*. It is unclear if there will be remaining debris in the thick subsurface clay that is now covering the seabed.¹¹

Figure 23: Torn hull plating and scuttle with deadlight at the *De Ruyter* site. The bronze deadlight with the cross on it is typical of those seen in Dutch cruisers and quite unlike the Admiralty pattern ones on HM and HMA ships.

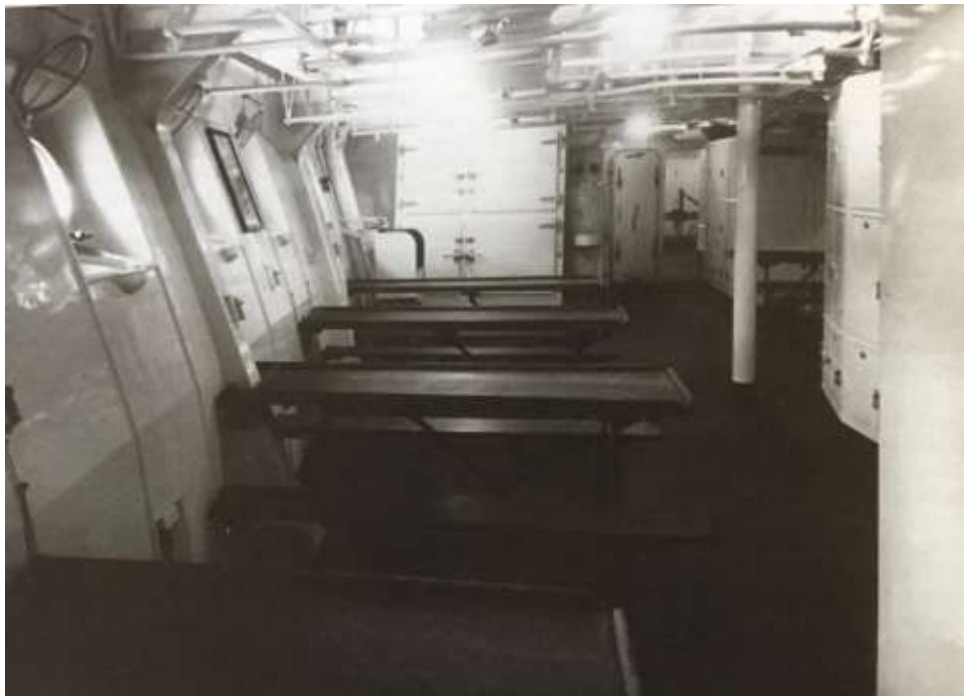
Figure 24: Pre-war photograph, crew quarters *De Ruyter*. Note pattern on deadlights compared to figure 23.

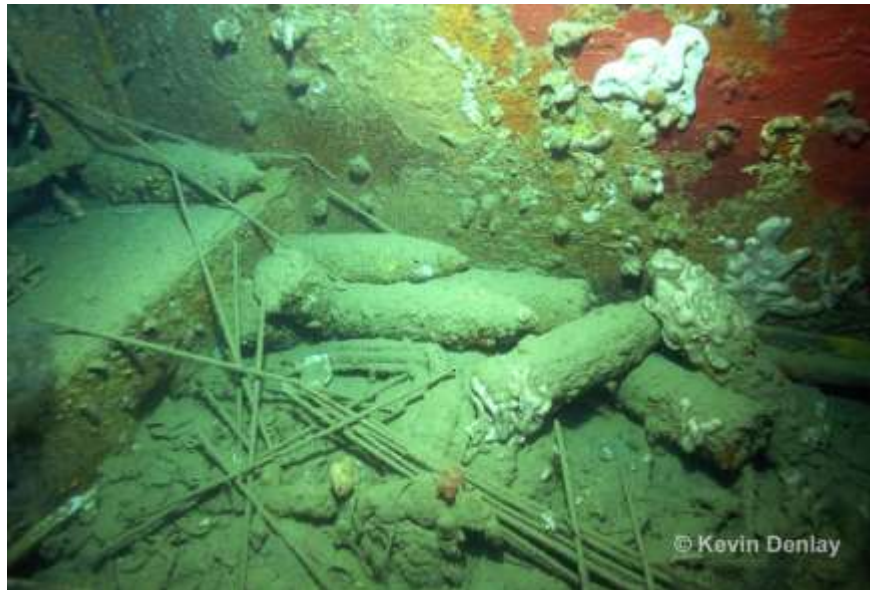
Figure 26: Unused (i.e. 'live' unexploded) 5.9 inch / 150mm projectiles laying against a bulkhead on the Dutch cruiser Hr.Ms. *Java*. The long thin strips (foreground) are cordite from inside the brass shell casings that would have been loaded with the projectiles.

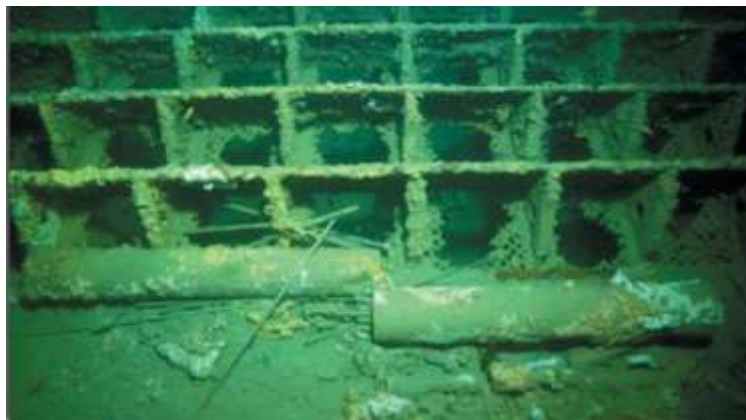
Figure 27: The unique 'baffled' base of the funnel that helped quickly identify *Java*. Sticks of cordite can still be seen protruding from the 15cm (5.9 inch) shells.

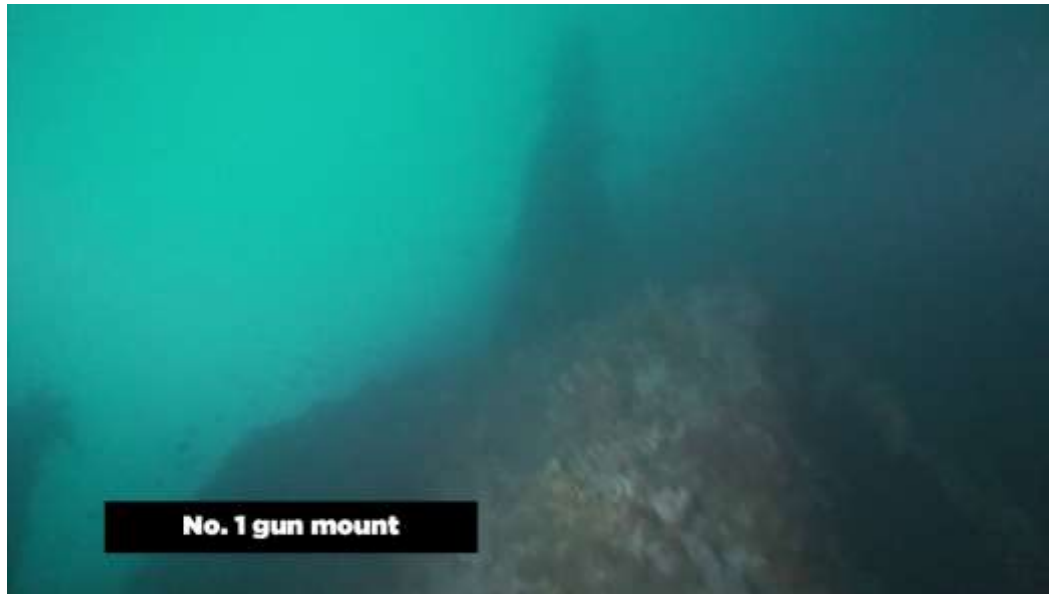
Site B, now identified by the divers as the Hr.Ms. *Java*, was still laying on her starboard side. The forward, remaining after and portside 15 cm gun mounts were trained to approximately Red 90 (figure 28).

Figure 28: No. 1 gun mount trained to approximately Red 90.

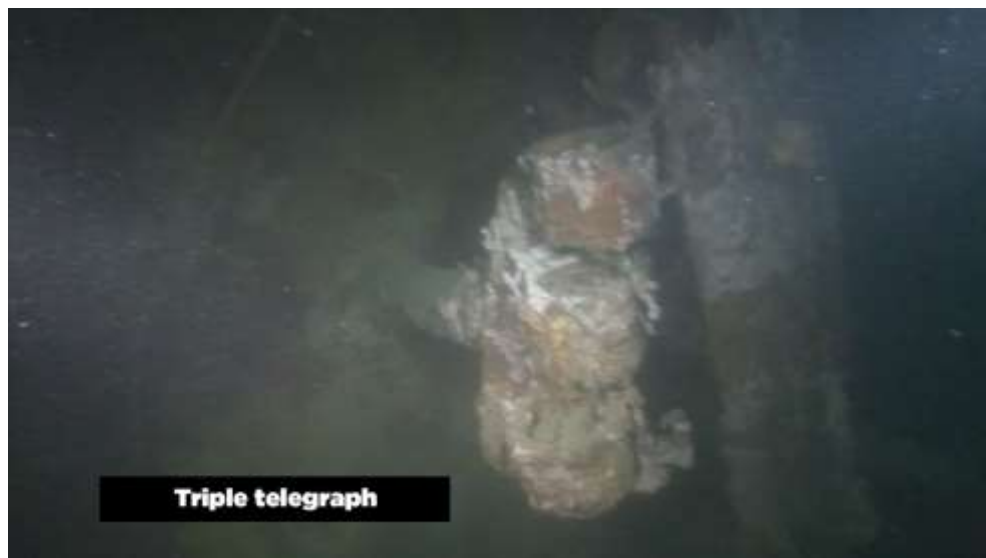
The bridge structure was intact with the frame for the canvas roof still present. Both the helm and telegraphs were present on the bridge (figure 29).

Figure 29: Triple telegraph still present on the bridge.

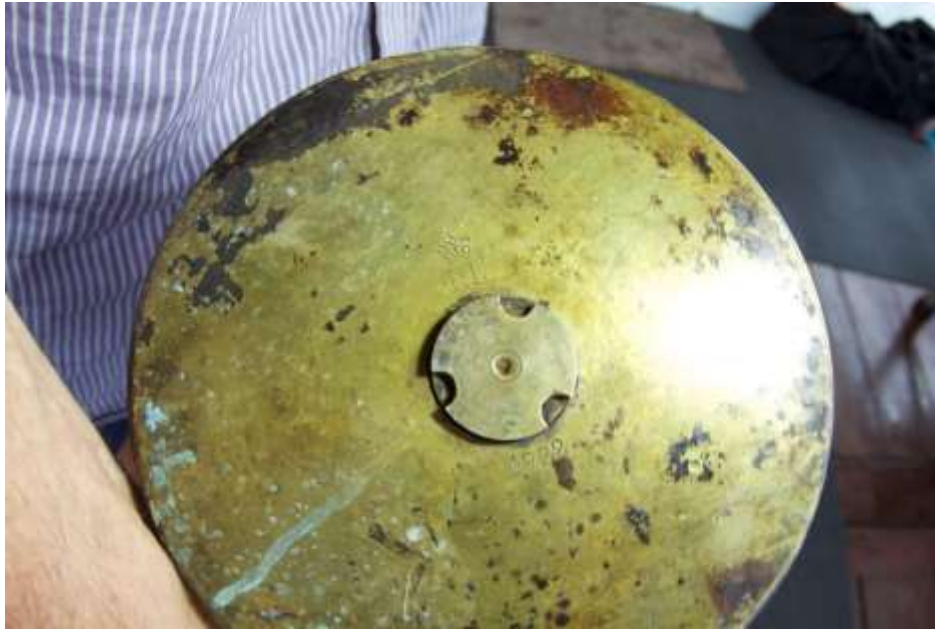
The diving operation in 2016 revealed a similar topography to the *De Ruyter* site (a large trench of 130 m) with subsurface mud/clay in the trench. Several scattered thick torn hull plates and minor fittings were found around the site. A 15cm copper-alloy cartridge case was recovered to help identification of the site. Base markings showed it to be indeed of Dutch manufacture and of the type used by Hr.Ms. cruisers.¹³

Figure 30: Base markings 15cm cartridge case from the *Java* site. Note the Dutch crown and manufacture date 1922.

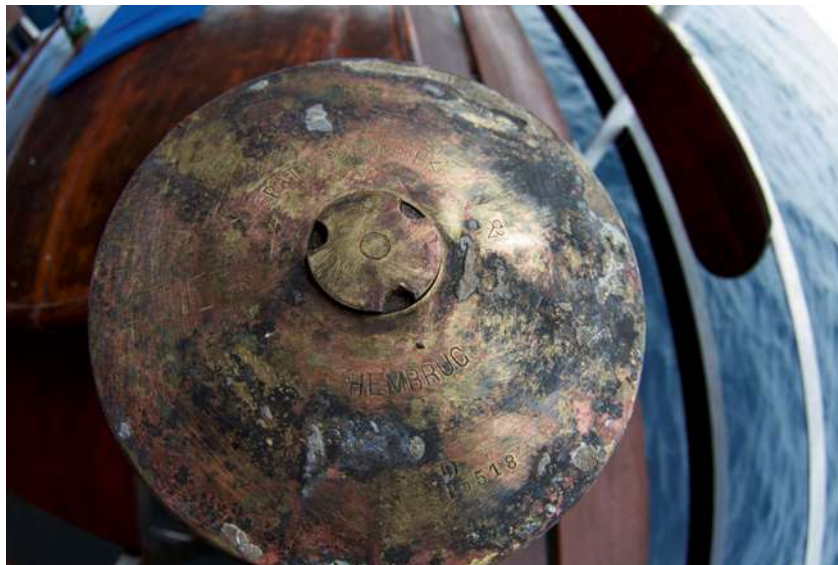
The identity of the ship was confirmed by the retrieval of a 12 cm cartridge case. Base markings showed it to be of Dutch origin, manufactured at the *Hembrug Armoury* north of Amsterdam in 1929.¹⁶

Figure 31: 12 cm copper alloy shell case that was recovered from the *Kortenaer* site.

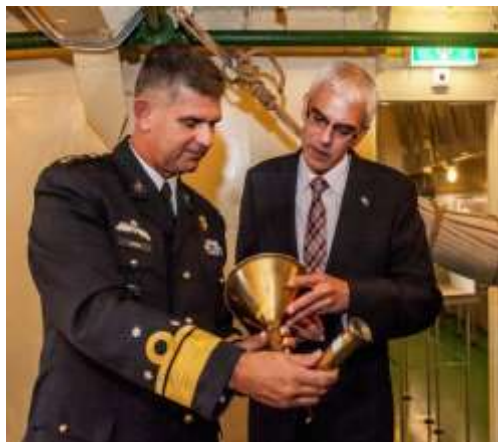
Figure 40: Figure 40: One of the three speaking tubes from the *De Ruyter*.

In 2014 three speaking tubes were put up for auction in Perth, Australia (see figure 40), but confiscated beforehand. Thanks to a lot of diplomatic work these object were finally sent back to the Netherlands. They are now part of the collection of the Marine museum in the Netherlands.³⁶

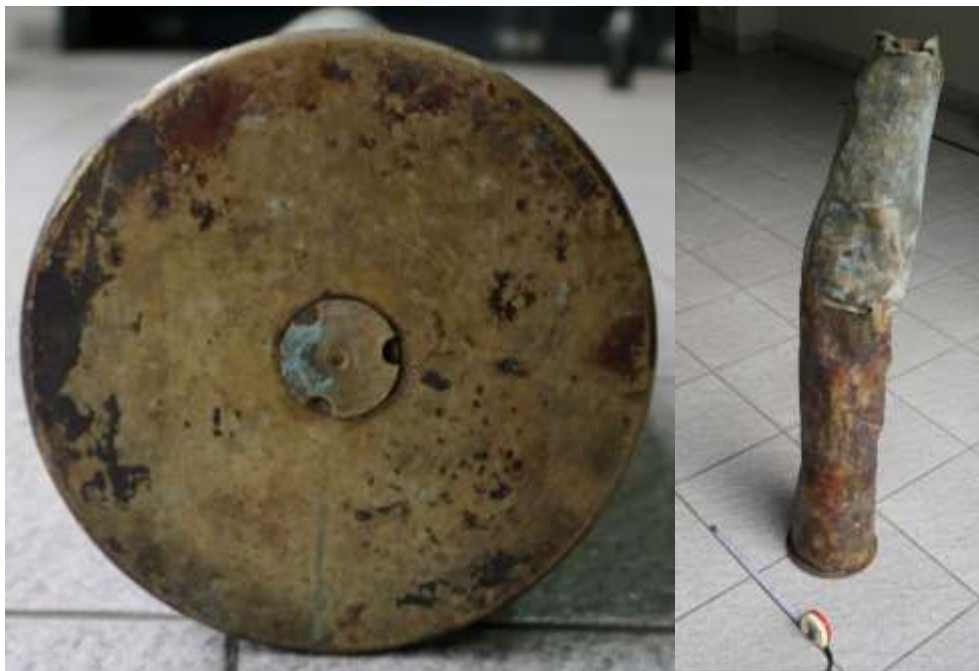
The copper alloy cartridge of the *Java* is 69 cm high and the base has a diameter of 17.5 cm. The numbers and texts on the base correspond with the information mentioned in the dive report of 2016.

Figure 41: The copper alloy cartridge of the *Java*.

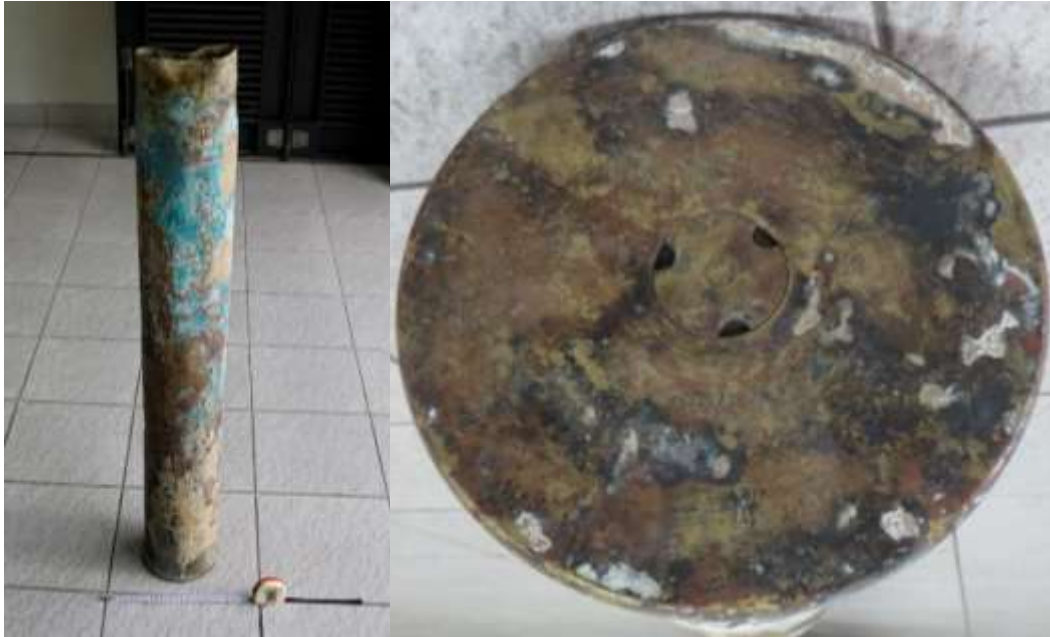
The copper alloy cartridge of the *Kortenaer* is 103 cm high and the base diameter is 16 cm. The numbers and texts on the base correspond with the information mentioned in the dive report of 2016.

Figure 42: The copper alloy cartridge of the *Kortenaer*.

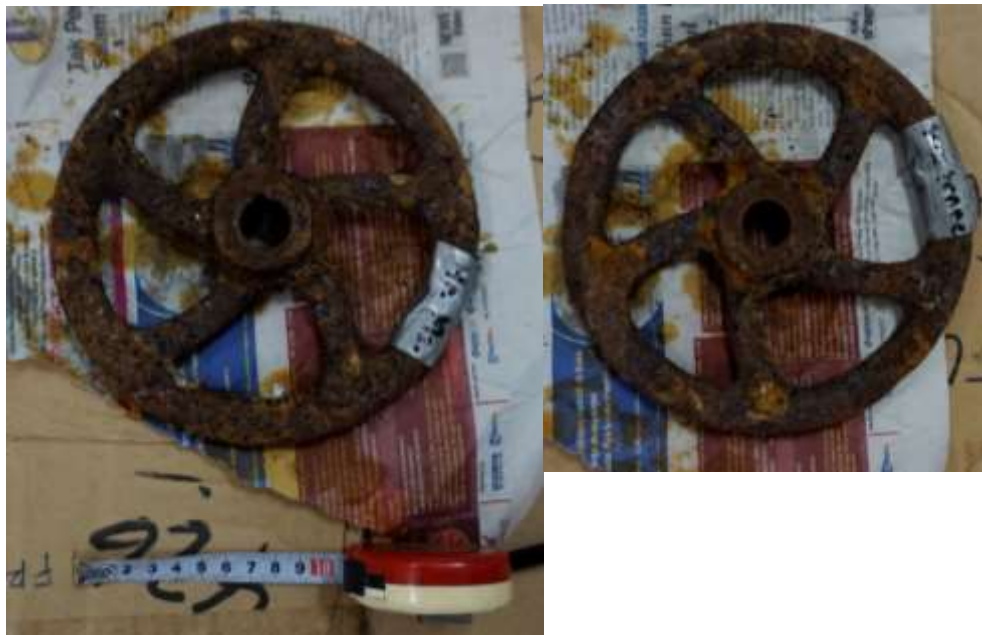
The iron valve hand wheel of the *Kortenaer* is corroded and does not contain any details to identify it as specific for Dutch ships or not.

Figure 43: The iron valve hand wheel of the *Kortenaer* (both sides).

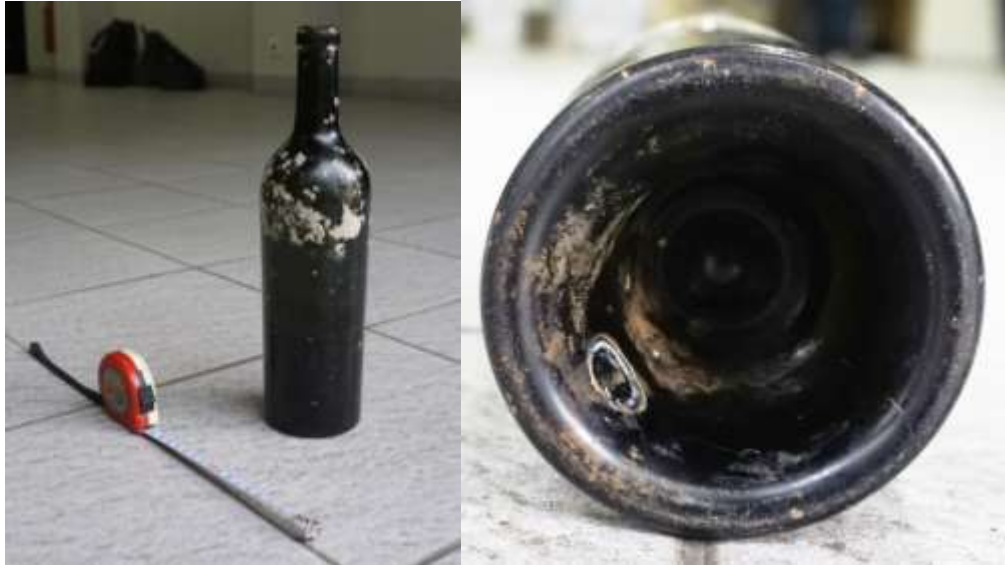
The thick green glass bottle has a deep sole. Although we cannot be certain it was originally from the *Java*, we can say it is quite likely from around that period. It is a typical wine bottle moulded with many irregularities in the glass.

Figure 44: Thick green glass bottle from the *Java*.
