The Science of the Total Environment 167 (1995) 255–271

# Role of fungi in the deterioration of wall paintings

K.L. Garg\*, Kamal K. Jain, A.K. Mishra

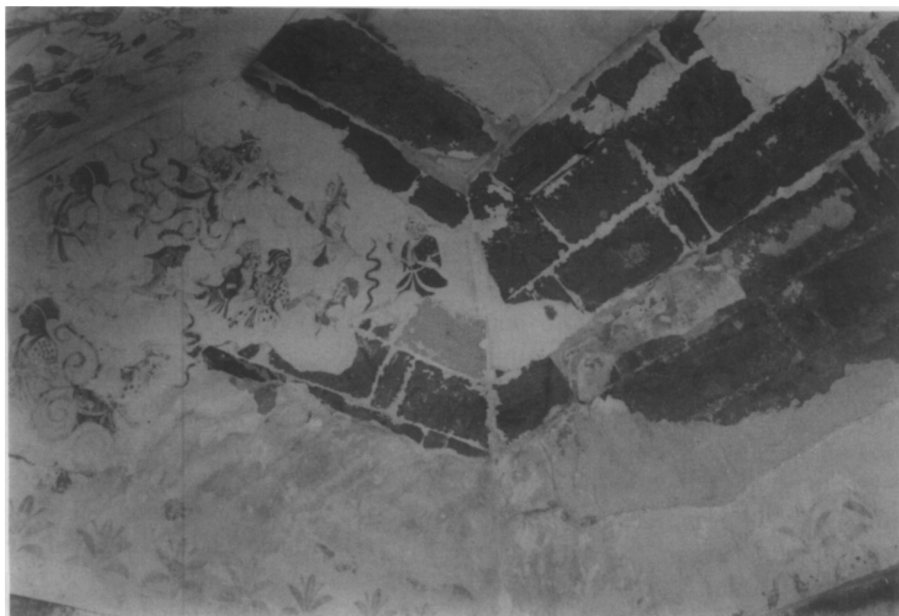
Fig. 2. The moisture traveling through the walls or roof is an important factor for the growth of fungi. In this extreme case, the plaster containing the paintings has fallen off (Nagaur fort, India).

Since moisture is the most vital factor which facilitates fungal growth, the control of biodeterioration of wall paintings could be achieved by proper ventilation of the area and by taking suitable measures to avoid moisture condensation on the surface. Such optimization of temperature and moisture was successfully carried out by Rebricova (1991, 1993) at the Cathedral of Birth of the Holy Virgin in Ferapontovo. In some cases, the use of hydrophobic materials to avoid condensation has also been suggested but in many cases the use of such materials may prove counter-productive, especially when the source of moisture is from the substrate. Air conditioning of the area has also been recommended as a step to control the environmental conditions. In order to eliminate another important source of moisture, i.e. wall humidity, use of epoxy resins as a damp proof course has also been made (Saiz-Jimenez and Samson, 1981; Rebricova, 1991, 1993). However, in many cases, the modification of environmental conditions, which requires regular monitoring, may not be easy besides being a costly proposition. Although modification of climatic conditions may be helpful in reducing further growth of fungi, one of the biggest problems faced by the conservators is to kill the already existing growth. A variety of chemicals, commonly termed biocides (fungicides), have been used for the purpose. The use of biocides for protecting

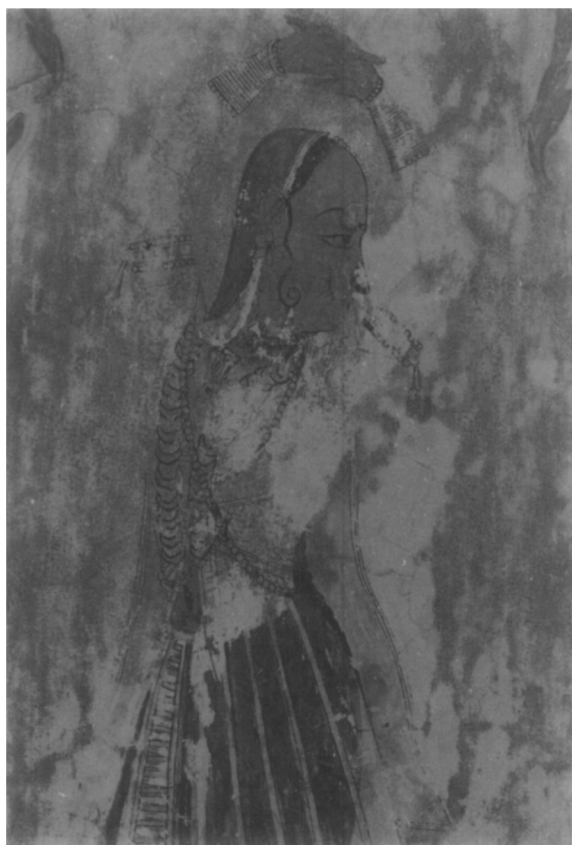
Fig. 3. In this wall painting at Nagaur fort (India), the fungal growth is visible in the form of black stains.

**Pigment formation.** As a consequence of their metabolic activity, many fungi produce organic pigments of different colours (green, grey, blue, purple, violet, etc.). These pigments, belonging to different classes of compounds like anthraquinones, xanthenes or carotenes, are characteristic of different species but the colour of the stain depends not only upon the chemical composition of the pigment but also on other factors like the composition of painting constituents, presence of other microbial species or environmental conditions. The release of pigments on the substrate or the presence of fungi containing pigments causes the appearance of different coloured stains or patches on wall paintings

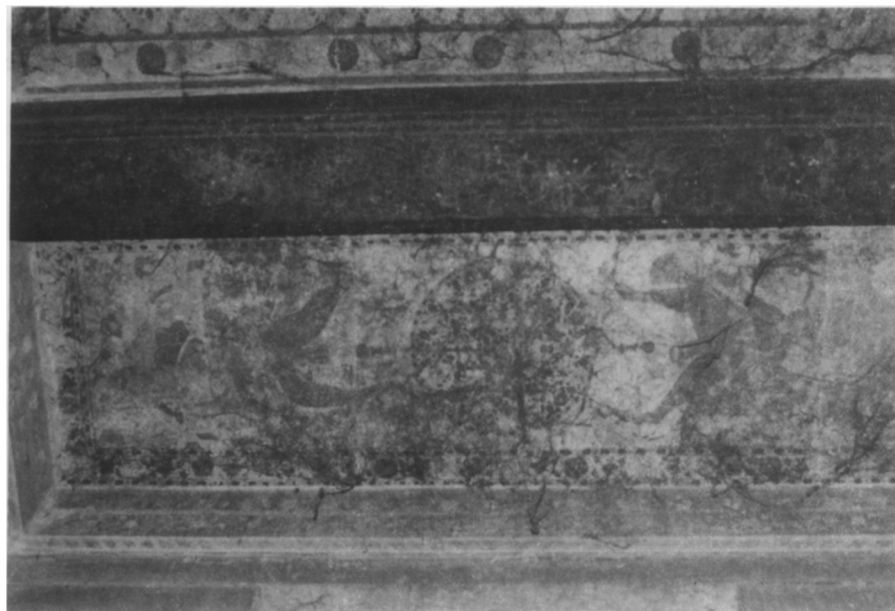
Fig. 4. The growth of fungi over the paintings is responsible for the covering of painting designs.

This type of decay of the wall paintings is mainly due to the physical action of the growth of fungal hyphae or the fruiting bodies either on or below the surface. According to Wazny and Rudniewsky (1972), the fungal hyphae growing inside the paint layer caused dislodging of the various layers. A similar effect may be brought about by fungal fruiting structures, which are frequently formed under the surface of the painting layer. If the growth is over the surface, it results in the formation of filaments, which on spreading over the surface mask the colour and design of the paintings.
