Weald Common Flood Meadows
Local Nature Reserve
North Weald Bassett
Site Management Plan 2016-2020

This plan was originally produced by Countrycare in 2002 and was updated in 2011 and 2016. It loosely follows the specifications laid down by Natural England for Site Management Plans. However, this plan is intended to be more of a "working document" and so some sections have been ignored and additional sections have been introduced.

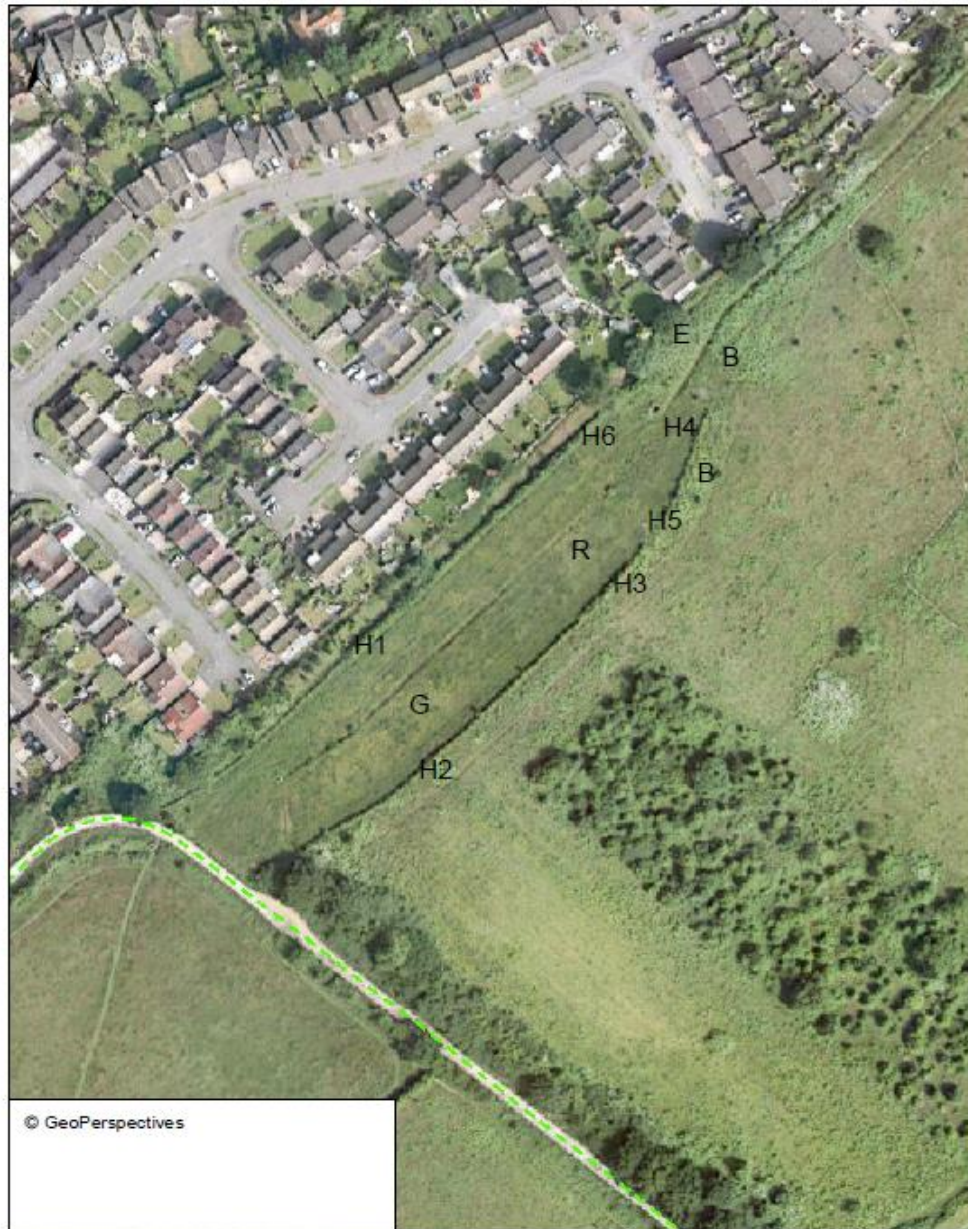
7.2 Thornhill 1 Habitat Existing state

- B Bramble
- E Site extension
- G Grassland
- H1 House side laid hedge
- H2 Field side laid hedge
- H3 Field side unlaid hedge
- H4 Field side unlaid hedge
- H5 Gap in hedgerow caused by deer browsing
- H6 House side unlaid hedge
- R Ragwort

1.6 Land Drainage (See Appendix I, map 7.2 & 7.3)

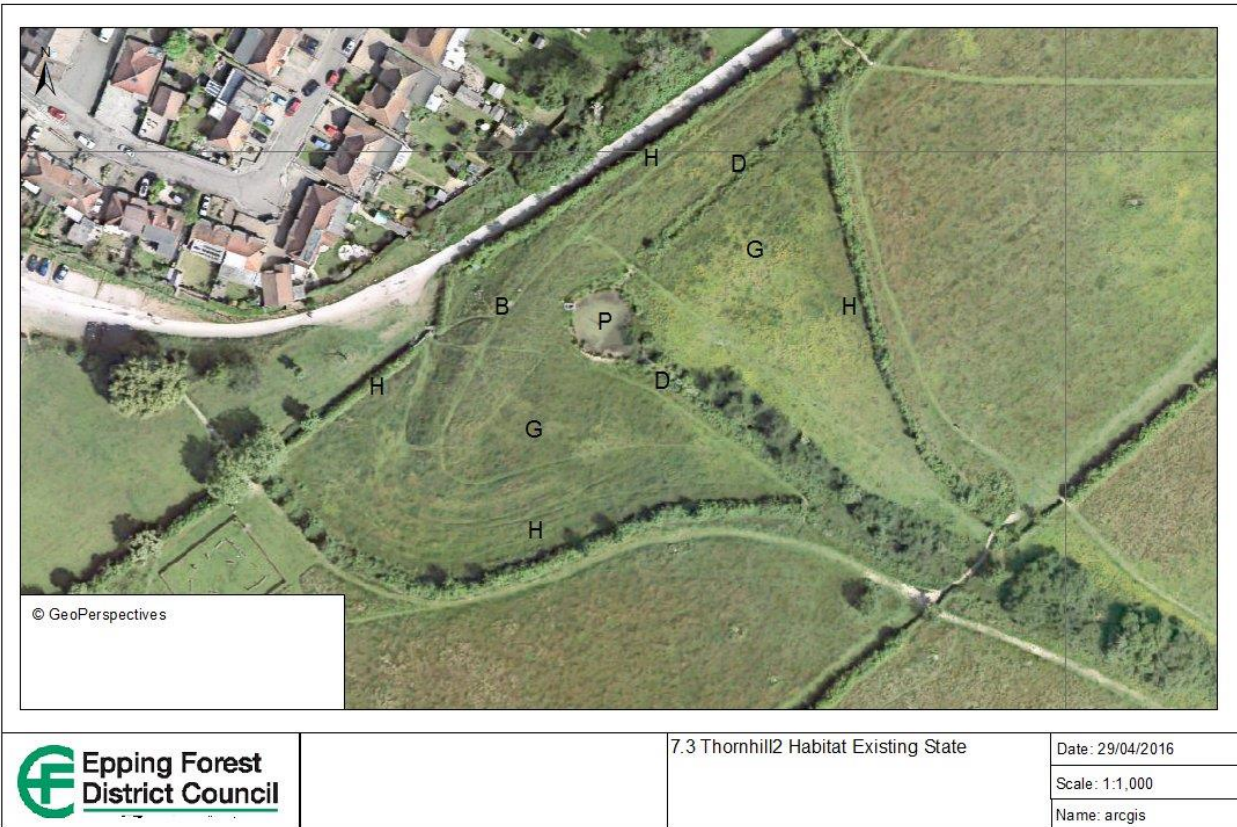
KEY	
D	Drainage channels
P	Pond
B	Raised bund.
G	Grassland
H	Hedges

Both meadows contain drainage channels. The Thornhill 1 channel flows downhill from the north into Thornhill 2. This meets a channel flowing from the east in Thornhill 2 at right angles forming a storage pond. This in turn drains into the North Weald brook and eventually Cripsey Brook.

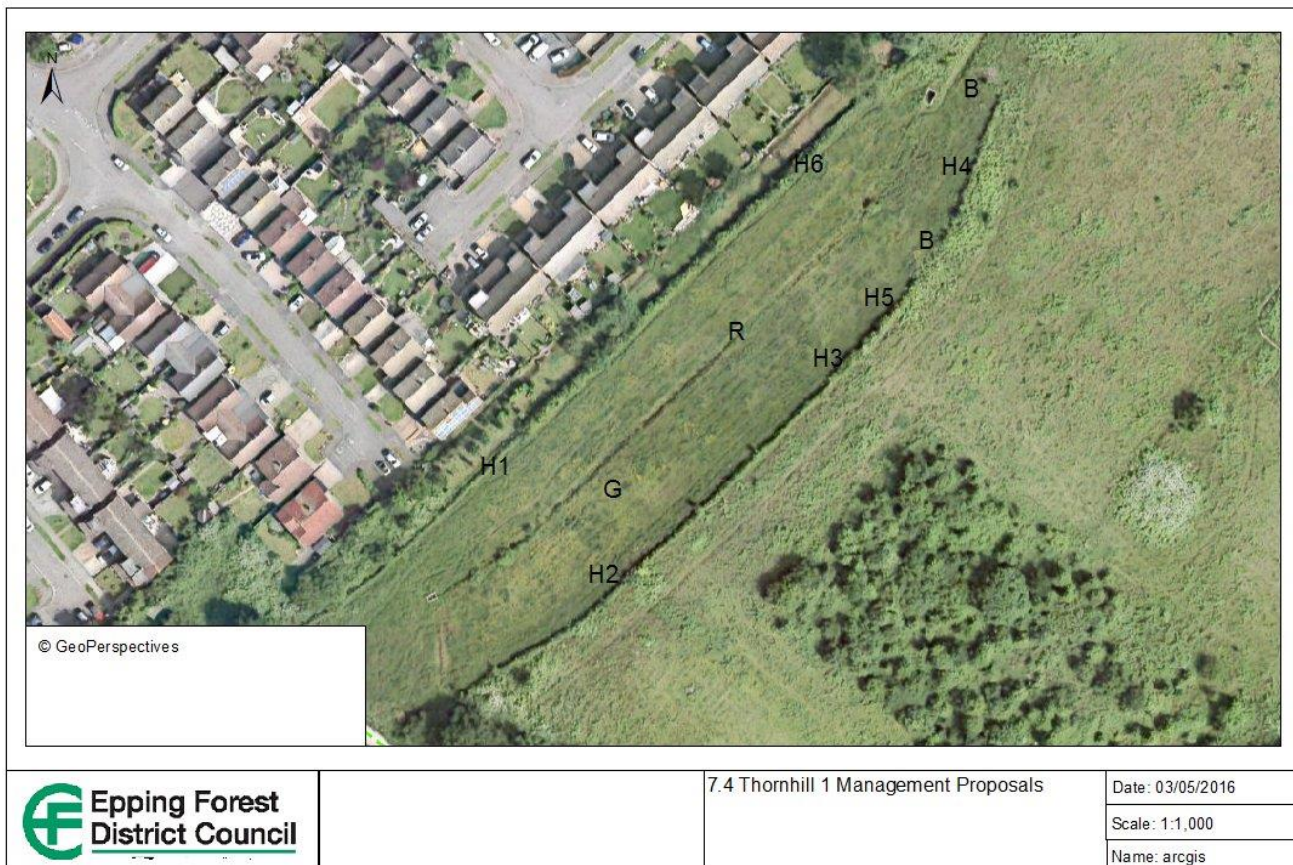
- B** Bramble to be cut annually.
- G** Grassland annual cut late summer.
- H1** Laid hedge to be allowed to thicken up, cut the field maple and leave the thorn every three years.
- H2** Laid hedge to be allowed to thicken up, cut the field maple and leave the thorn every three years.
- H3** Hedge to be laid winter 2016/17.
- H4** Hedge to be laid winter 2017/18.
- H5** Gap caused by deer browsing to be planted up and protected.
- H6** Hedge to be laid winter 2015/16.
- R** Ragwort to be pulled annually in July/August.

6.1 Work Programme: Five Year Period (See Maps in Appendix 7.4 & 7.5)

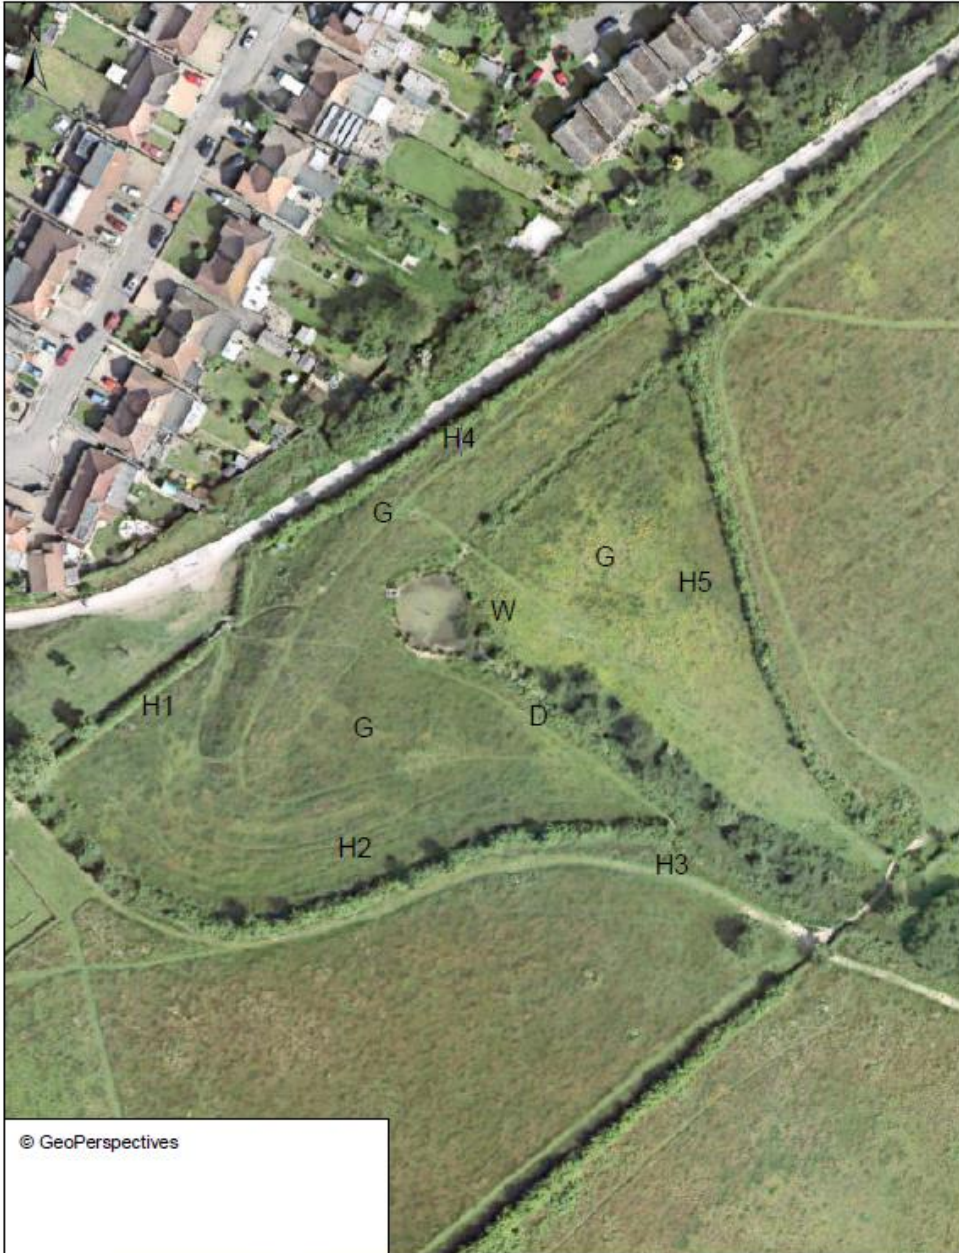
7.5 Thornhill 2 Management proposals

- D** Ditch to be cleared every four years
- G** Grassland to be cut annually in late summer.
- H1** Hedge to be cut in December even years
- H2** Hedge to be cut in December odd years.
- H3** Hedge to be cut 2016 and every four years
- H4** Hedge to be cut every four years
- H5** Hedge to be cut every four years
- W** Willow to be coppiced every three years

5.2.2.3 The vegetation along the central ditch, running east to west on Thornhill 2 along the drainage line, requires cutting back and thinning out to prevent scrub encroaching onto the grassland particularly at the eastern end. (See map appendix I, 7.5).

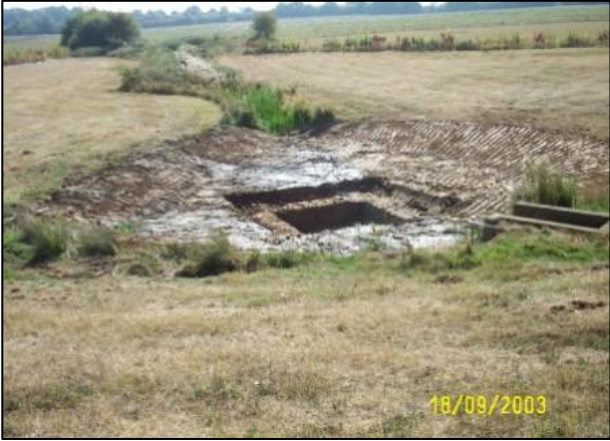
Thornhill 2 pond excavations Sept 2003

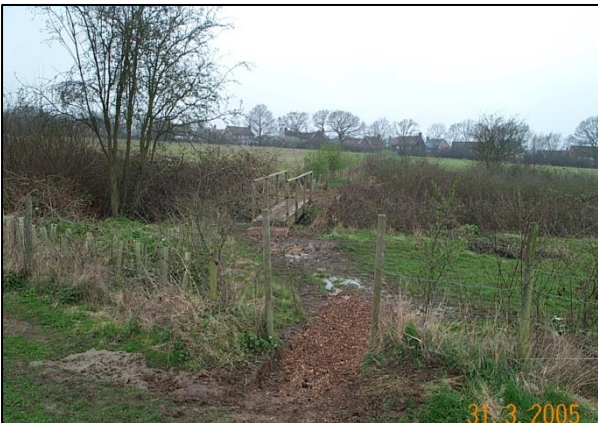
Thornhill 2 Hedge 3 and bridge Mar 2005

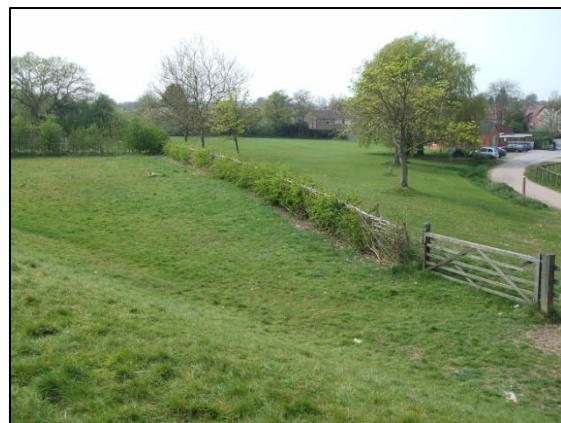
Thornhill 2 Hedge 1 laid Nov 2006

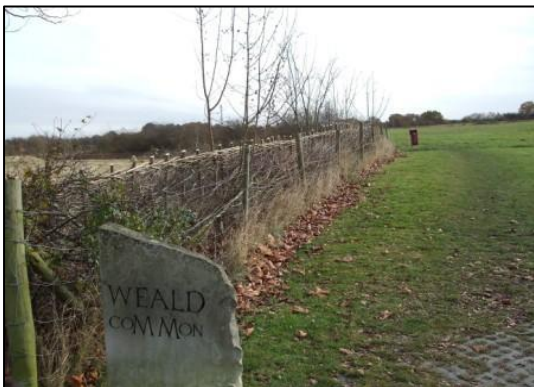
Thornhill 2 Hedge 2 laid Nov 2007

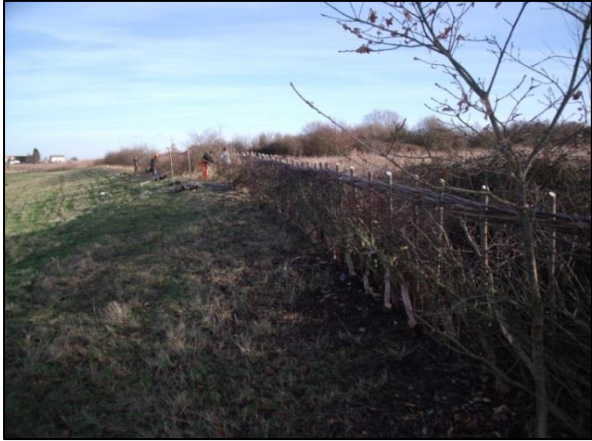
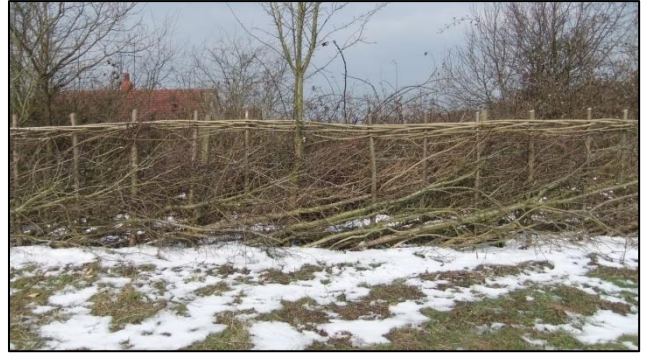
Thornhill 1 Hedgelaying January 2012
