Waitati Curve Archaeological Assessment

Prepared for MWH

Southern Pacific Archaeological Research

June 2010

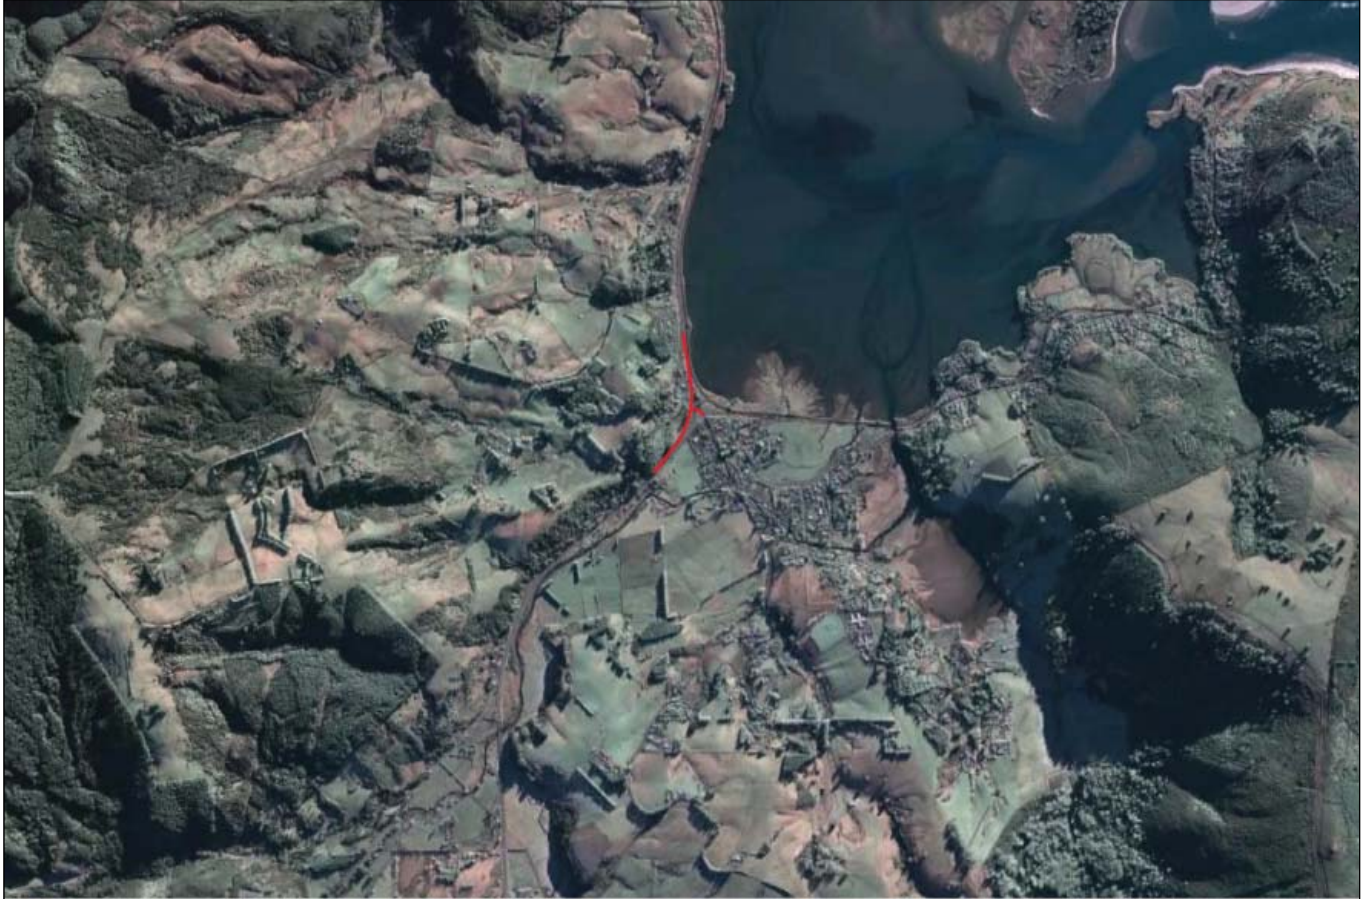
Figure 1. Location of the proposed realignment (red line indicates location of new highway and side road. SPAR sketch based on MWH design drawing (Fig. 2)).

The scope of this project was to survey the proposed c.1 km realignment of State Highway One centred approximately on the Waitati turnoff (Figure 1, 2). The proposal also requires the establishment of a temporary location for the Waitati Store during construction of the realignment (Figure 2).

The proposed realignment is at the Waitati Curve, Waitati, north of Dunedin (Fig. 1-3).

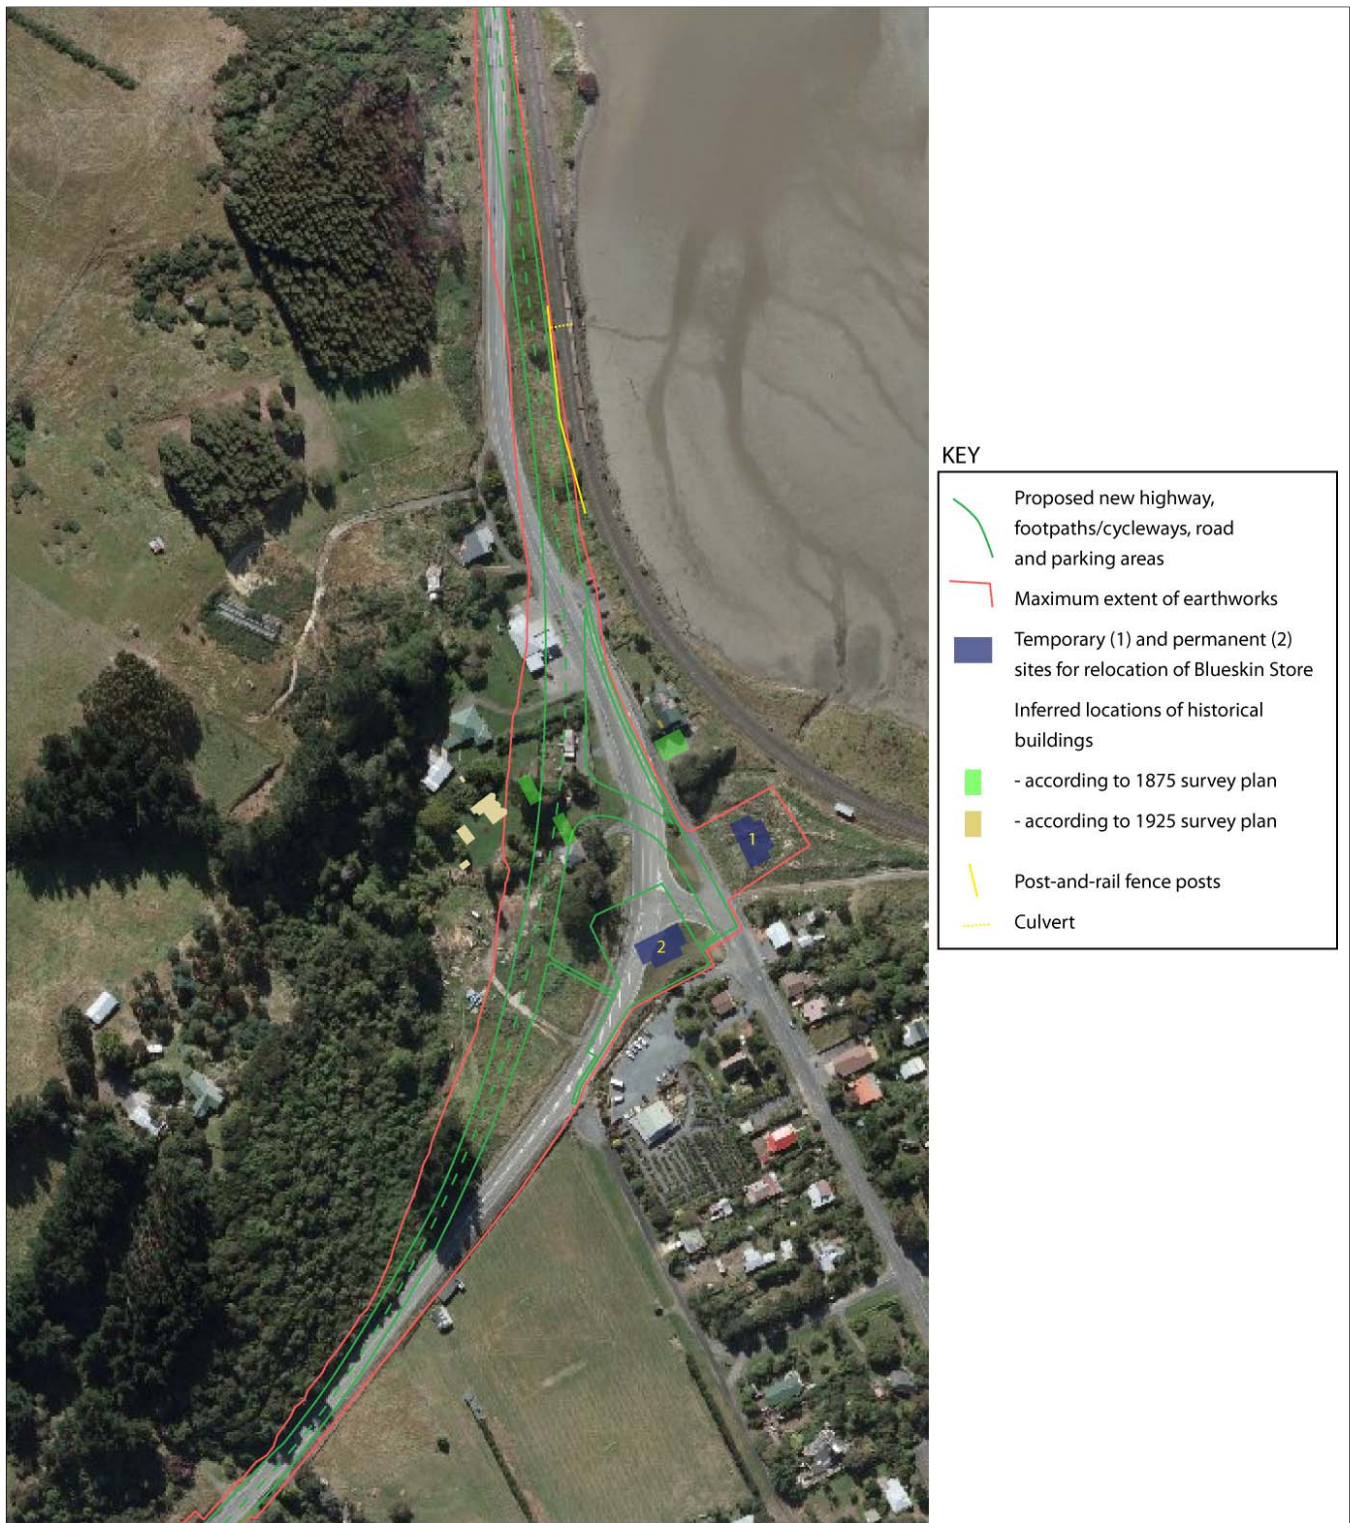
Figure 8. Proposed realignment of SH1 at Waitati showing maximum extent of earthworks in relation to inferred locations of possible archaeological sites.

There is no firm evidence that any of the buildings identified from the documentary research were situated within the footprint of the proposed realignment. However, it is possible that at least one structure associated with Grant in 1875 was situated within the alignment. The location of Grant's residence is ambiguous; it seems most likely that its location on the 1925 plan is the most accurate, but the possibility that there was an earlier building or buildings cannot be discounted. If the 1875 plan is accurate, therefore, then there were two buildings constructed within the path of the proposed realignment. This assessment takes a conservative (risk-averse) approach and assumes that the 1875 plan is accurate. This means that there is a potential for there to be archaeological remains of the two 1875 structures, one of which is identified as Grant's residence, preserved beneath the ground surface within the proposed realignment. The following assessment and recommendations are based on the assumption that such remains are present.

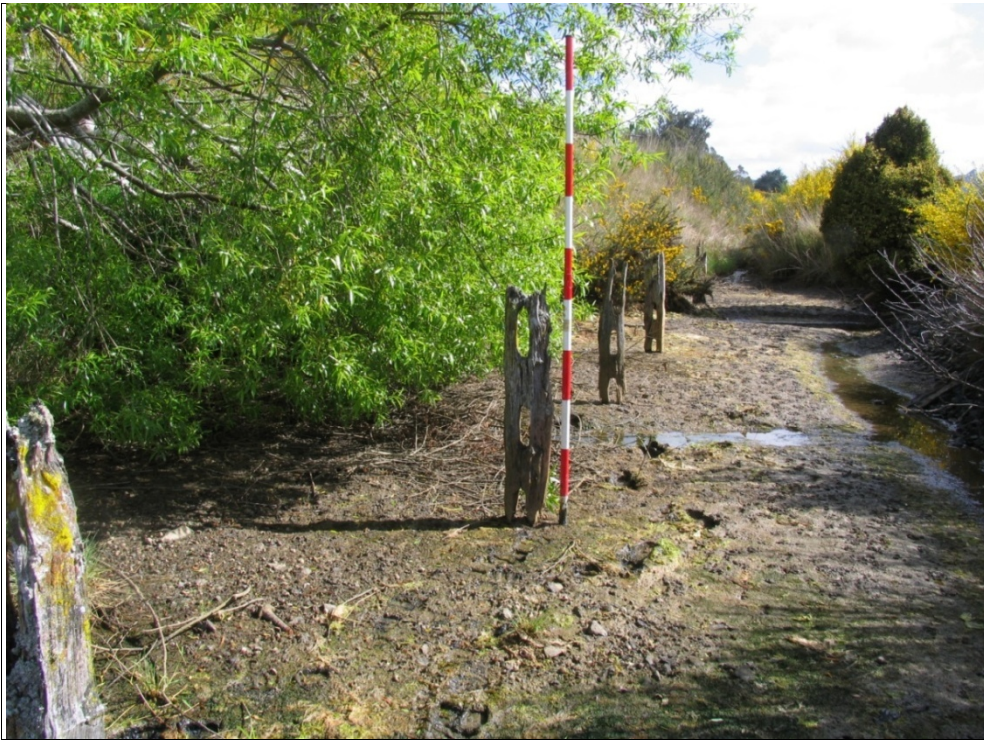
No clear evidence of any of the possible buildings identified through the documentary research described above was seen during the field inspection. However, a short (c.100 m) stretch of mortised posts that are the remains of the nineteenth century post and rail fence was recorded adjacent to the rail embankment (Figure 9).

Figure 10. Remains of post-and-rail fence adjacent to railway embankment.

2. That all of the largely complete fence posts that are going to be buried by the realignment earthworks are removed and used for interpretative purposes off site if practical.

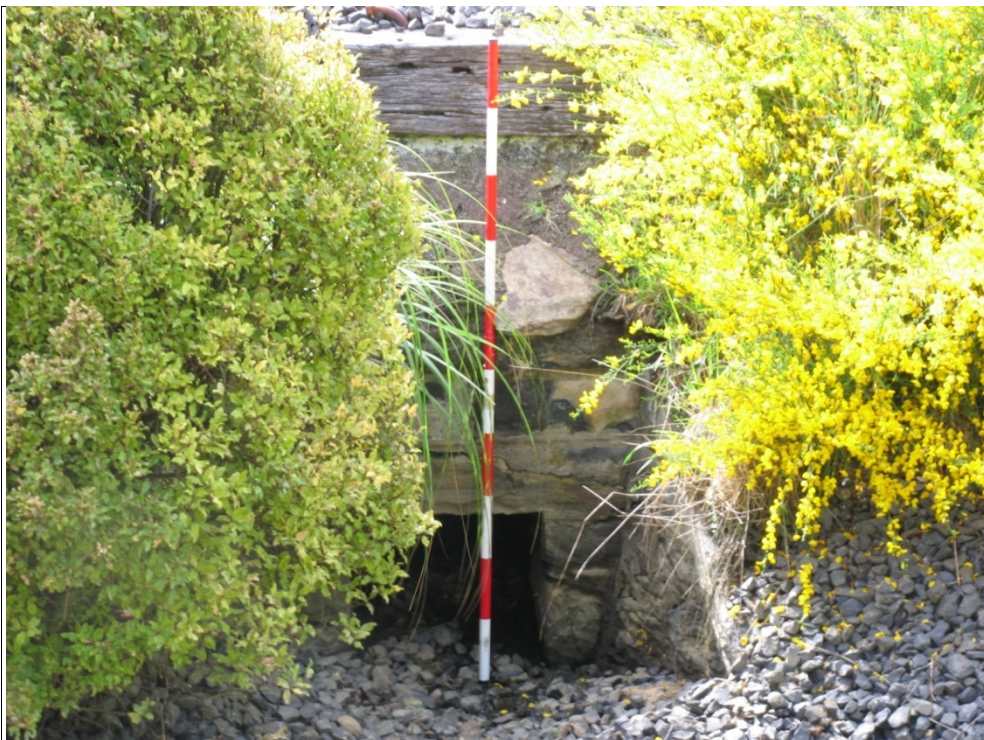
The railway through Waitati was constructed in 1876 and 1877 and was opened on 11 December 1877. It was fenced on both sides with a post-and-rail fence. The Pullar brothers won the contract to construct the fence, which ran from the cliffs south of Waitati to Puketeraki, near Karitane. This required 11,000 posts of either broadleaf or kowhai and 44,000 manuka rails (Church et al. 2007: 76). A mortared, stone-lined culvert crossing beneath the railway embankment was also recorded. Its outer end is buried under the ballast of the second rail line but its inner end is clearly visible – although partly silted up (Figure 11, 12).

Figure 11. Stone culvert under railway embankment.

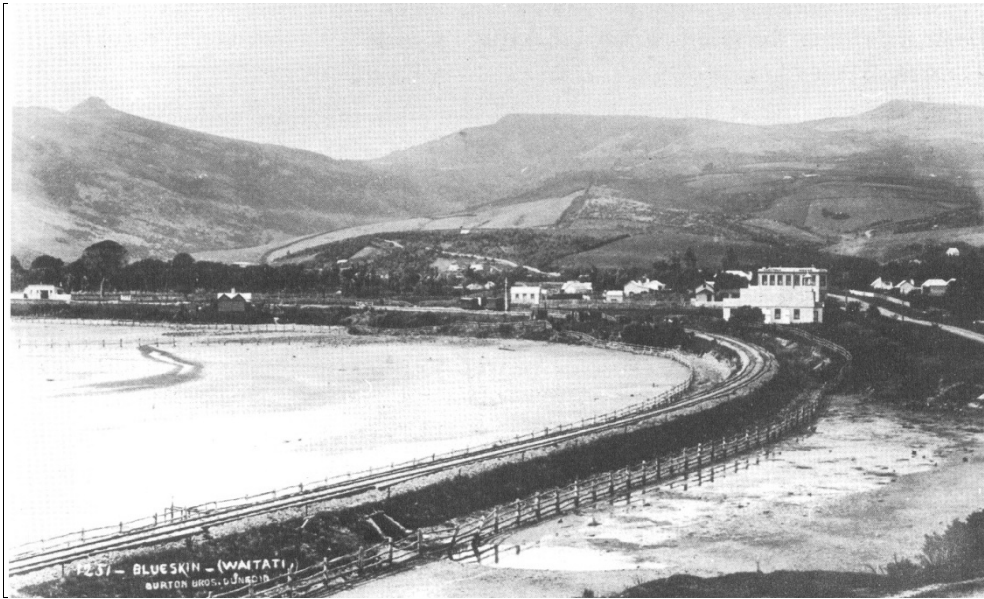
Figure 12. Historical view south towards Waitati from vicinity of Double Hill Rd showing rail line with stone culvert and post-and-rail fences along either side of embankment (Burton Brothers photograph, Hocken Collections E1173/6). Note mudflat on both sides of rail line and culvert in foreground.

is unlikely that any Maori sites will be present there as it is clear from the historical photograph (Figure 12) that the railway embankment was constructed over the mudflats in the area where earthworks will result in the deposition of new fill.

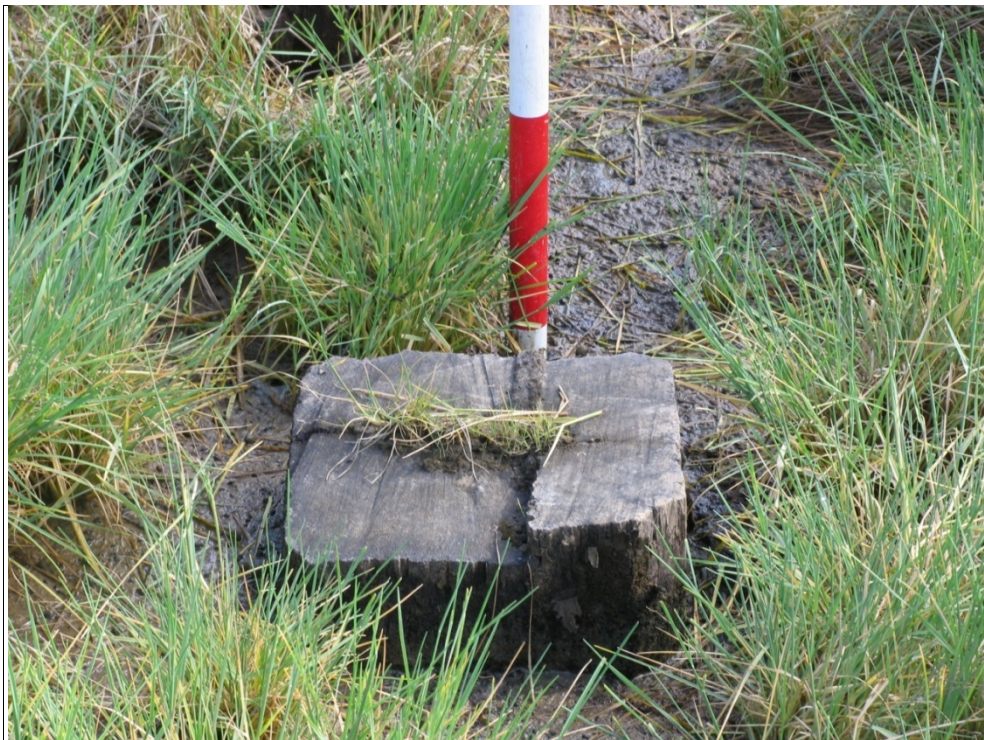
Approximately half-way along the fence line a 300 x 300 mm post or pole was visible where it had been cut off close to the ground surface (Figure 13). Its function was not clear but it was close to a bend in the fence line and it is possible that it was a strainer post that was added once the rails had either rotted or had been removed and the fence converted to a post-and-wire fence. It may alternatively have been a power pole, although it was not in the usual position for this purpose and is more likely to have been directly associated with the fence. Whatever its function, it is clearly post-European in origin and almost certainly associated with the railway in some way.

Figure 13. Cut-off base of large post or pole (300 x 300 mm).

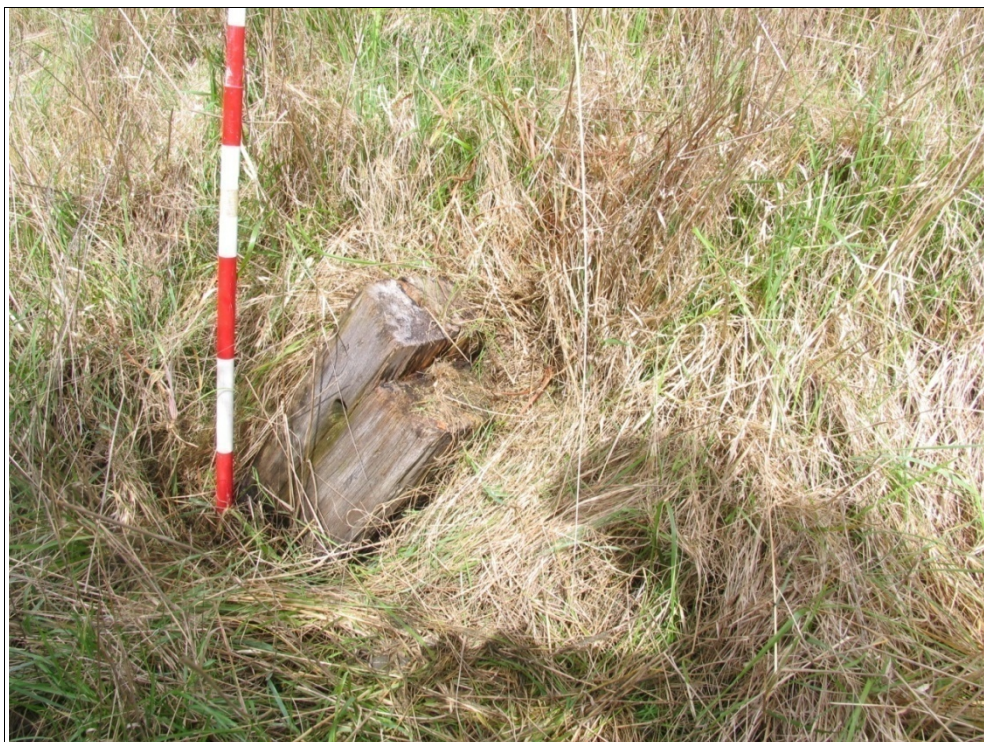
A second 300 x 300 mm post was found 9 m north of the northernmost fence post, but this one was on an angle of about 30 degrees off vertical (Figure 14). Its function has not been determined but it is, again, of post-European origin and almost certainly associated with the railway.

Figure 14. Angled post (300 x 300 mm) found 9 m north of northernmost fence post.

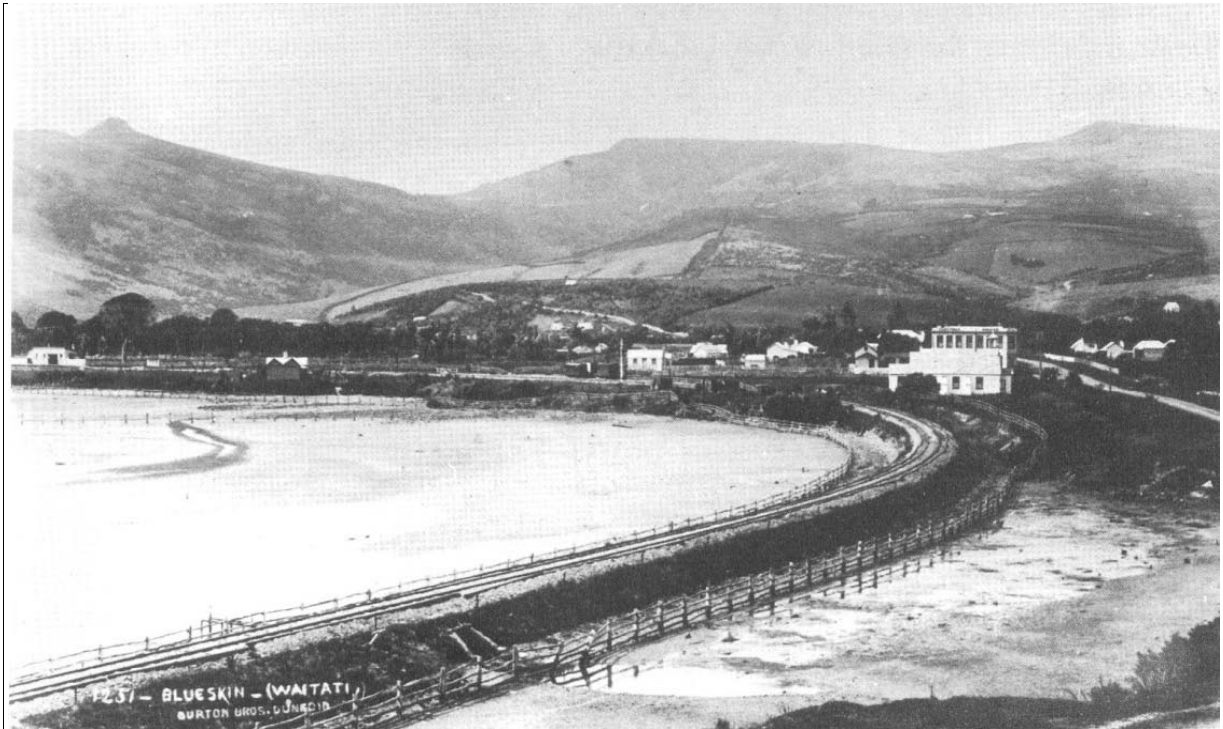
Historical view south towards Waitati from vicinity of Double Hill Rd showing rail line with stone culvert and post-and-rail fences along either side of embankment (Burton Brothers photograph, Hocken Collections E1173/6). Note mudflat on both sides of rail line.

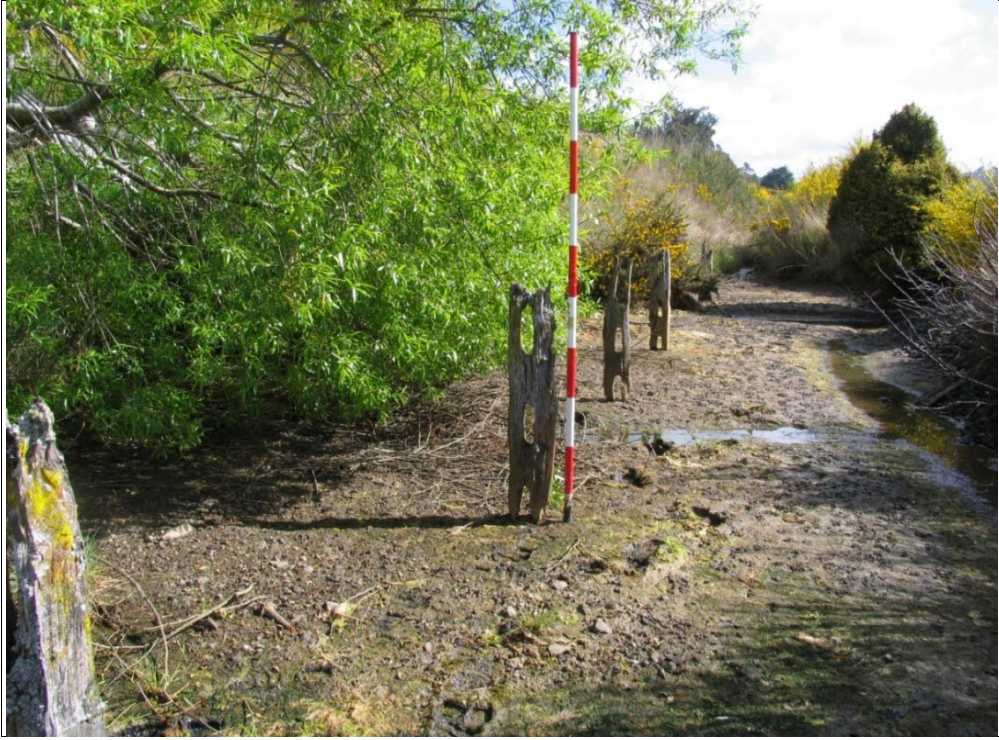
Updated: 01/04/2010, Visited: 08/12/2009 - Site comprises a row of upright fence posts mortised for a post-and-rail fence. The rails (manuka) have all rotted away but the posts (kowhai) have lasted reasonably well. The posts extend about 90 cm above the ground surface and have three oblong holes mortised in.

Updated: 01/04/2010, Visited: 08/12/2009 - Posts have survived well considering their age (about 130 years at the time of writing). However, they are in poor condition overall. The majority of the posts are the subject of an authority application and will be relocated and interpreted off site.

Remains of post-and-rail fence adjacent to railway embankment (view to northwest, scale 2 m).
