Process of architectural wooden preservation in Japan

T. L. Park

Architectural preservation in Japan is discussed through the study and observation of Gekko-den pavilion at Gokoku-ji Temple in Central Tokyo. Gekko-den's importance lies in its affiliation with Onjo-ji Temple, founded in early Heian Period, 672, a designated National Treasure of Japan, and head temple of the Tendaijimon Buddhist sect. Preservation of Gekko-den commenced in November 2008, and will continue through to October 2013. Historical analysis and overview of Cultural Property definition in Japan and the legal system and administration that functions to oversee the protection and preservation of the cultural properties are examined in detail.

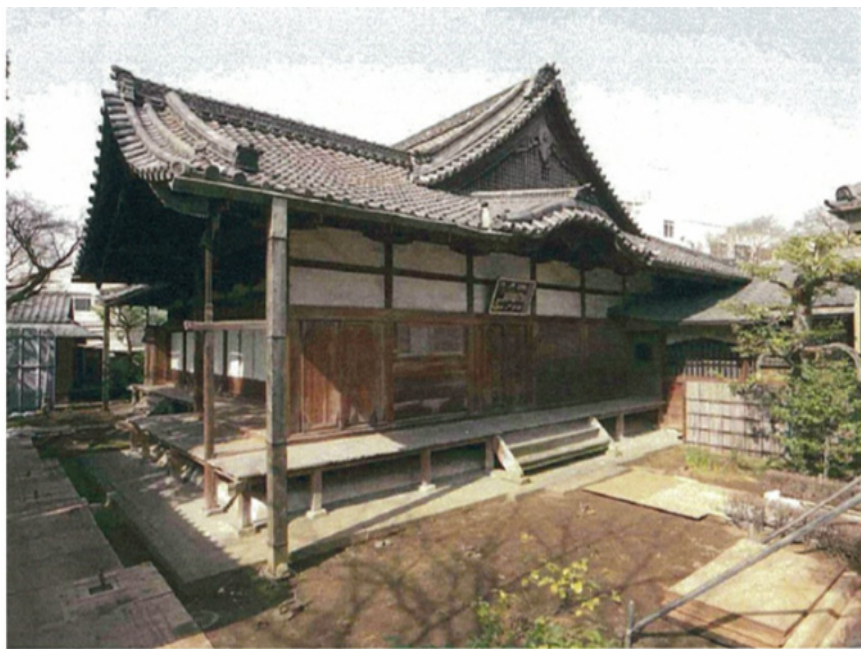
Figure 1: Gekko-den pavilion prior to preservation.

During the eighty years following the move of Gekko-den to its current site, the structural members had begun to show obvious weakening. Depression of the ground under the flooring system was extensive, deformation and sinking of the structure had become significant. It was due to these contributing factors, the decision for full dismantlement was made.

Gekko-den is a single story structure with a side of roofing that extends out and up from each side of the rectangular structure. Partway up two of the shorter opposite sides stop and the remaining two continue to the top where they are joined. The Irimoya style roof was considered the most elegant of the Edo period; the top level of all castles has an Irimoya roof style.

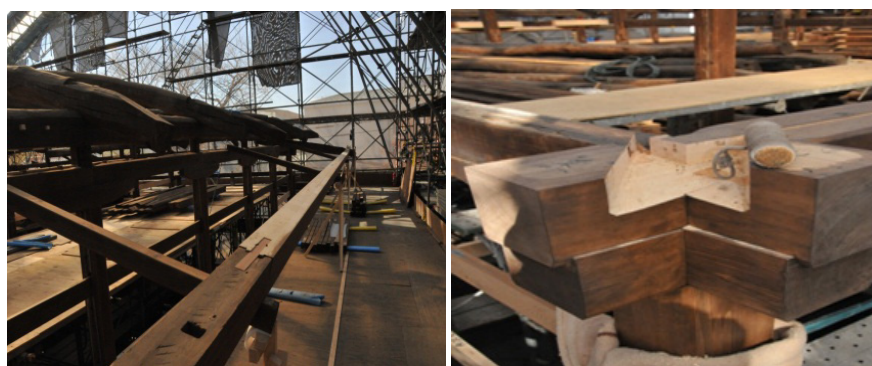
Figure 2: Examples of *Tsugite* and *Shigushi* jointing.

Two main methods of joints are generally deployed, *Tsugite* and *Shigushi*. Due to the obvious limitations of the possible length of wood, where a continuous member is required, intricate and involved jointing methods have evolved to create an uninterrupted linear member. The name for lengthening joints is *Tsugite*, due to the necessity with which these joints are required; there are 50 types of *Tsugite* joints deployed by Japanese carpenters. *Shigushi* is a system developed for securing members at oblique and right angles; generally there are eight types of angle joints deployed. Complex joints and detailed members are intricately measured and carved in a separate carpenter's room, within the temple grounds. A large template is fashioned; on the surface are 1:1 drawings of curved struts and complex joints. The entire floor is covered in white card, shoes are removed and the area used to draw one to one scale of composite joint. Models are also evident on site of the cypress bark roofing, clearly depicting the thickness of the bark, copper flashings and connections to the roofing structure.
