**COMMITTEE FOR THE RE-INVESTIGATION
OF THE SMOLENSK AIR CRASH**

TECHNICAL REPORT

**Facts regarding the crash of the TU-154M No. 101,
(Fight PLF101), that took place in Smolensk, Russia on the 10th of April 2010**

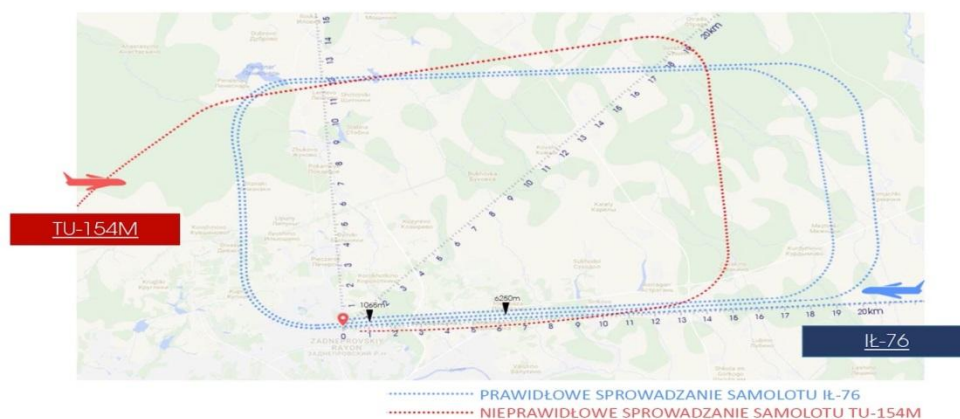
Fig. 1. Comparison of guidance of IL-76 and TU-154M on April 10th, 2010.

Yak-40 and IL-76 and TU-154M were guided with the use of a well-functioning, precision approach radiolocation station and properly functioning radio technical devices.

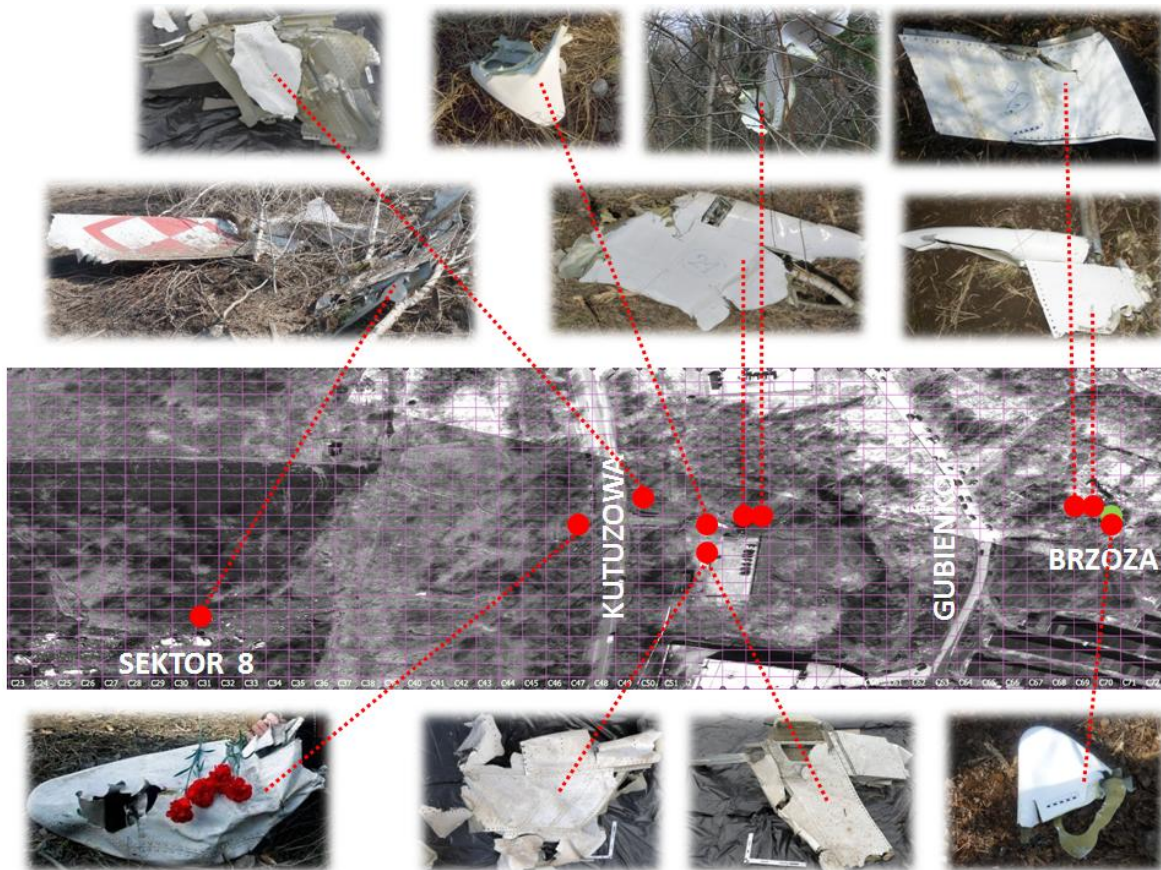
The majority of elements from the flaps of the detachable wing part were scattered from the bb tree in the direction of the main crash site in an area 15m-225m according to the flight direction of TU-154M. (Fig. 20).

Fig. 20. The locations on the ground of various parts from the left wing.

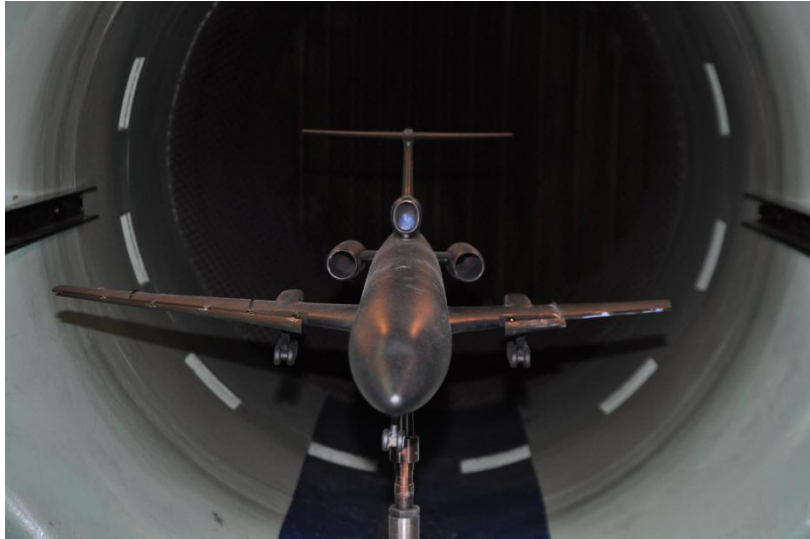
Experiments in the aerodynamic tunnel, conducted in IL, showed that the loss of lift force between 4.8% and 8.7%, due to the loss of the left wingtip, does not have to end in a left roll. This work shows that the pilots, even with an angle of attack up to 11.5degrees, can fully balance the rolling moment by introducing a 7degree sideslip (they have to change the configuration of the plane so that the left wing is moved forward). Further balancing is possible with the move of the right aileron. A side slip is an element of basic aviation training and instinctive for every experience pilot, which is used during side-wind. When losing 1/3 of the left wing, the decreased wind resistance on this side will result in a right-turn of the plane to the sideslip with the left wing to the front. (Fig. 25).

Fig. 25. Airplane model in the wind tunnel of the Institute of Aviation. Here in version with a cut left wing and without slats and the outer flap.

The loss of the left wingtip, 1/3 length, together with the loss of the left slats and flaps (which were found before the Kutuzov street) will result in a major loss of lift force (16%-20%), which can't be balanced by the activities of the pilots and has to lead to a left roll and deepening turn on the left wing connected with a sudden loss of altitude.

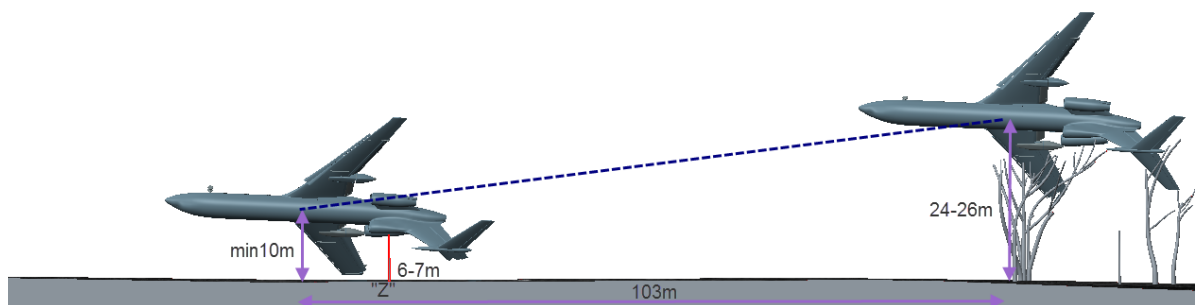
A 6-7 meter high tree marked with the letter “Z” on fig 29 to fig. 31b and directly above the trajectory of flight was not damaged by the plane which means that the altitude to the balance point in that moment, when the tail passed the “Z” tree, was at least 10m.

Fig. 29. A view to the north at the moment the plane flew from Kutuzov street (right) to the crash site (left). The 6-7m tall tree is here marked with the letter "Z".

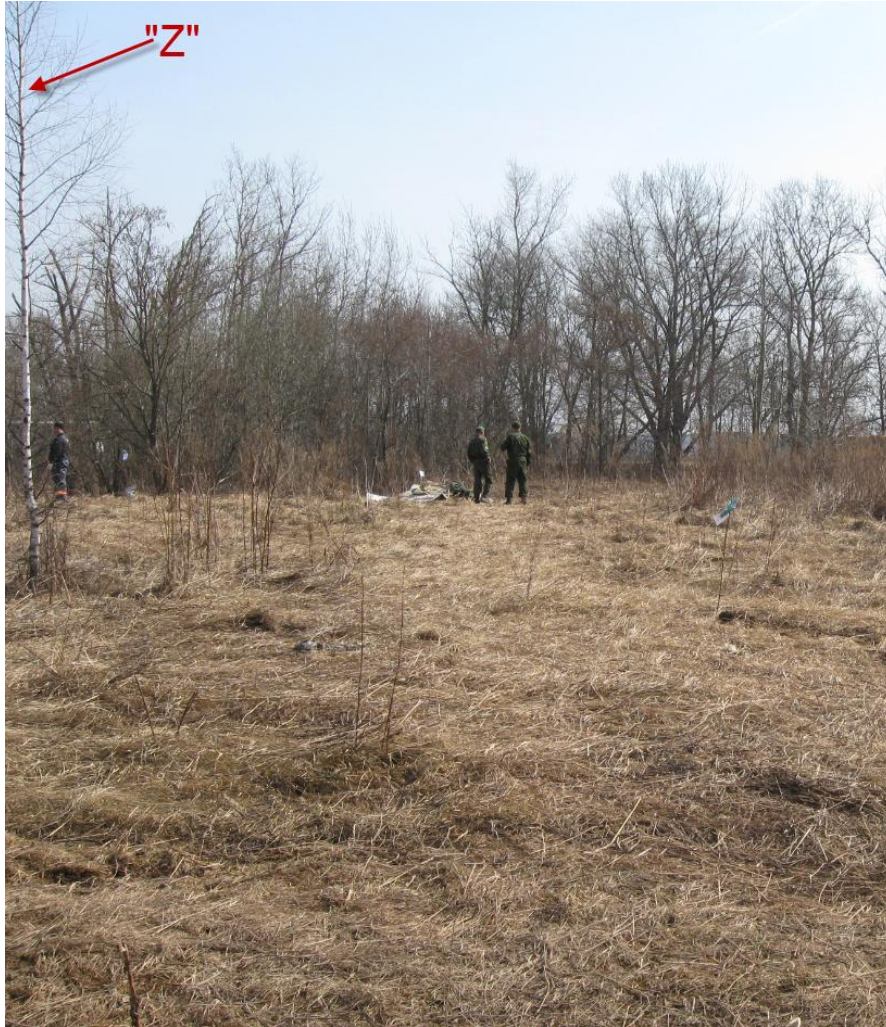
Fig. 30. The tree marked "Z" growing in the direct vicinity of the flight path, when the plane was flying from Kutuzov Street (in the background) to the place of crash. On the right side, starting at the blue marker on a stick there is a visible ground trace when the ground was hit with the left stabilizer.

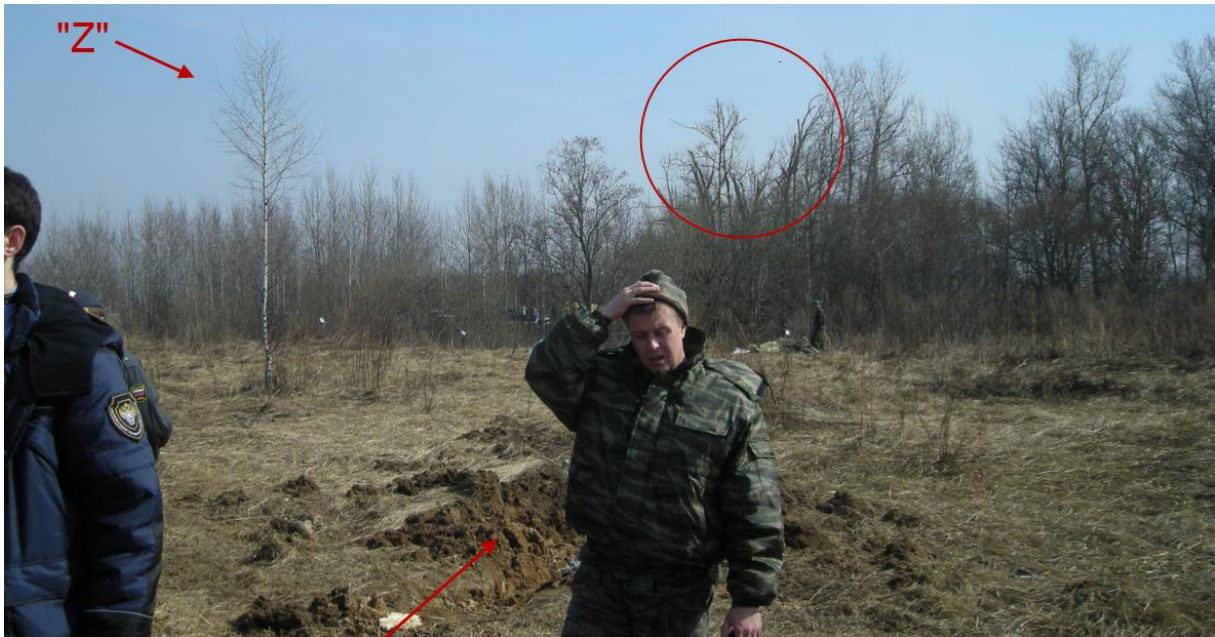
Southern Ground Trace

Fig. 31a. The tree marked "Z" growing in the direct vicinity of the flight path, when the plane was flying from Kutuzov Street (red circle) to the place of the crash. The ground trace from the tail is visible and marked here as "Southern Ground Trace".

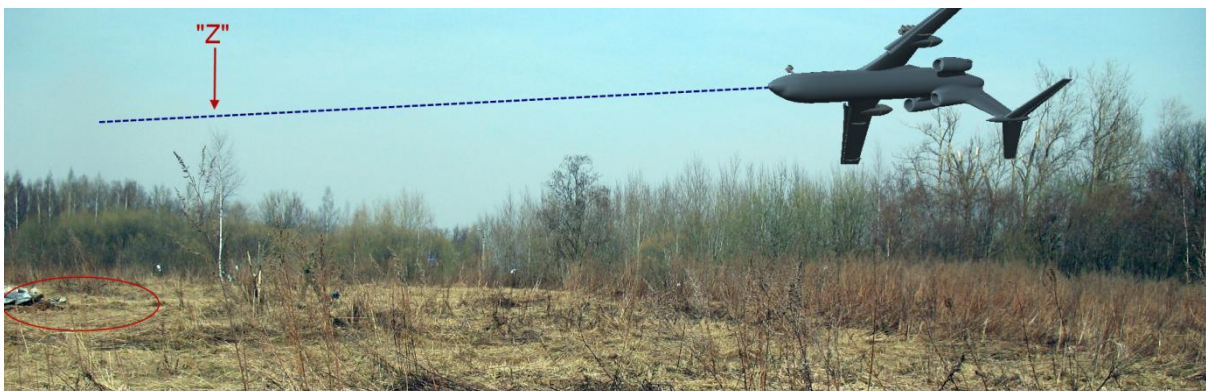
Fig. 31a. The tree marked "Z" growing in the direct vicinity of the flight path, when the plane was flying from Kutuzov Street (right side) to the place of the crash (left side). The ground trace from the tail is visible and marked here with a red ellipse. The white part inside the ellipse shows the new position of the left horizontal stabilizer after Russians had moved it 35m closer to the crash site.

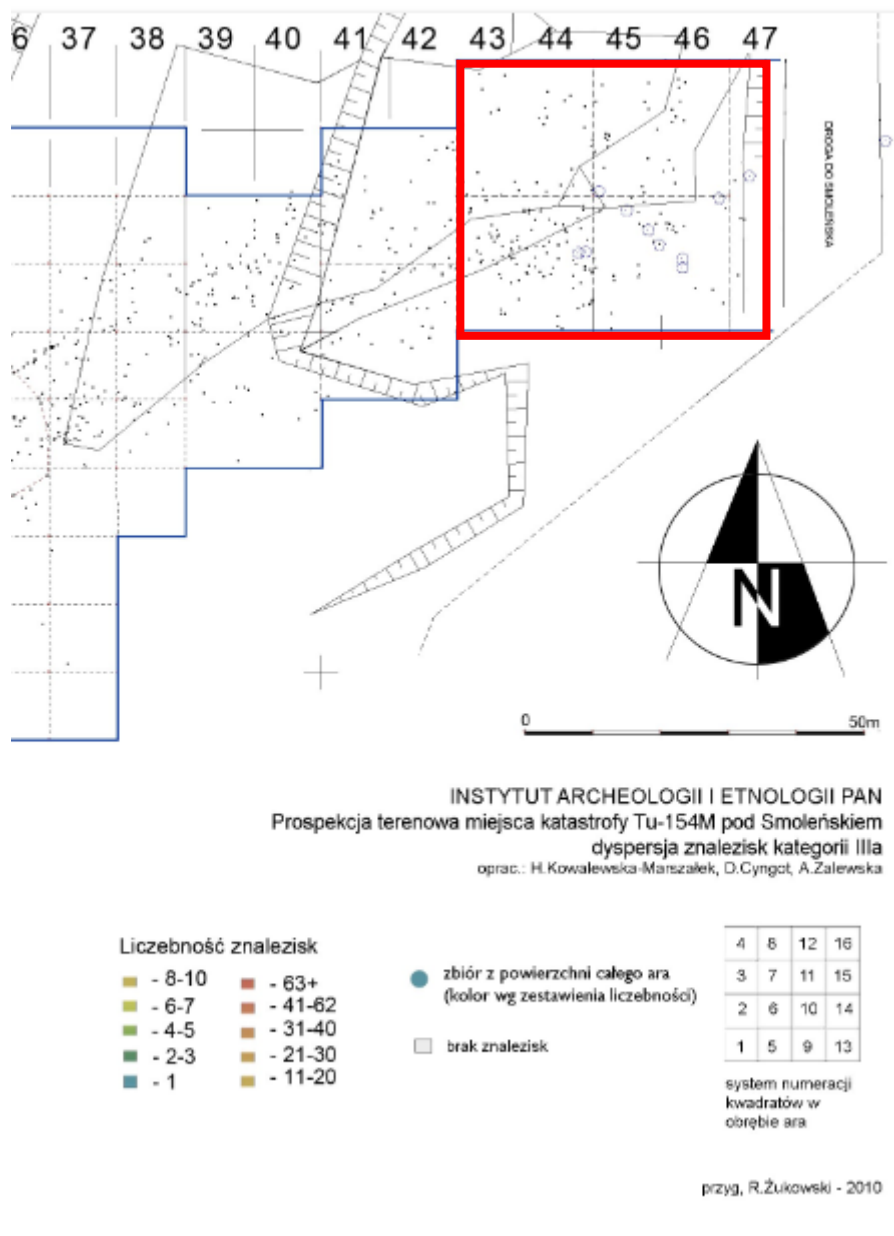
During a terrain analysis, done by Polish archeologists in Smolensk in October 2010 in sector 13 behind Kutuzov Street and before the main crash site, numerous pieces of the plane were found (fig 32). Those pieces, varying in size, from a couple to tens of square centimeters, had traces of thermal and mechanical effects (fig 33).

Fig. 32. Map from the archeologists report showing where pieces were found behind Kutuzov street (marked "Droga do Smolensk" at the right).

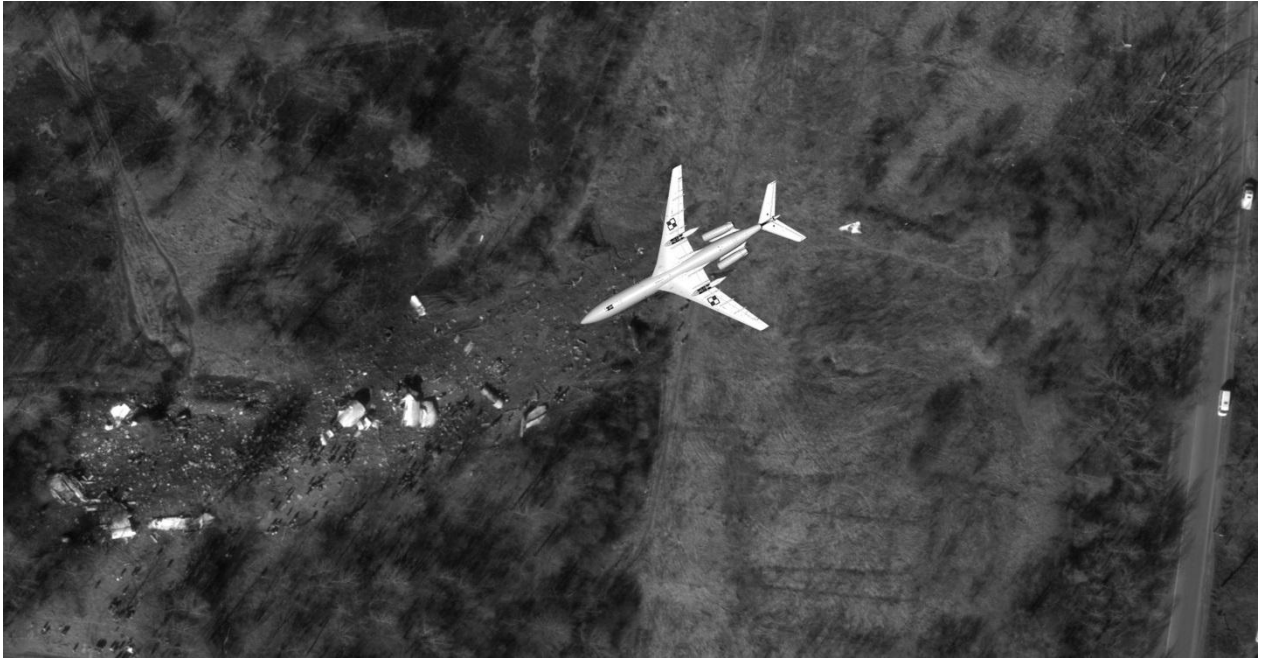
General view of the crash site compared to the shape of TU-154M in a 1:1 proportion show that the pieces of the plane fell down as a result of an explosion in the air and not the disintegration in time when sliding on the ground (no visible crater). (Fig. 35).

Fig. 35. A general view of the crash site compared to TU154M in a reverse position, in the correct scale.

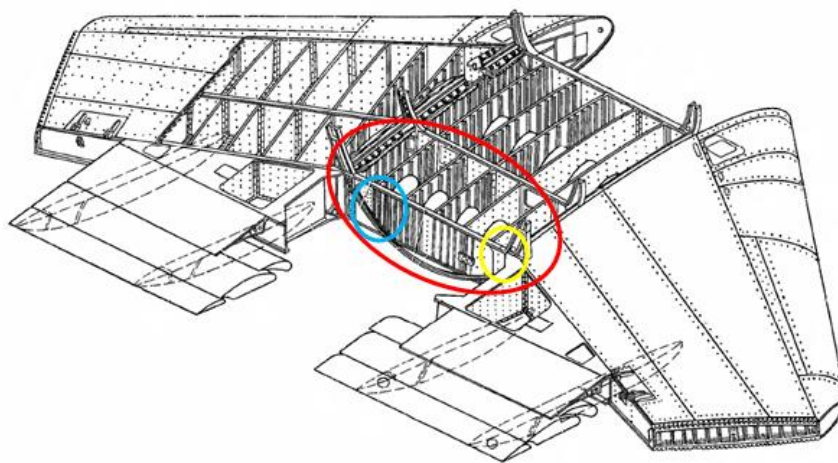
Fig. 39. Center wing box of TU-154M. Highlighted in red **fuel box no.1.**

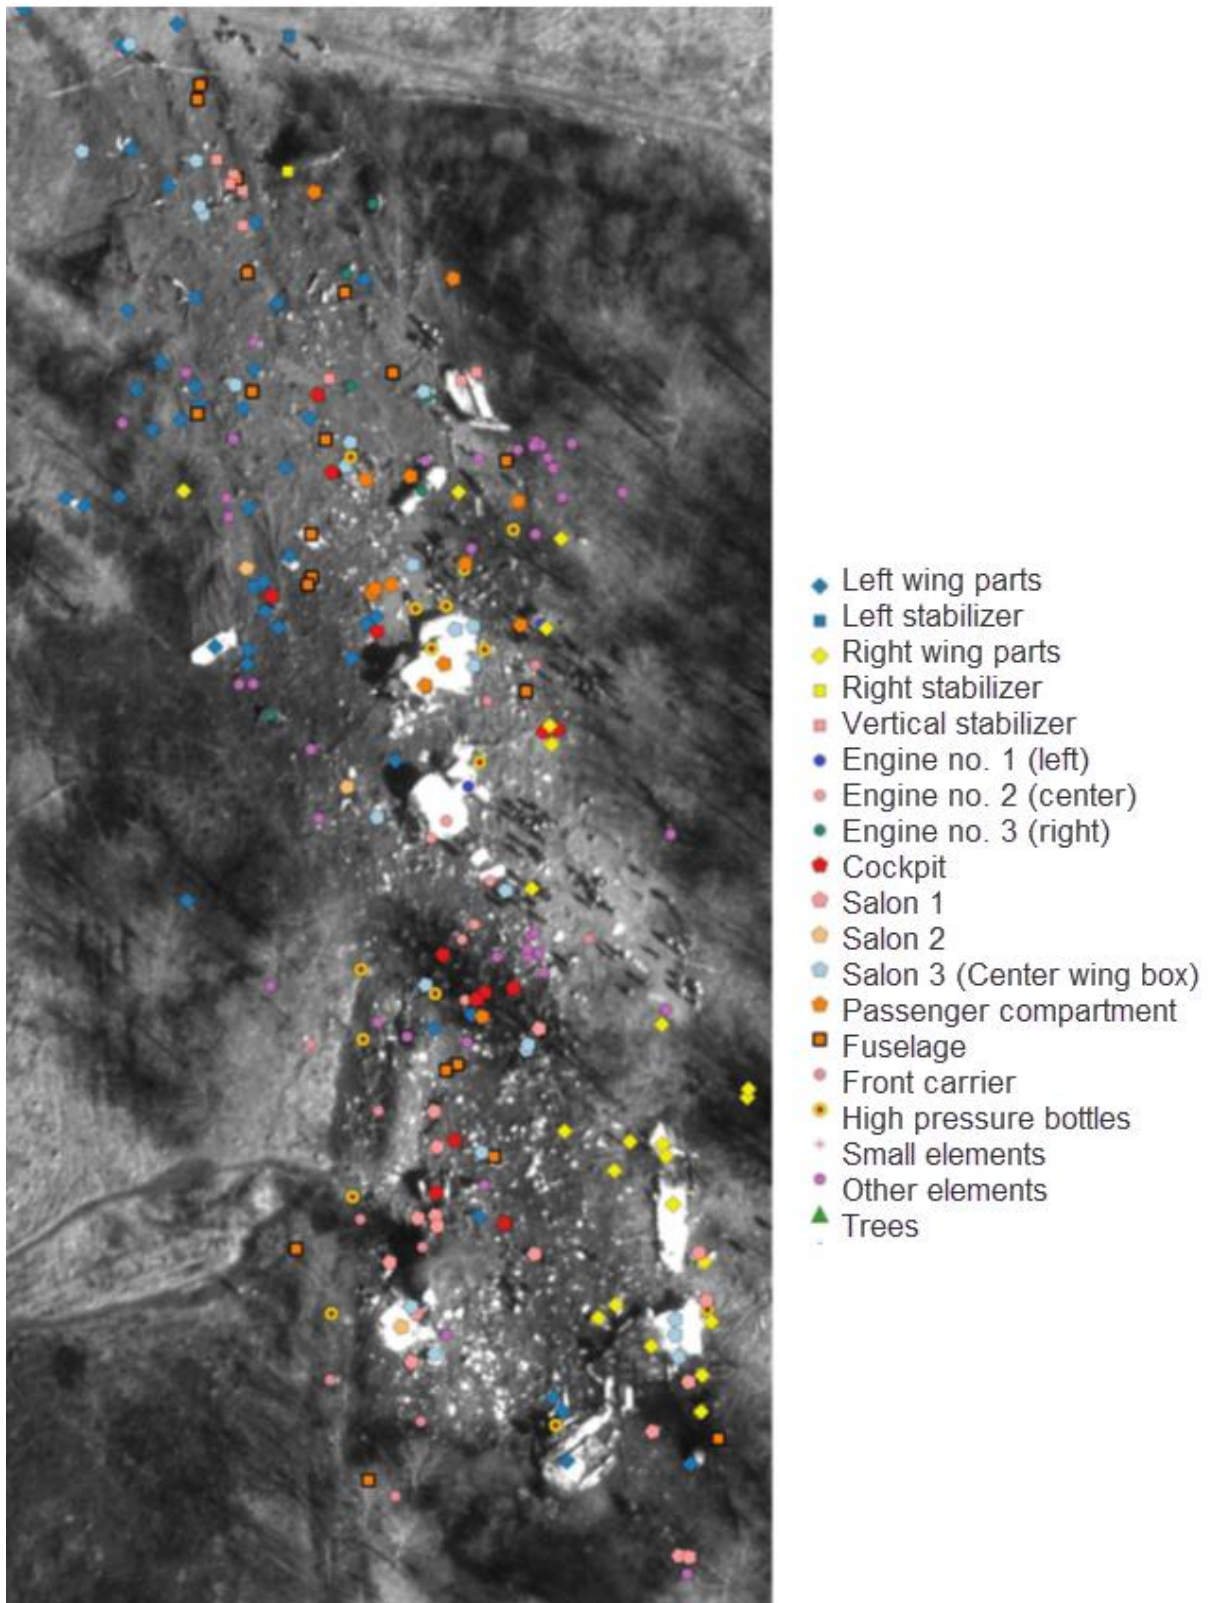
Fig. 43. Dispersion of part of the aircraft on the wreck. Study of the Committee. The direction of the flight is from the top left corner and down towards the bottom right corner.

The TU154M aircraft disintegrated into more than 60,000 pieces. The majority of the elements were rammed into the ground, and though located, they were never extracted. 10,000 pieces were collected 6 months after the crash. Up until the present day the number of elements that were in the ground was not calculated and were not collected when the debris was put at the debris storage place.

The main crash site is 45mx160m, which means that the movement of the aircraft in this area, with its total destruction, happened in a distance corresponding to 3 lengths of the plane. The plane's impact on the ground happened in the reverse position to the aircraft, which is visible based on the dispersion of pieces of the left and right wing at the crash site. Indentations were observed in the ground at the place of the crash but without a deep crater. On the entire crash site there is no trace of a strong impact of the fuselage in the ground. All the seats were totally destroyed, meaning that the seating part, back lean, armrest, frame lay separately. Apart from the front part of the fuselage between the nose and the beginning of the center wing, pieces from the right side of the plane were found mainly on the left side of the crash site, and pieces from the left side of the plane were found mainly on the right side of the crash site.

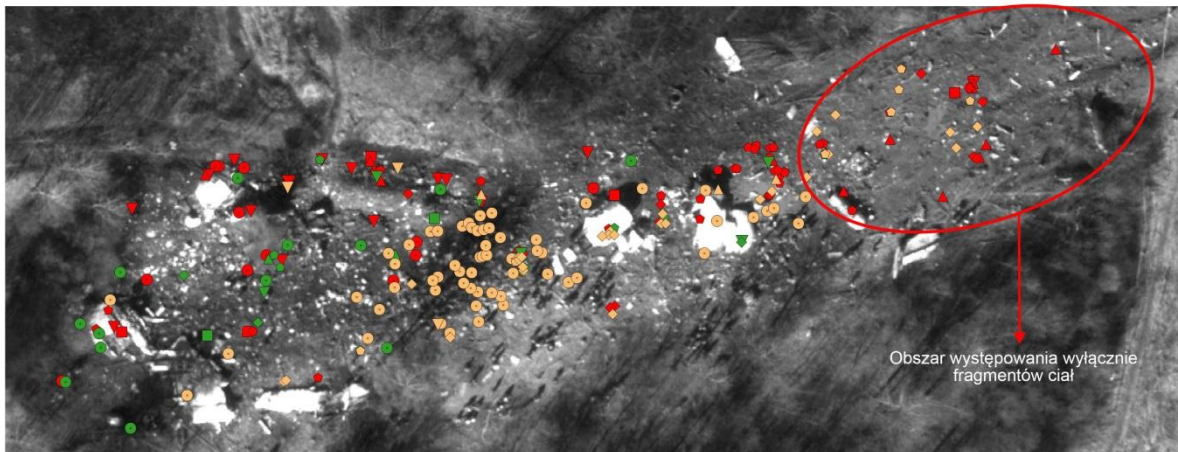
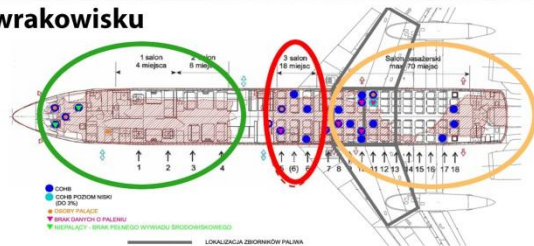
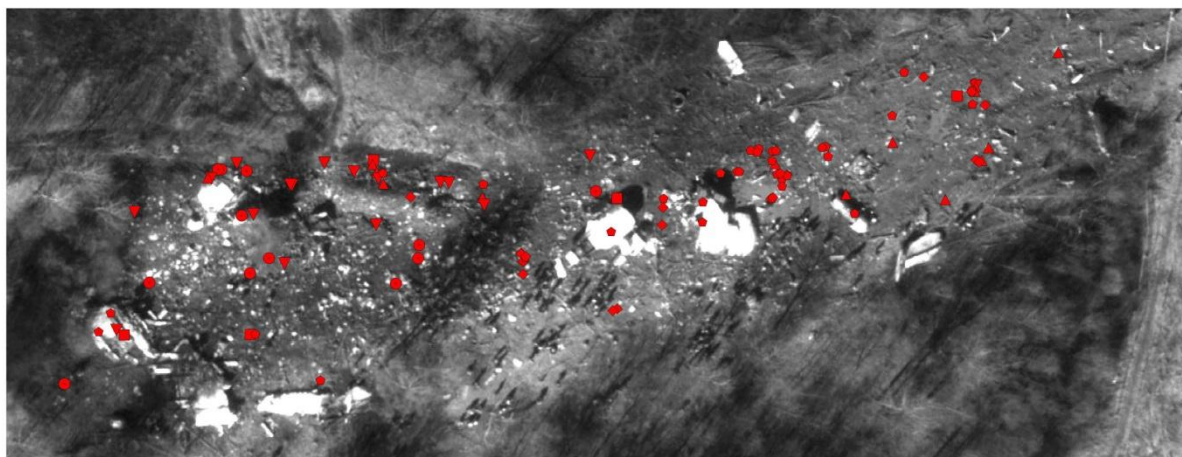
All 96 occupants on board died. All occupants were thrown outside of the fuselage, as were the seats, on which they were sitting, including the floor-covering with insulation. At the beginning of the crash site, apart from pieces of the plane, only small, torn pieces of the bodies of victims were found, and numerous internal organs identified. This shows that even before the plane hit the ground the bodies of the occupants sitting in the center part of the plane (lounge no.3) were damaged and torn into pieces. (Fig. 46).

Fig.46. Location of bodies on the crash site. Only small body fragments and intestines were found in the area circled at the top picture, often far from the main body. The fuselage was more than 6m above the ground when passing this area. Whole bodies are marked with a red circle.

Parts of the body were found at the beginning of the crash site, before the fuselage hit the ground. This shows that the movement of the body parts was opposite to the movement of the plane. In all the cases identified these were body parts of people sitting at the front part of the plane, especially in lounge 3. At the same time it is important to say that the door rammed into the ground was found nearby, as well as the galley (distributed on 1/3 of area of the crash site) and the left center wing.

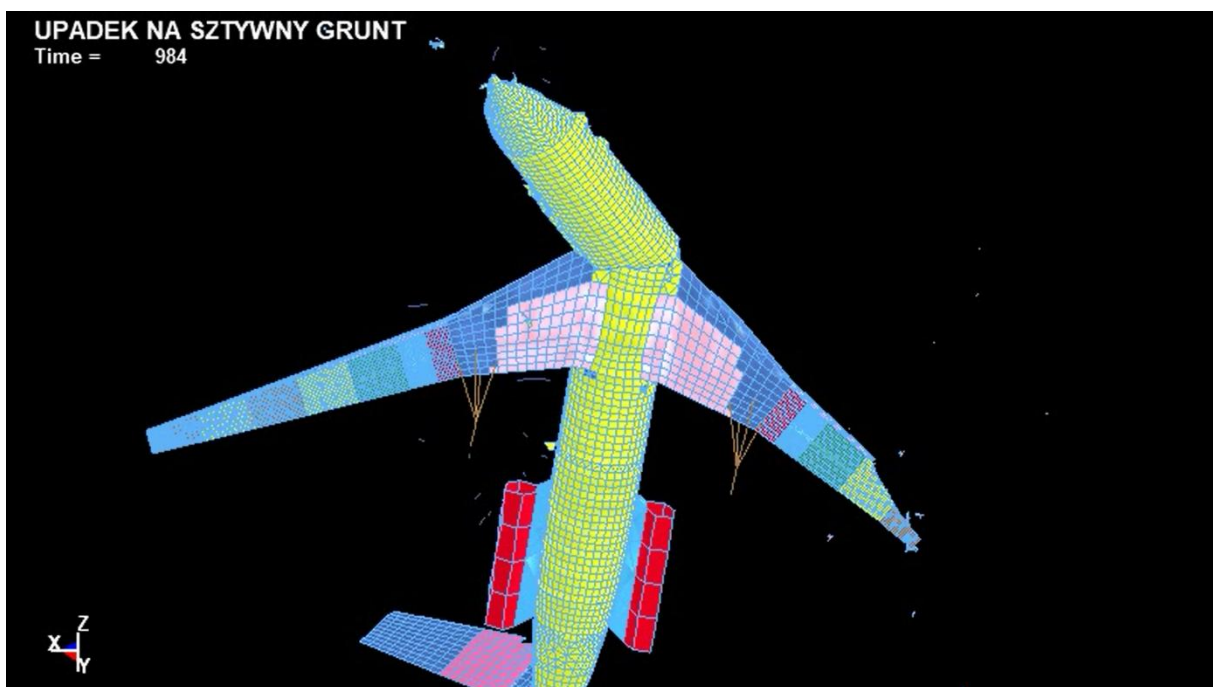
Rys. 47. Simulation of the disintegration of an airplane hitting stiff ground (concrete). The aircraft only breaks into a few parts.

1. The simulation of the plane's destruction shows a completely different destruction of the construction than the one found at the crash site.

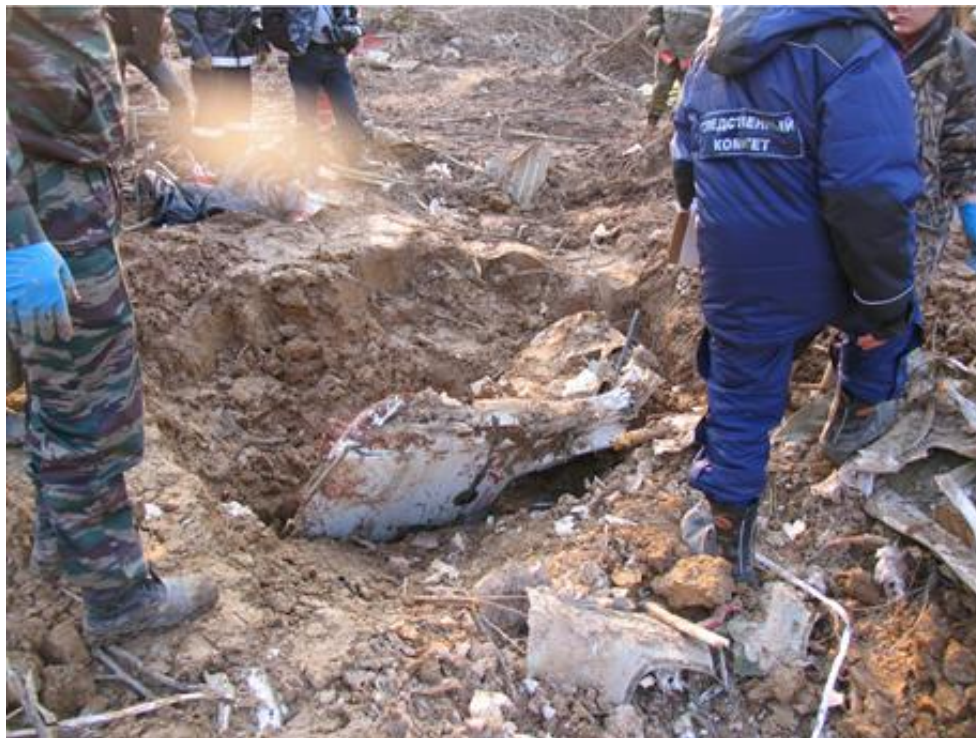
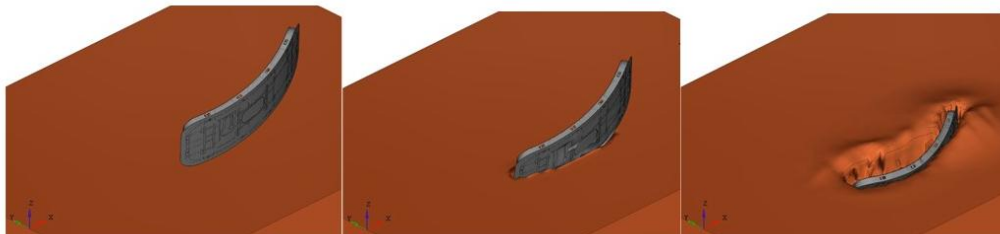
Figure 48 Shows results from NIAR's simulation of the door hitting soft ground and the door buried 1meter in the ground as Russians were digging it out by hand.

When pulling the left passenger door 2L, driven over 1m into the ground, a human hand and forearm were found near the door handle. Source: Images of the door driven into the ground

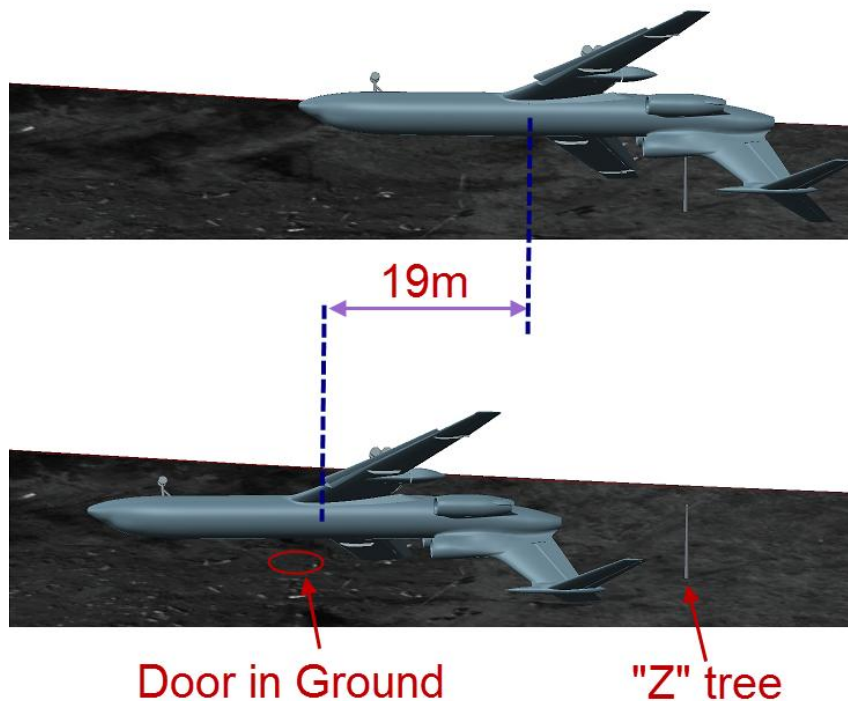
Fig. 49. The position of the plane the moment it passes the Z tree and the position of the plane above the rammed door.

The distance between the trees west of the street and the tree marked "Z" is about 103m and the time it takes to travel this distance can be worked out as $\Delta t = 103\text{m}/75\text{m/s} = 1.37\text{s}$

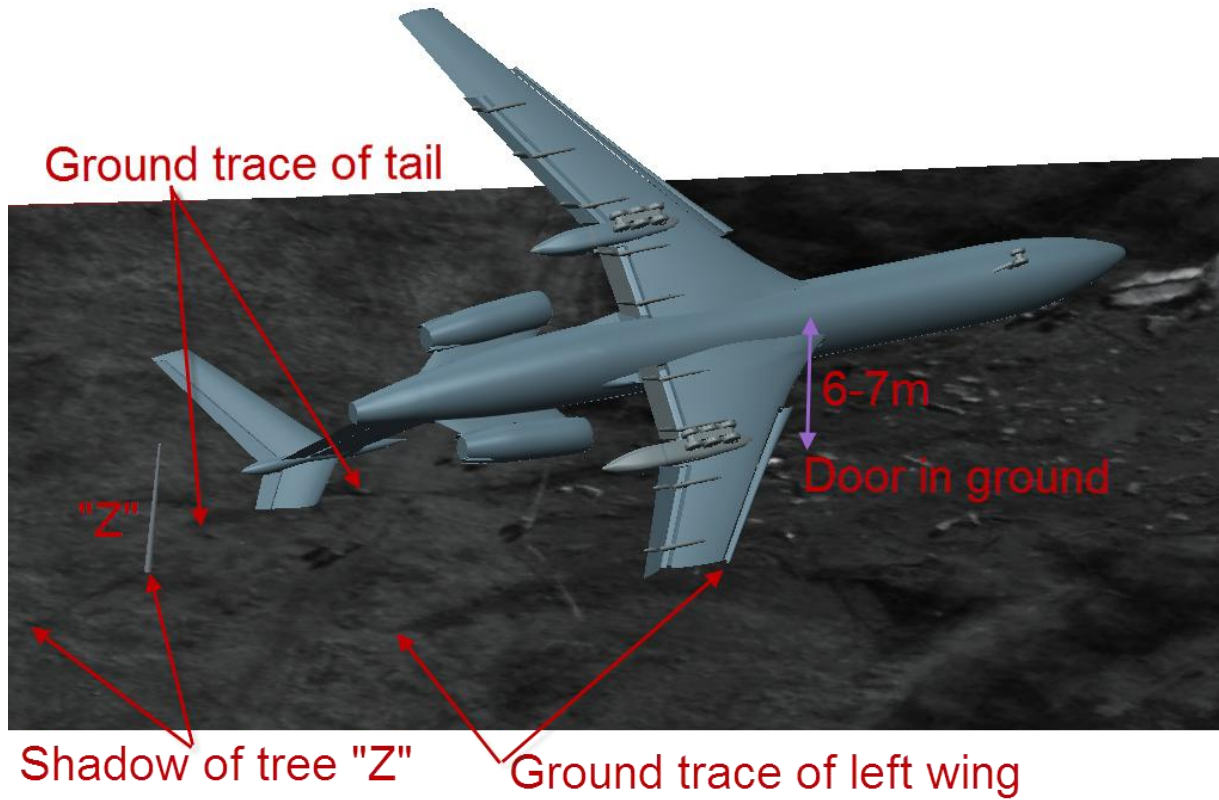
Pic.50. The moment the plane hit the ground

Analysis of the ground traces assumes the left roll of the aircraft to be about 130° when the remains of the left wing touched the ground at the beginning of the main crash site. They assume the height above the ground was about 6-7m when the fuselage was positioned with the left passenger door above the location it was in the ground.

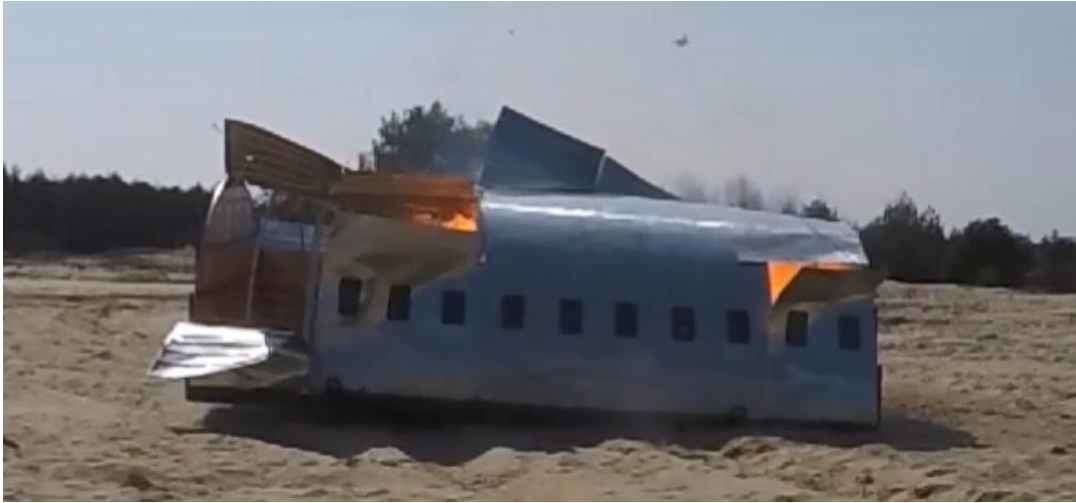
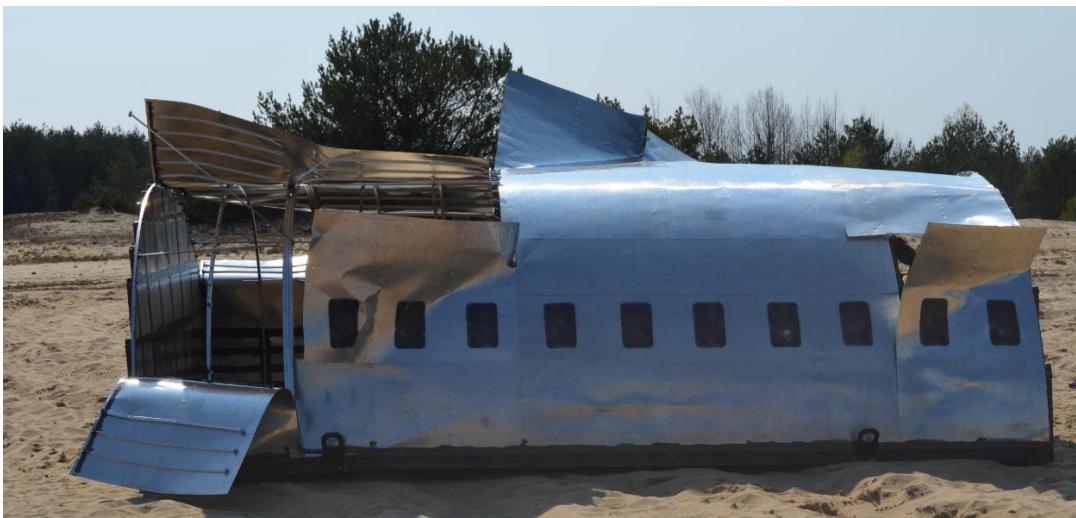
Experiments carried out by the Committee on a model of the occupants part of TU154M on a 1:1 scale show that the destruction of the plane observed in Smolensk could not be the result of a fuel explosion. (Fig. 51).

Fig.51. Explosion of jet-fuel in the occupant's part of the fuselage resulting in a large opening but not resulting in destruction into small pieces.

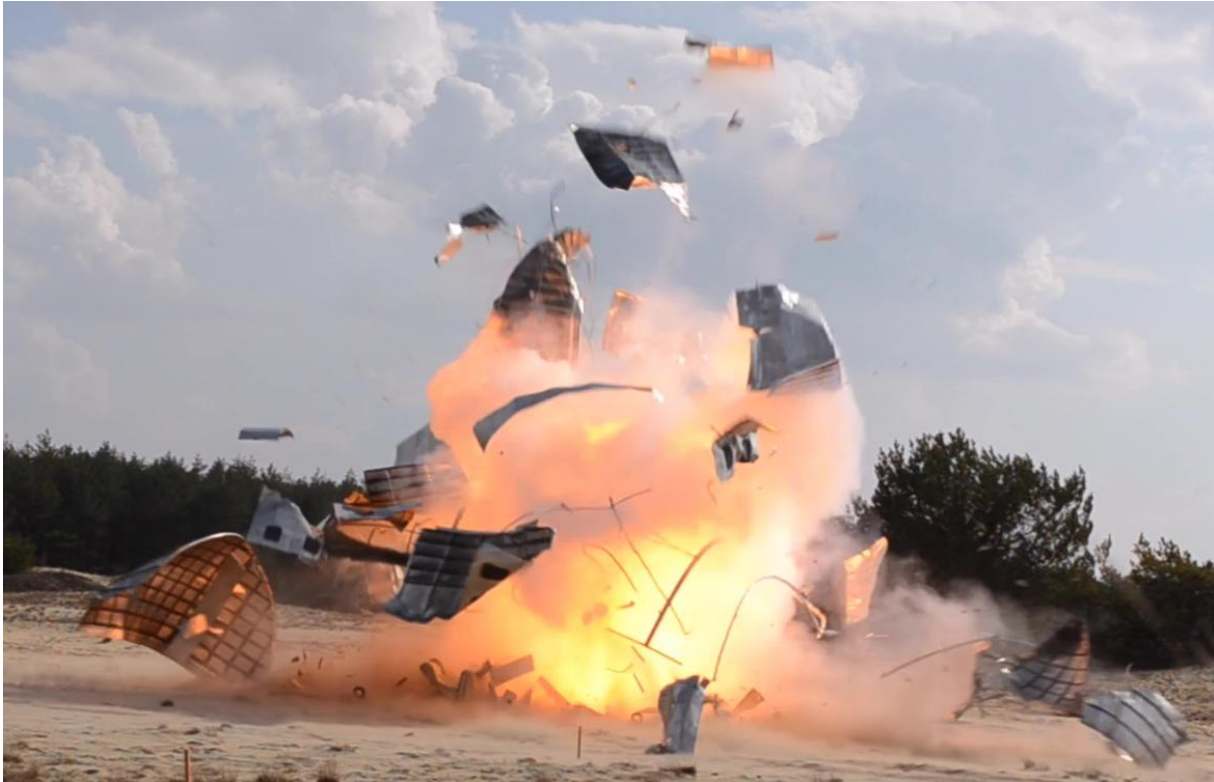
Experiments conducted by the Committee on a model 1:1 of the occupant's part show that such disintegration, as observed in Smolensk, can be the effect of one or many detonations of air-fuel charges, with special consideration given to a thermo-baric charge with a longer tension impulse propagated inside the fuselage before hitting the ground. (Fig. 52).

Fig. 52. Explosion of a thermo-baric charge in the occupant's part of the fuselage resulting in the complete destruction of the fuselage and the formation of a lot of small debris.

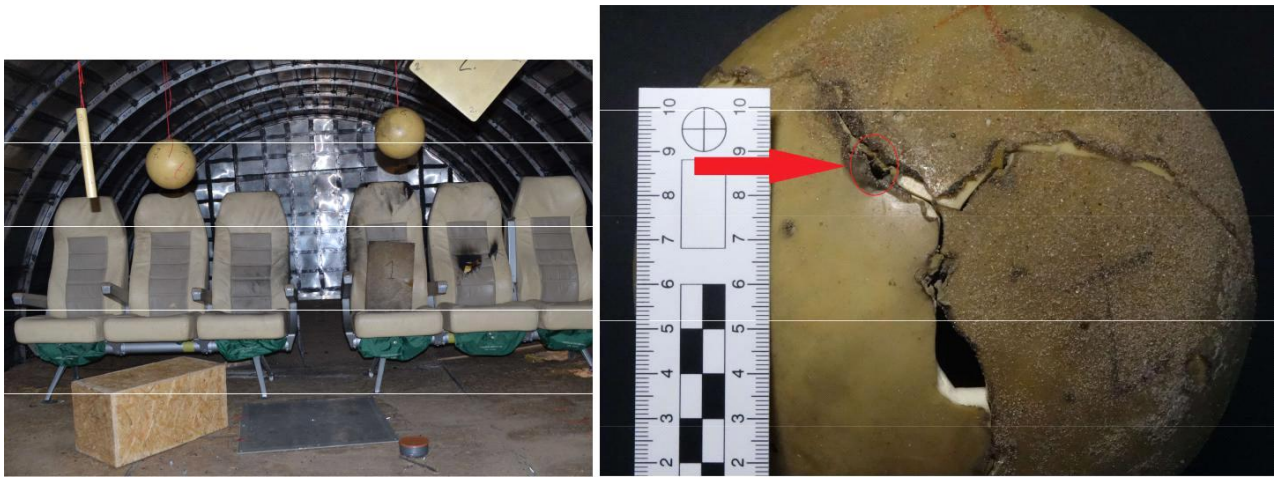
Fig. 53 Medical phantoms inside the model of the occupants part of the plane
