Vladimir Putin's Russian Government Inquiry into the Crash of The Polish Air Force One in Smolensk, Russia, April 10, 2010

**Polish Parliamentary Committee for the investigation of
the Tu-154M crash in Smolensk, Russia on April 10th, 2010
under the chairmanship of Antoni Macierewicz**

Study prepared by Kazimierz Nowaczyk, Ph.D.

European Parliament, Brussels, March 2015

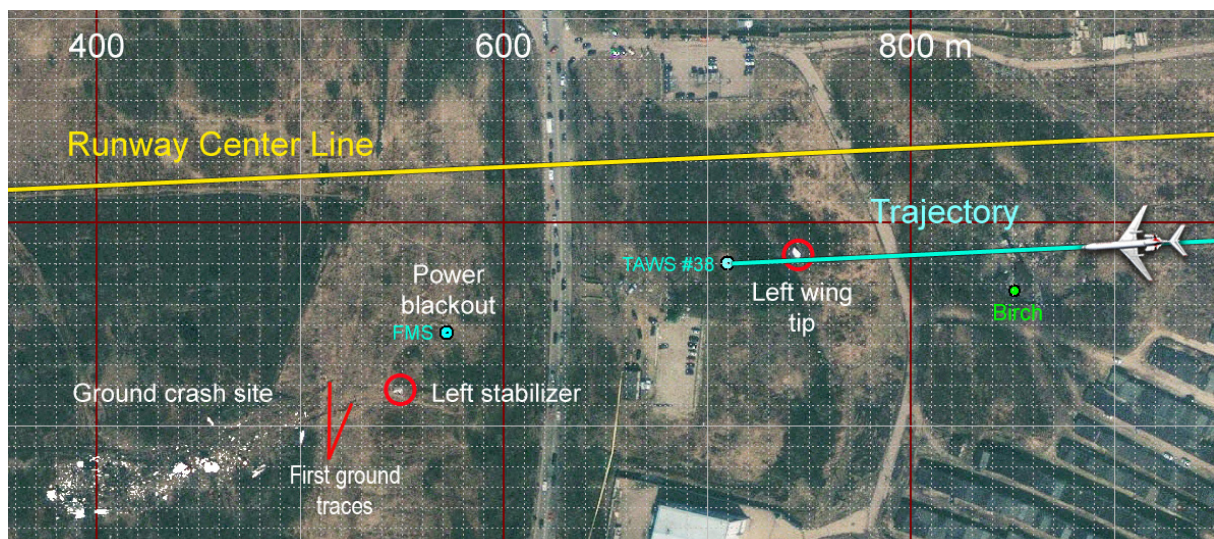
Figure 2. Airplane trajectory (cyan line) compared to the runway center line (yellow line). Map prepared based on IAC report (Appendix VIII), satellite picture (Appendix VI) and NTSB report (Appendix VII). FMS and TAWS #38 positions from Universal Avionics NTSB Expertise (Appendix X). Power blackout at altitude 15 m, 70 m in front of the first traces of hitting the ground.

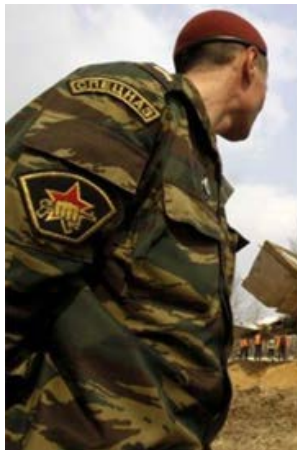
Figure 16-17. From the very beginning, Spetsnaz special military unit was present at the crash site. Arrival of additional Spetsnaz (special purpose forces) personnel two days after crash (4-12-10).

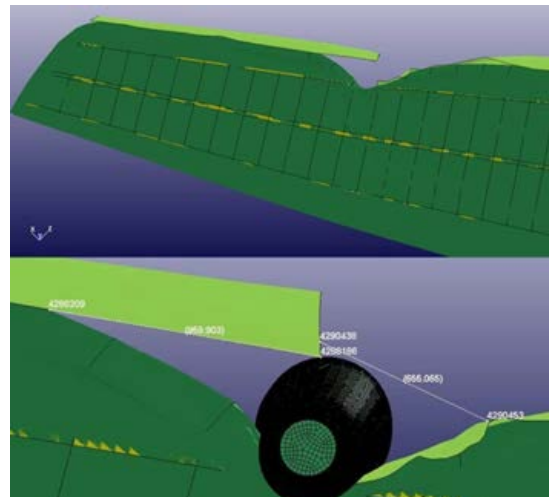
plane had hit the birch tree at the velocity 75 m/s, the wing would have cut the tree. There would only be a minor damage to the wing edge (Figure 25).

Figure 25. Prof Binienda LS-Dyna wing-birch collision simulation.
