Toe Protection for H-piles on Sloping Bedrock at Rainy River

Jon E. Bischoff, Bengt H. Fellenius, Richard E. Riker

Proceedings of Deep Foundations Institute Annual Meeting, Pittsburgh October 18 - 20, 1993 pp. 215 - 222

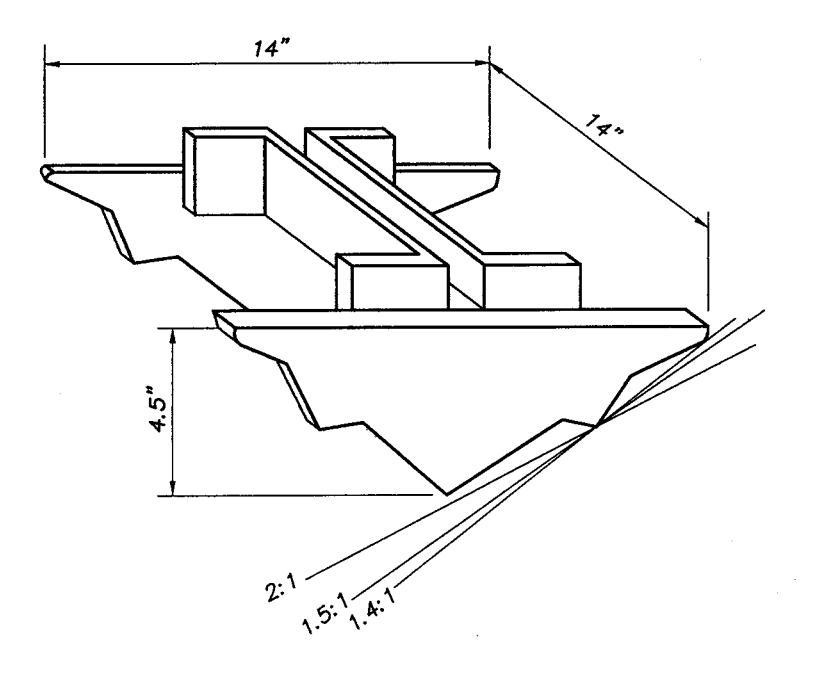
Fig. 2 Geometry of the Hardbite HP77750 rock shoe (14 inch = 356 mm, 4.5 inch = 114 mm)

The inability of the pile to grip and penetrate the bedrock surface is not considered due to any defect in the Hardbite shoe, but a consequence of the steep and strong bedrock surface. Where conditions were less extreme, piles with the Hardbite shoe met the required termination criterion and showed no sign of sliding or toe damage.

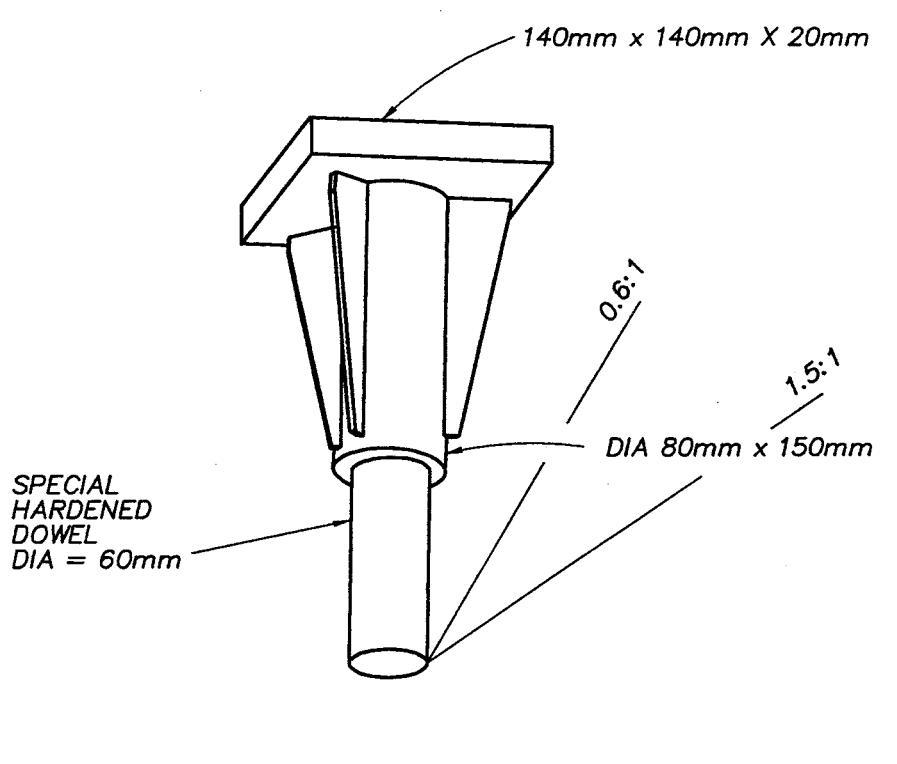
The geometry of the Herkules shoe is illustrated in Fig. 5. Its main component is a small-diameter dowel of specially hardened steel alloy inserted in a laterally supporting cylinder and bearing on a steel plate. The concave shape of the dowel end and the very pointed appearance of the shoe ensures that the dowel contacts the bedrock surface before the side of the shoe or pile, thereby keeping the toe force concentric with the pile.

It is important that the hardening is done so that the dowel steel does not become too brittle and shatter on impacting the bedrock. Furthermore, the steel in the main body of the dowel must be strong enough to serve as a reliable base for the hardened 'skin' of the concave dowel end. To maintain the hardeness of the dowel, the dowel is not welded to its support (which would destroy the hardening) but held in place by a set-bolt through the wall of the supporting steel cylinder. (The Herkules rock shoe is not the same as what is commonly known a the Olso-point. The latter is a generic term for a shoe with a larger diameter dowel of mild steel welded to a base plate or cylinder and with no or little hardening of the dowel end).

Fig. 5 Geometry of the main component of the Scanpile Herkules rock shoe (140 mm = 5.5 inch, 20 mm = 3/4 inch, 60 mm = 2.4 inch)

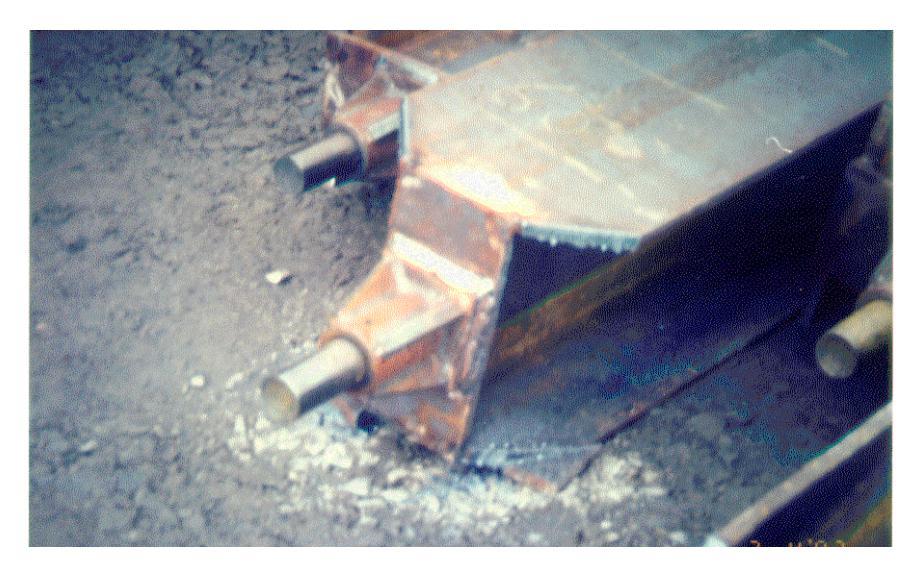
Fig. 6a H-pile with the Herkules rock shoe attached

A supply of Herkules shoes was ordered from the manufacturer's stock and air-shipped to the site to be used as an alternative to the Hardbite shoe in areas where the bedrock was steep. Figs. 6a and 6b show photos of piles lying on the ground with the Herkules shoe attached ready to be picked-up and driven. Some of the piles with the Herkules shoe were driven as replacement piles directly adjacent to failed piles (within 2 feet-0.6 m). In every case, the piles with the Herkules shoe drove well and to the specified termination criterion.

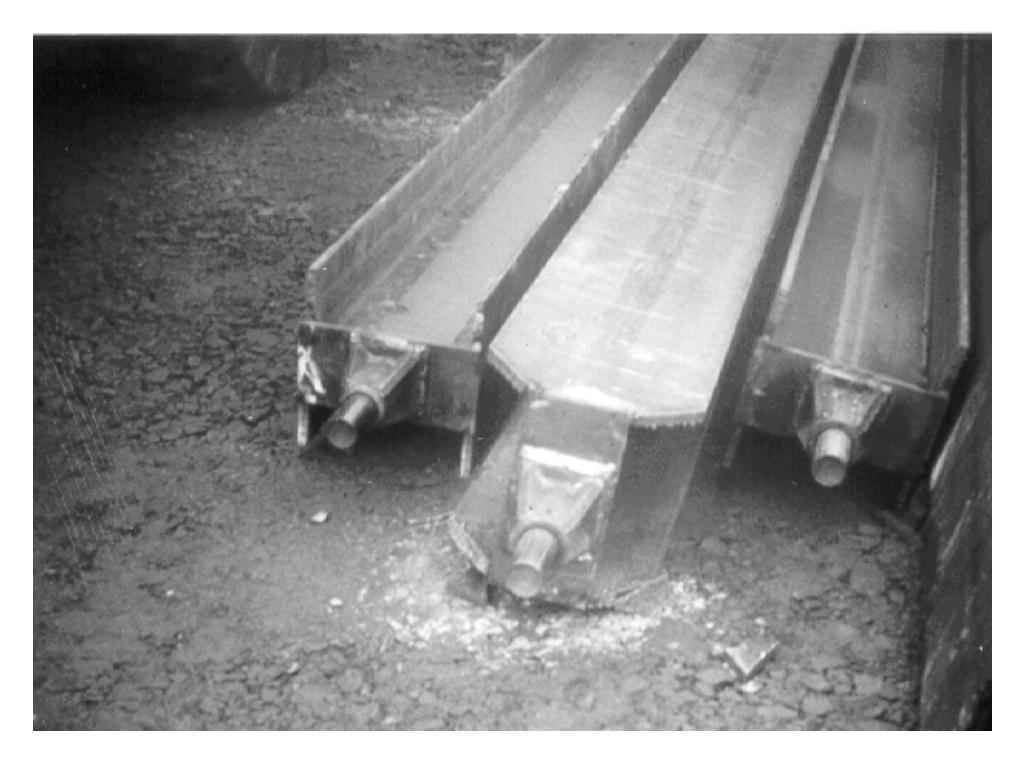
Fig. 6b H-piles with the Herkules rock shoe attached ready to be driven
