SCIENCE OF TSUNAMI HAZARDS

FIELD SURVEY REPORT OF TSUNAMI EFFECTS CAUSED BY THE AUGUST 2012 OFFSHORE EL SALVADOR EARTHQUAKE

Francisco Gavidia-Medina*

MARN – Ministerio de Medio Ambiente y Recursos Naturales, El Salvador

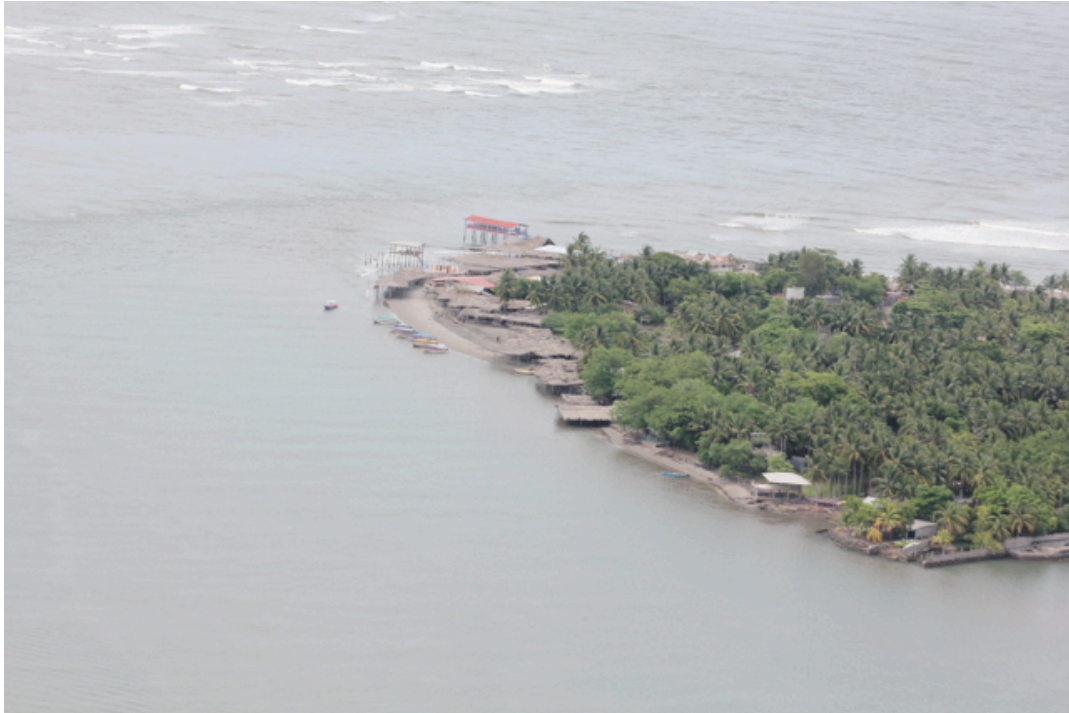
Figure 3.31 La Puntilla.

To the west of the study area is a popular and highly developed beach resort area known as Costa del Sol (see Figure 3.1). At the eastern end of this area is a grouping of restaurants built directly on the water front. Indeed some of the restaurants have seating areas set directly over the water (Figure 3.31 and Figure 3.32). Given the extremely vulnerable location of these structures, it could reasonable by expected that if a tsunami wave the same size as that which affected Isla de Mendez hit this area, there would have been reports of significant effects or damage.

During the initial survey immediately after the earthquake and tsunami conducted by MARN, residents and proprietors here did not report any such effects, nor was any evidence observed supporting that notion. Only at the isla Tasajera, between Costa del Sol and rio Lempa, the turtle hatchery workers report that they hear something unusual coming from the sea, but no evidence of the tsunami was find it.

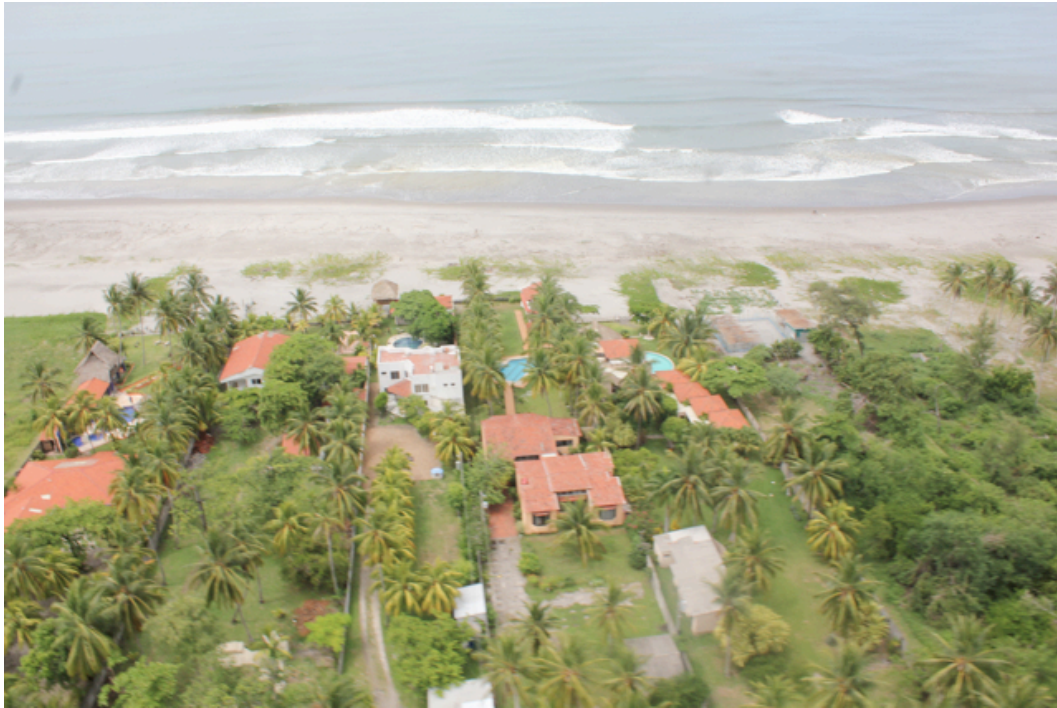
Figure 3.33 Costa del Sol.

Just to the west of La Puntilla is the popular resort area of Costa del Sol (Figure 3.33 through Figure 3.35).

As seen in the aerial images, the area is very developed with numerous structures built close to shore and many potential witnesses in the area on the night of the tsunami. During the preliminary MARN survey, there were no reports from this area of inundation, damage or effects, again suggesting that the tsunami here was very small.

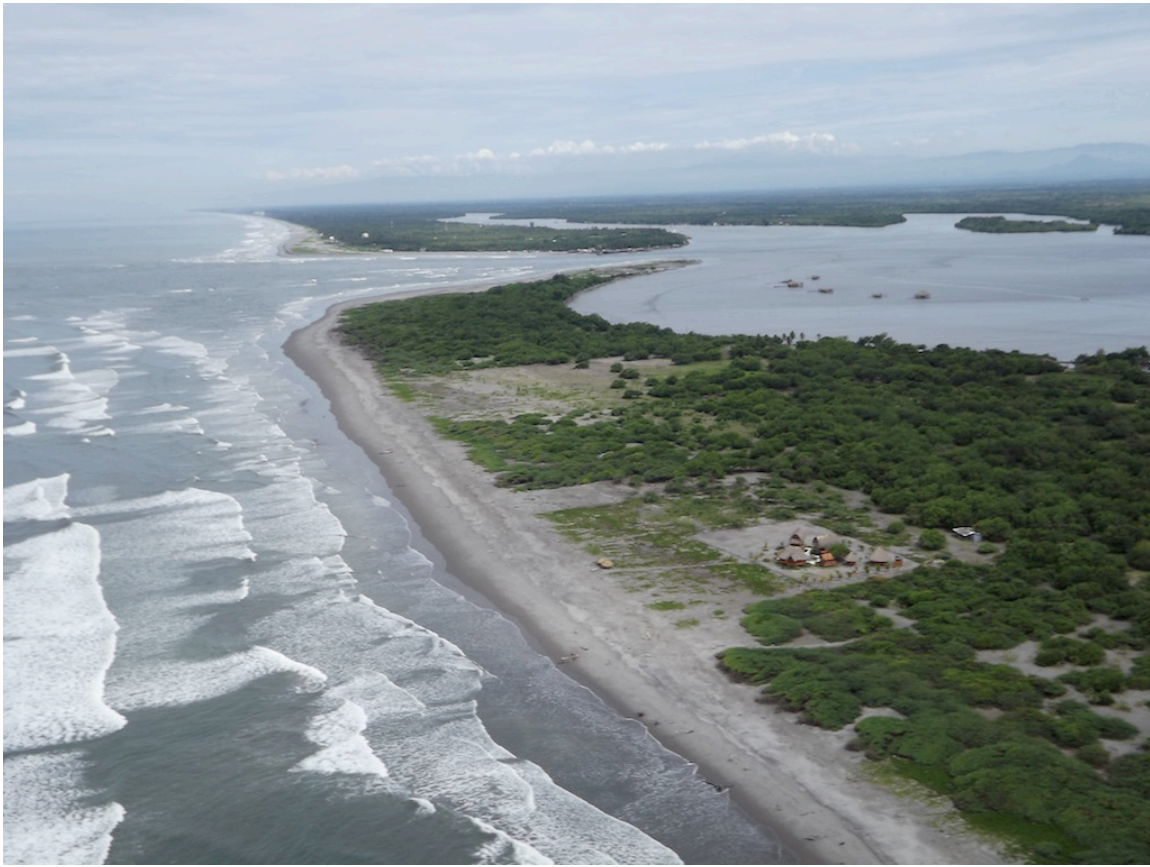
Figure 3.35 Aerial view towards La Puntilla and Costa del Sol to the west.
