This document is an English translation of the Final Report on the accident on 10 April 2010, on Smolensk "Severny" airdrome, to the Tupolev Tu-154M tail number 101 of the Republic of Poland.

**INTERSTATE AVIATION COMMITTEE
AIR ACCIDENT INVESTIGATION COMMISSION**

FINAL REPORT

Type of occurrence	Accident
Type of aircraft	Airplane, Tu-154M
Registration	Tail number 101, Republic of Poland
Owner	Republic of Poland
Operator	Ministry of Defense, Republic of Poland
Site of occurrence	Between the middle marker and runway 26 threshold, Smolensk "Severny" Airdrome, N 54°49.450' and E 32°03.041'
Date and time	10.04.2010, 06:41 UTC, 10:41 local time, daytime

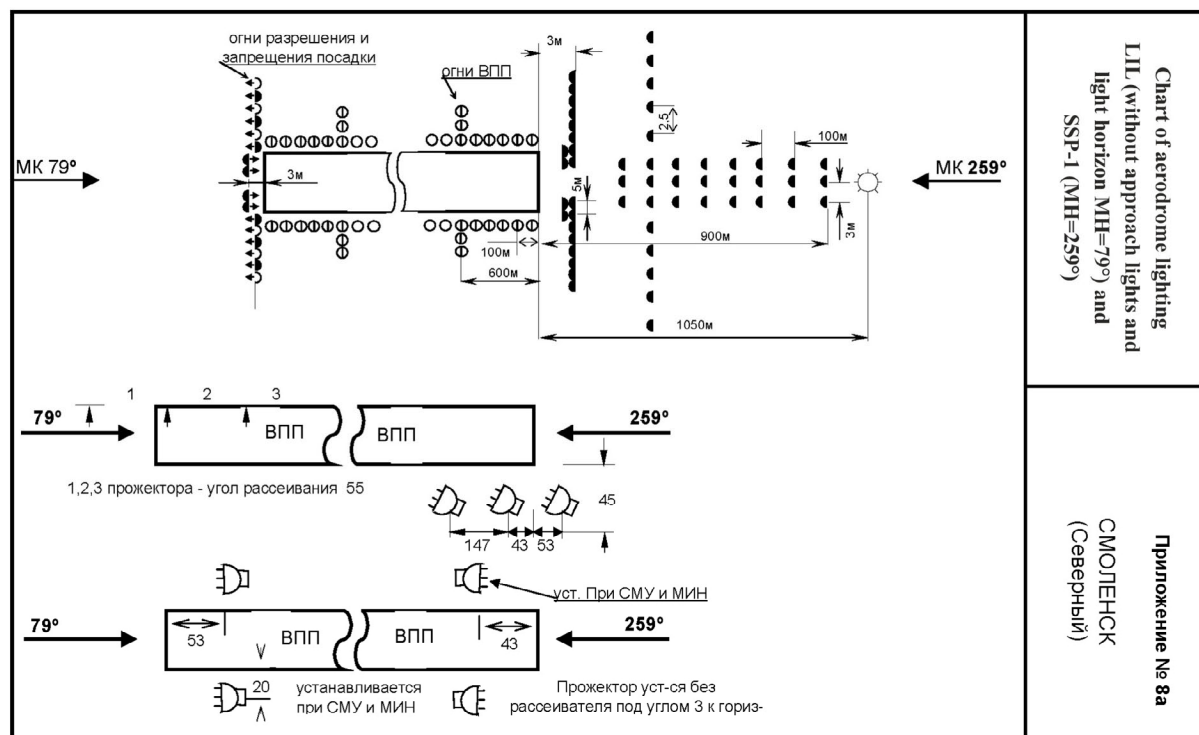
Figure 11

The fly-around check on 15.04.2010 (Figure 12, Figure 13) revealed that in comparison with the shown scheme, there is one more light line at a distance of 100 m from RWY 26 threshold, the actual number of threshold lights (green) is 6 instead of the 8 lights specified in the RTP. The lighting equipment check also revealed that depending on the aircraft position and

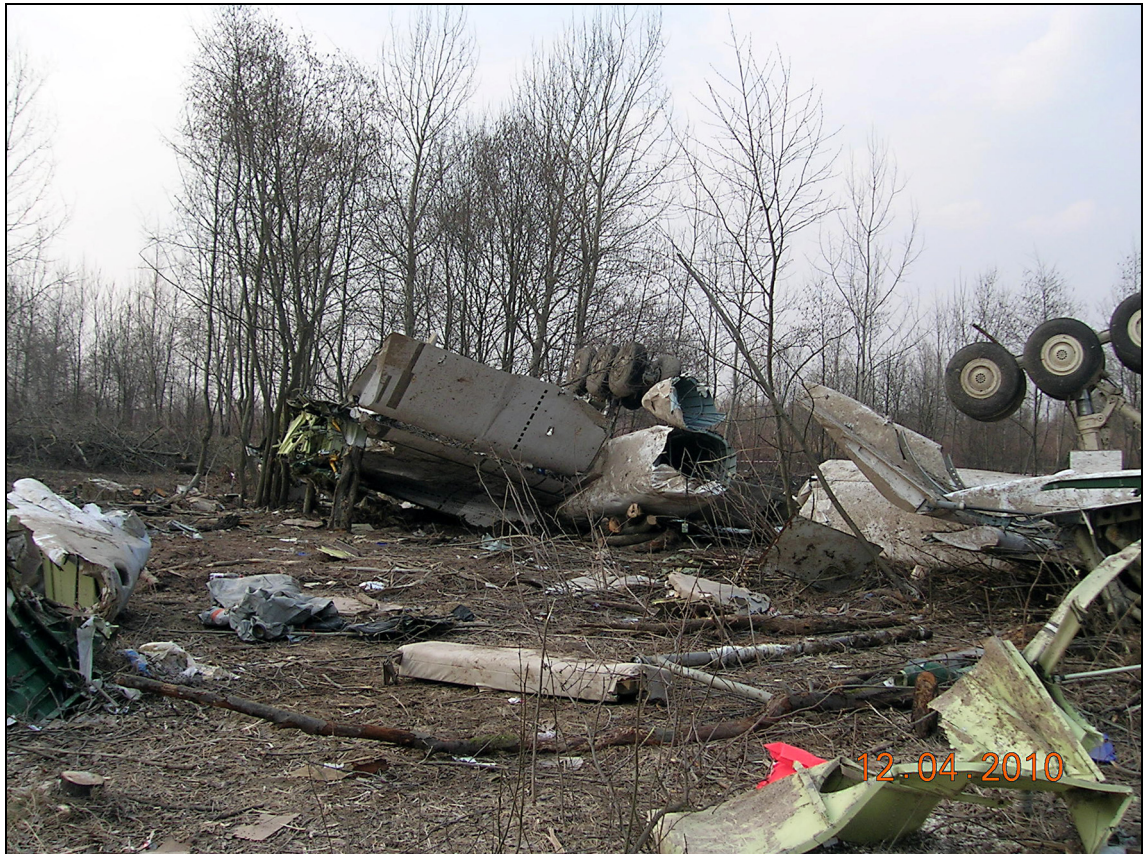
Figure 32

The wreckage area along the aircraft path is about 130 m long and 30-50 m wide, with lateral deviation from the extended runway centerline of 100 to 160 m. Within the whole wreckage area there are multiple fragments of airframe and aircraft systems (Figure 32). The center of this area is located N 54°49.450' and E 32°03.041' at a distance of 670-680 m from the place of first impact (about 420 m from the runway threshold).

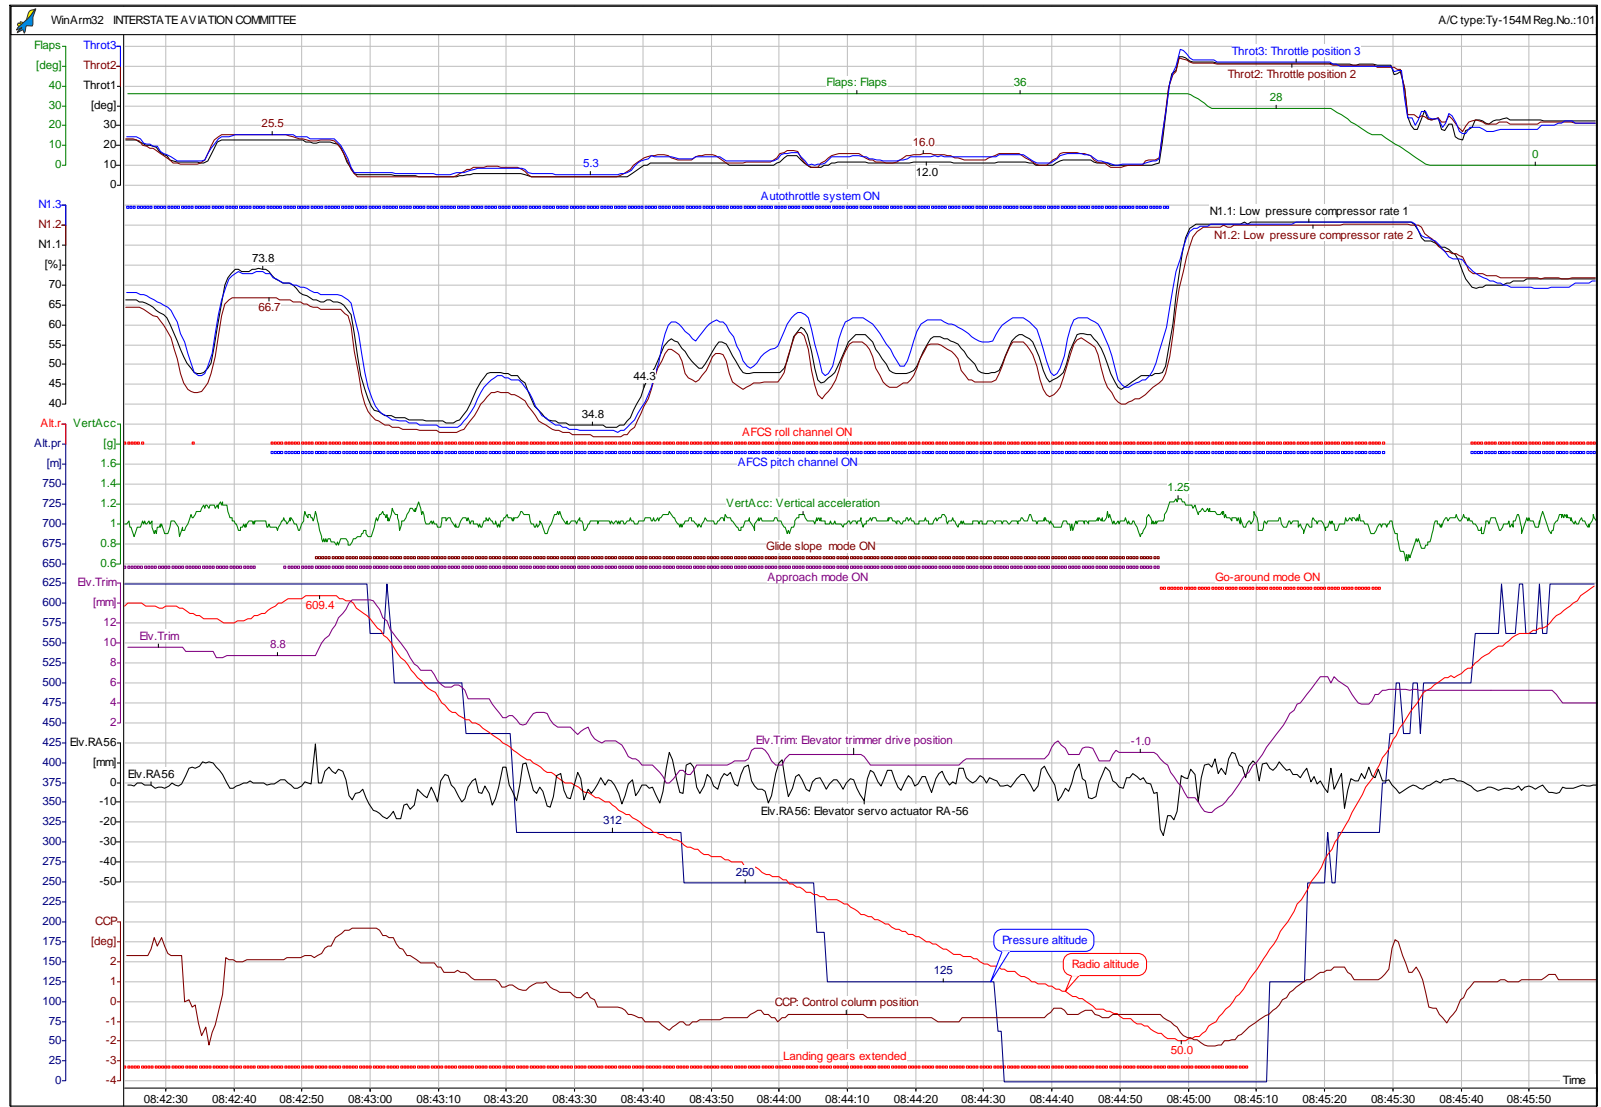
Figure 44

Note: *On April 6, 2010⁴⁵ during an ILS approach at Warsaw airport this aircraft made an automatic go-around. The FDR recorded the relative on/off-signals (autoflight modes): Approach, Glide slope, and Go-around (Figure 44).*

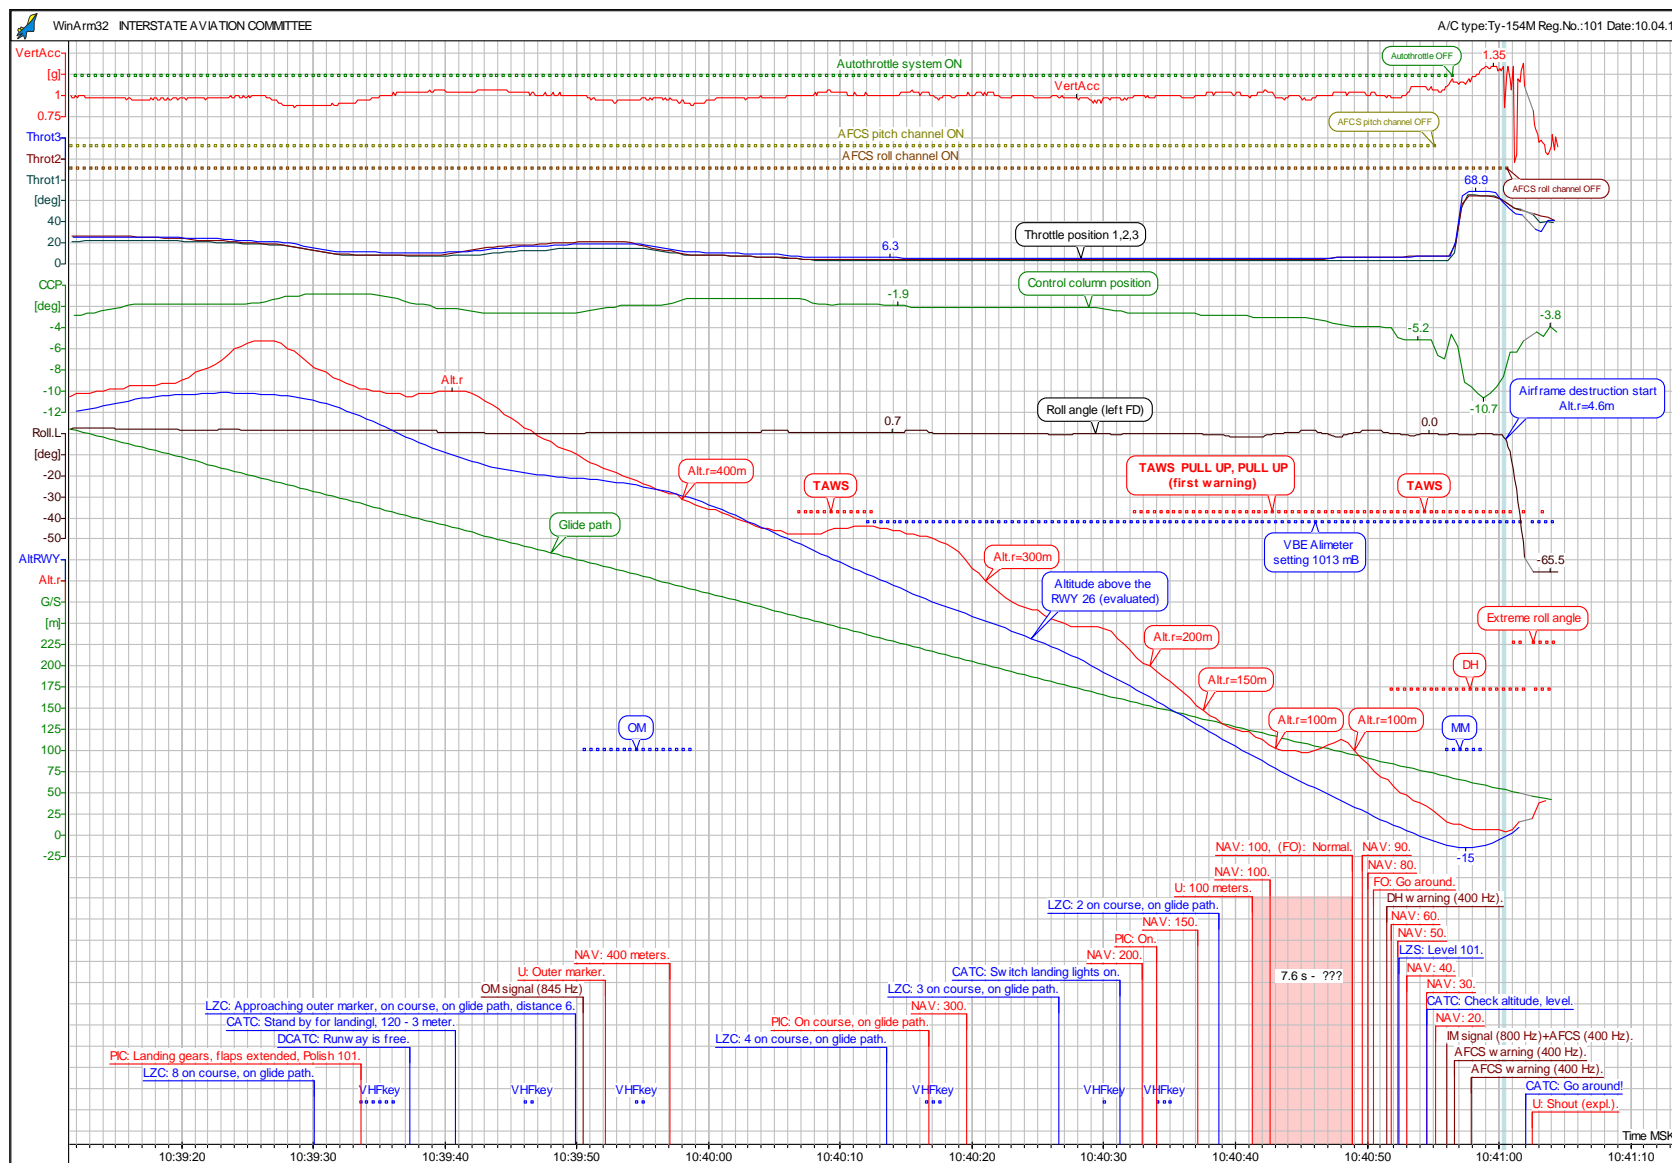
The actual descent path of the aircraft is shown in Figure 45 and Figure 46.

Aircraft TU-154M TailNo 101 (Republic of Poland) flight parameters during the accident happened on April 10, 2010 near the aerodrome Smolensk "Severyn"

At 10:40:20 the navigator reported the height: “300”. The comparison of this and further navigator’s reports on the flight height (250 m, 200 m, 150 m, 100 m) with the actual pressure altitude and radio height especially in the time interval from 10:40:41 – 10:40:49 indicated in color on Figure 45 reveals that at least from that moment the altitude was monitored by the radio altimeter⁵⁰. It should be noted that the navigator had not conducted flights on Tu-154M flying as a co-pilot of Yak-40 for the last 2.5 months. The interview of the Yak-40 PIC who was flying to Smolensk "Severny" Airdrome on April 7 and 10 showed that for the crews of Yak-40 in the regiment “there is a procedure of monitoring altitude by the radio altimeter from the height of 250 m”. The actual terrain along the flight path is shown on Figure 46. It is clear from the picture that after the outer marker the terrain level was much lower than RWY 26 threshold (up to 80 m).

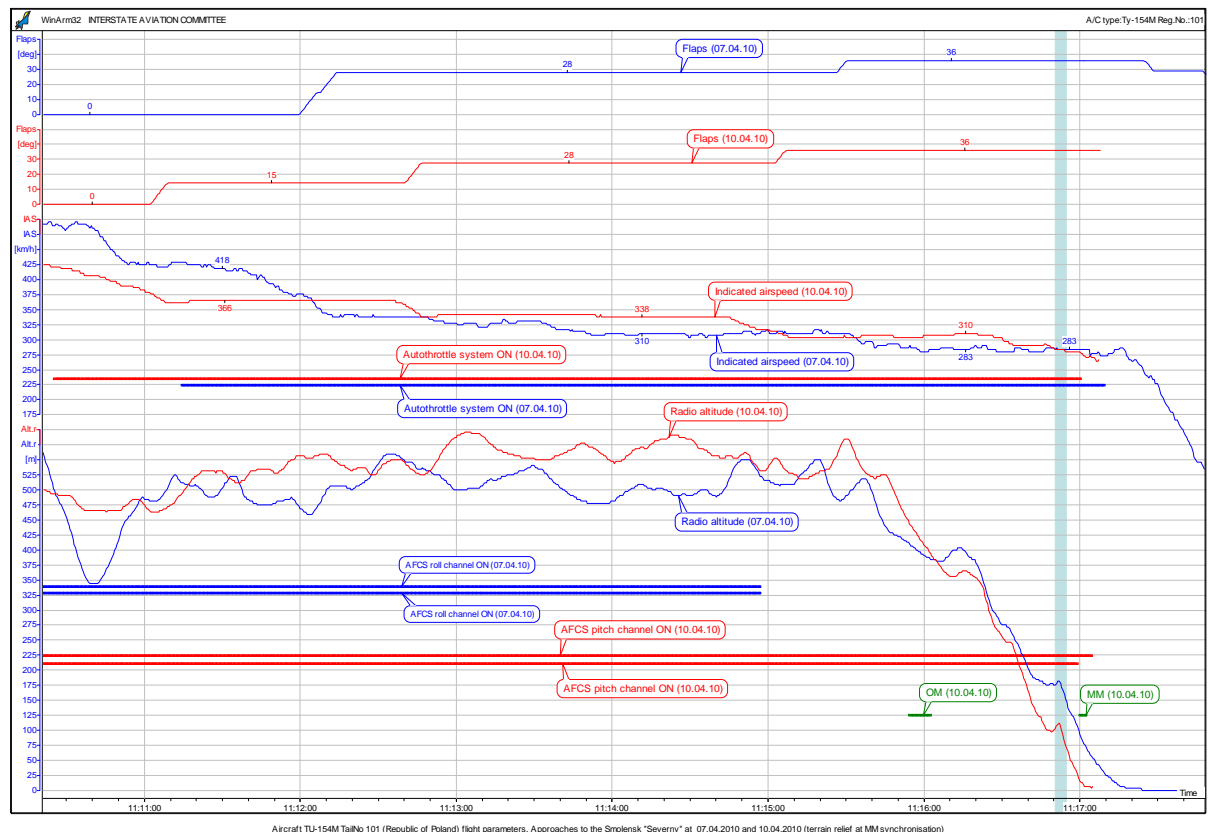
Figure 47

Note: *The analysis of the flight made to Smolensk "Severny" Airdrome on this aircraft on April 7, 2010 reveals that the crew switched to manual control column steering before starting the glide path descent (Figure 47).*

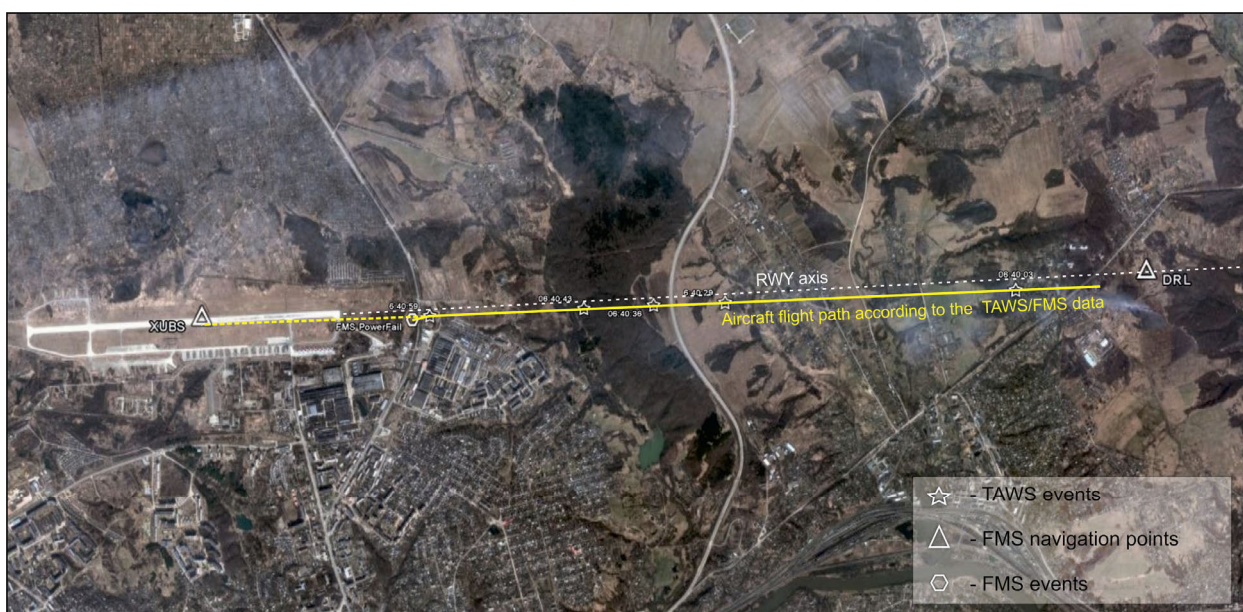
Figure 48

From the outer marker to XUBS (the last waypoint in the active flight plan), the flight path calculations (Figure 48) suggested two possible methods as to how the flight crew was controlling the airplane - either by the FMS, or by the use of the TURN (HEADING) knob. The flight path calculations revealed that, after passing the outer marker, the airplane was to the left of the extended runway centerline (within the course tolerance area) heading directly to the XUBS waypoint. It is possible the FMS could have provided the course adjustment for the airplane to track directly to XUBS and, therefore, converge on the line between the waypoints. In addition, the flight crew could have used the autopilot TURN (HEADING) knob to adjust the airplane's track.

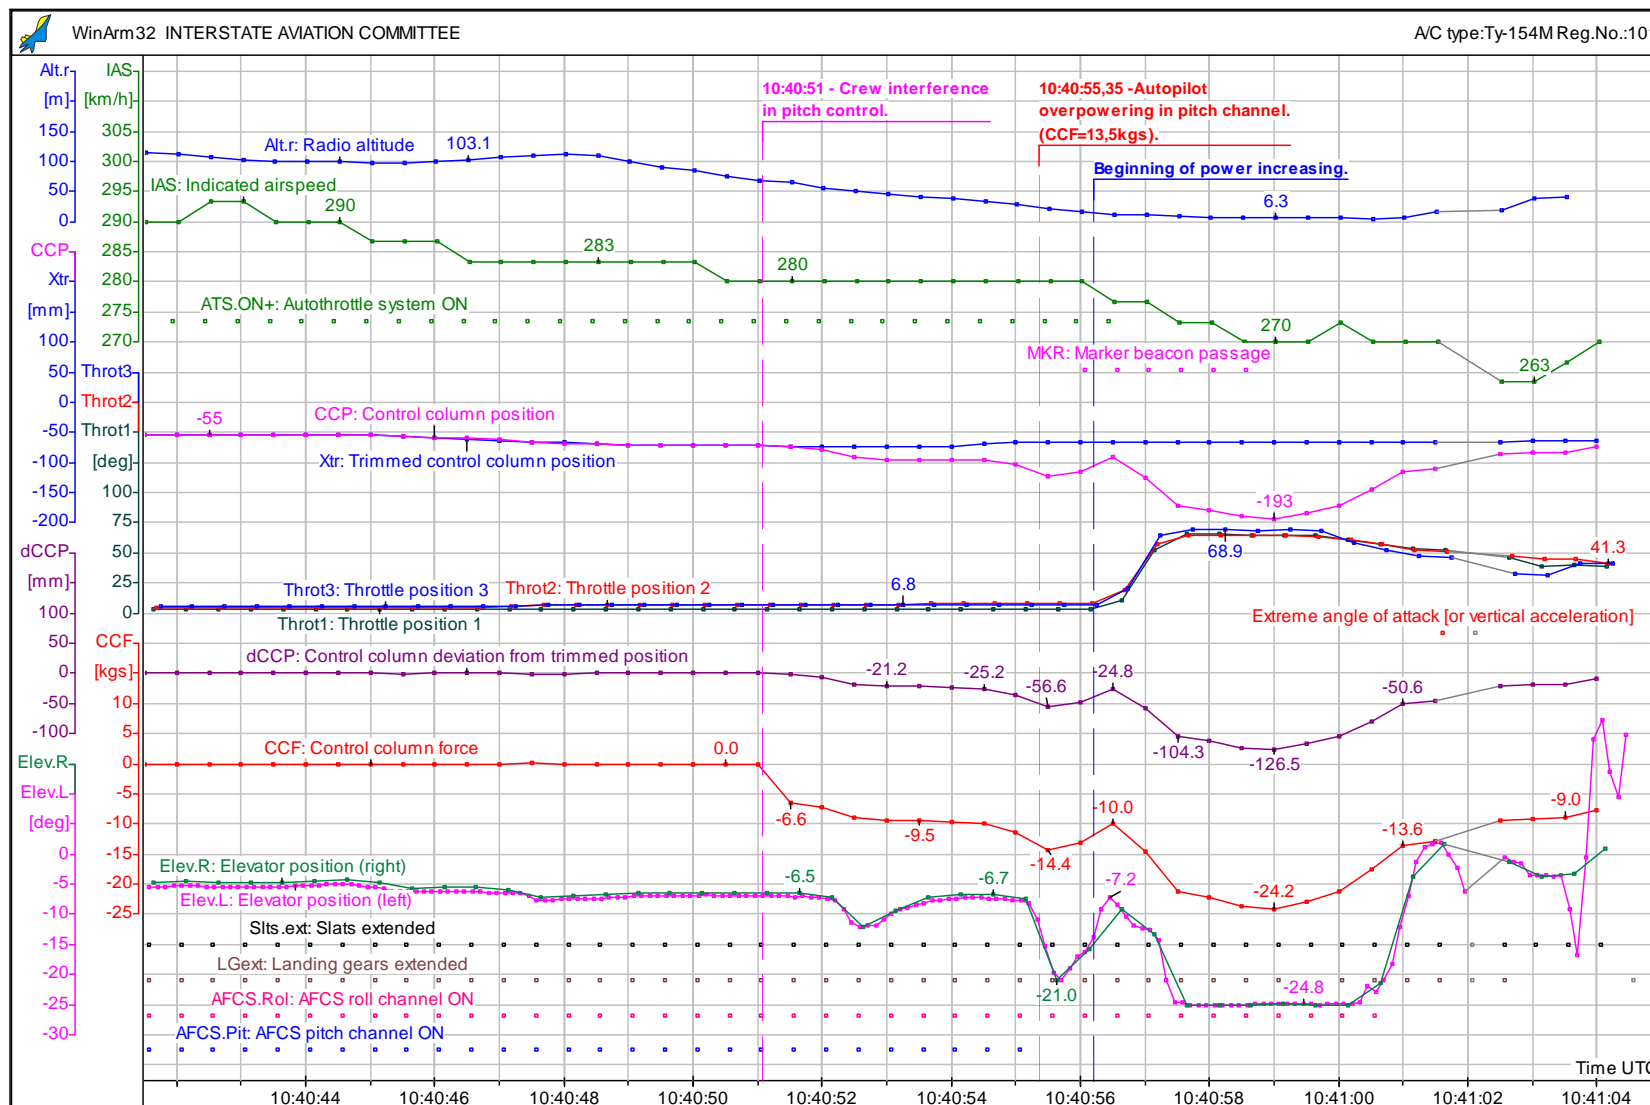
Figure 49

At 10:40:55 at a height of about 30 m the CATC instructed: "Check altitude, level" and simultaneously the control column was abruptly pulled up (moving the elevator to 20° pitch up, load forces up to 15 kg) which led to autopilot being overpowered in the pitch channel. In a second throttles of all engines were set to takeoff mode (with a rate of one second) which led to the disengagement of the autothrottle. Usually when the missed approach is made in control column steering mode the autopilot is disengaged by pressing the quick switch-off button on the pilot's control wheel.

Calculated forces on the control column.
