AIRCRAFT ACCIDENT REPORT

DELTA AIR LINES, INC.

MCDONNELL DOUGLAS DC-9-14, N3305L
GREATER SOUTHWEST INTERNATIONAL AIRPORT
FORT WORTH, TEXAS
MAY 30, 1972

REPORT NUMBER: NTSB-AAR-73-3

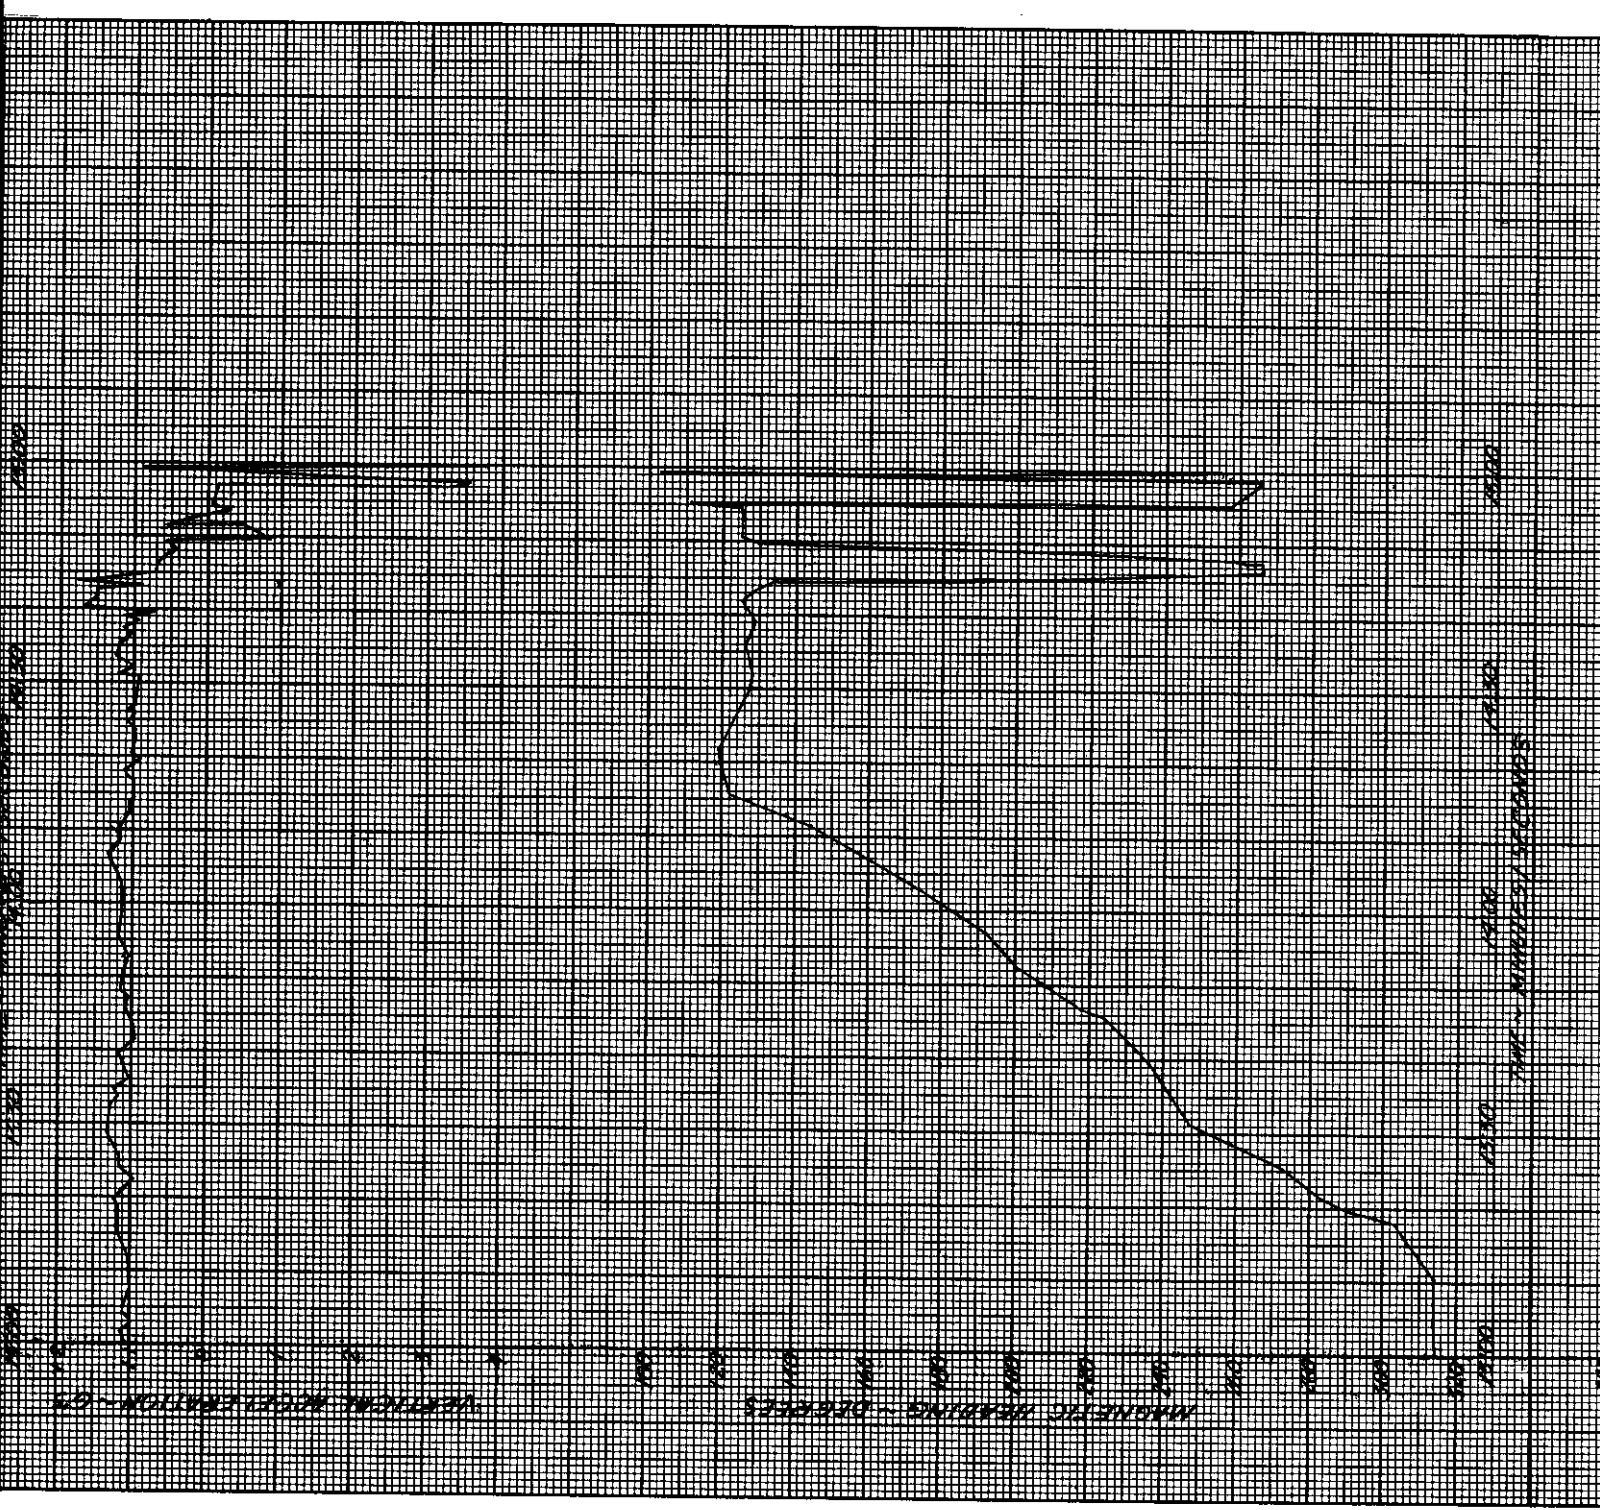
APPENDIX D

NATIONAL TRANSPORTATION SAFETY BOARD
 WASHINGTON, D.C.
 FLIGHT TRACK PRESENTATION
 OF
 DELTA AIR LINES INC. DC-9 TRAINING FLIGHT 9570
 AND
 AMERICAN AIRLINES INC. OC-10 TRAINING FLIGHT 1114
 AT GREATER SOUTHWEST AIRPORT, FORT WORTH, TEXAS
 ON MAY 30, 1972
