1. Report No. NTSB-AAR-78-8		2. Government Accession No.		3. Recipient's Catalog No.	
4. Title and Subtitle Aircraft Accident Report -- United Airlines, Inc., Douglas DC-8-54, N8047U, near Kaysville, Utah, December 18, 1977.		5. Report Date July 27, 1978		6. Performing Organization Code

AIRCRAFT ACCIDENT REPORT

UNITED AIRLINES, INC.
DC-8F-54, N8047U
NEAR KAYSVILLE, UTAH
DECEMBER 18, 1977

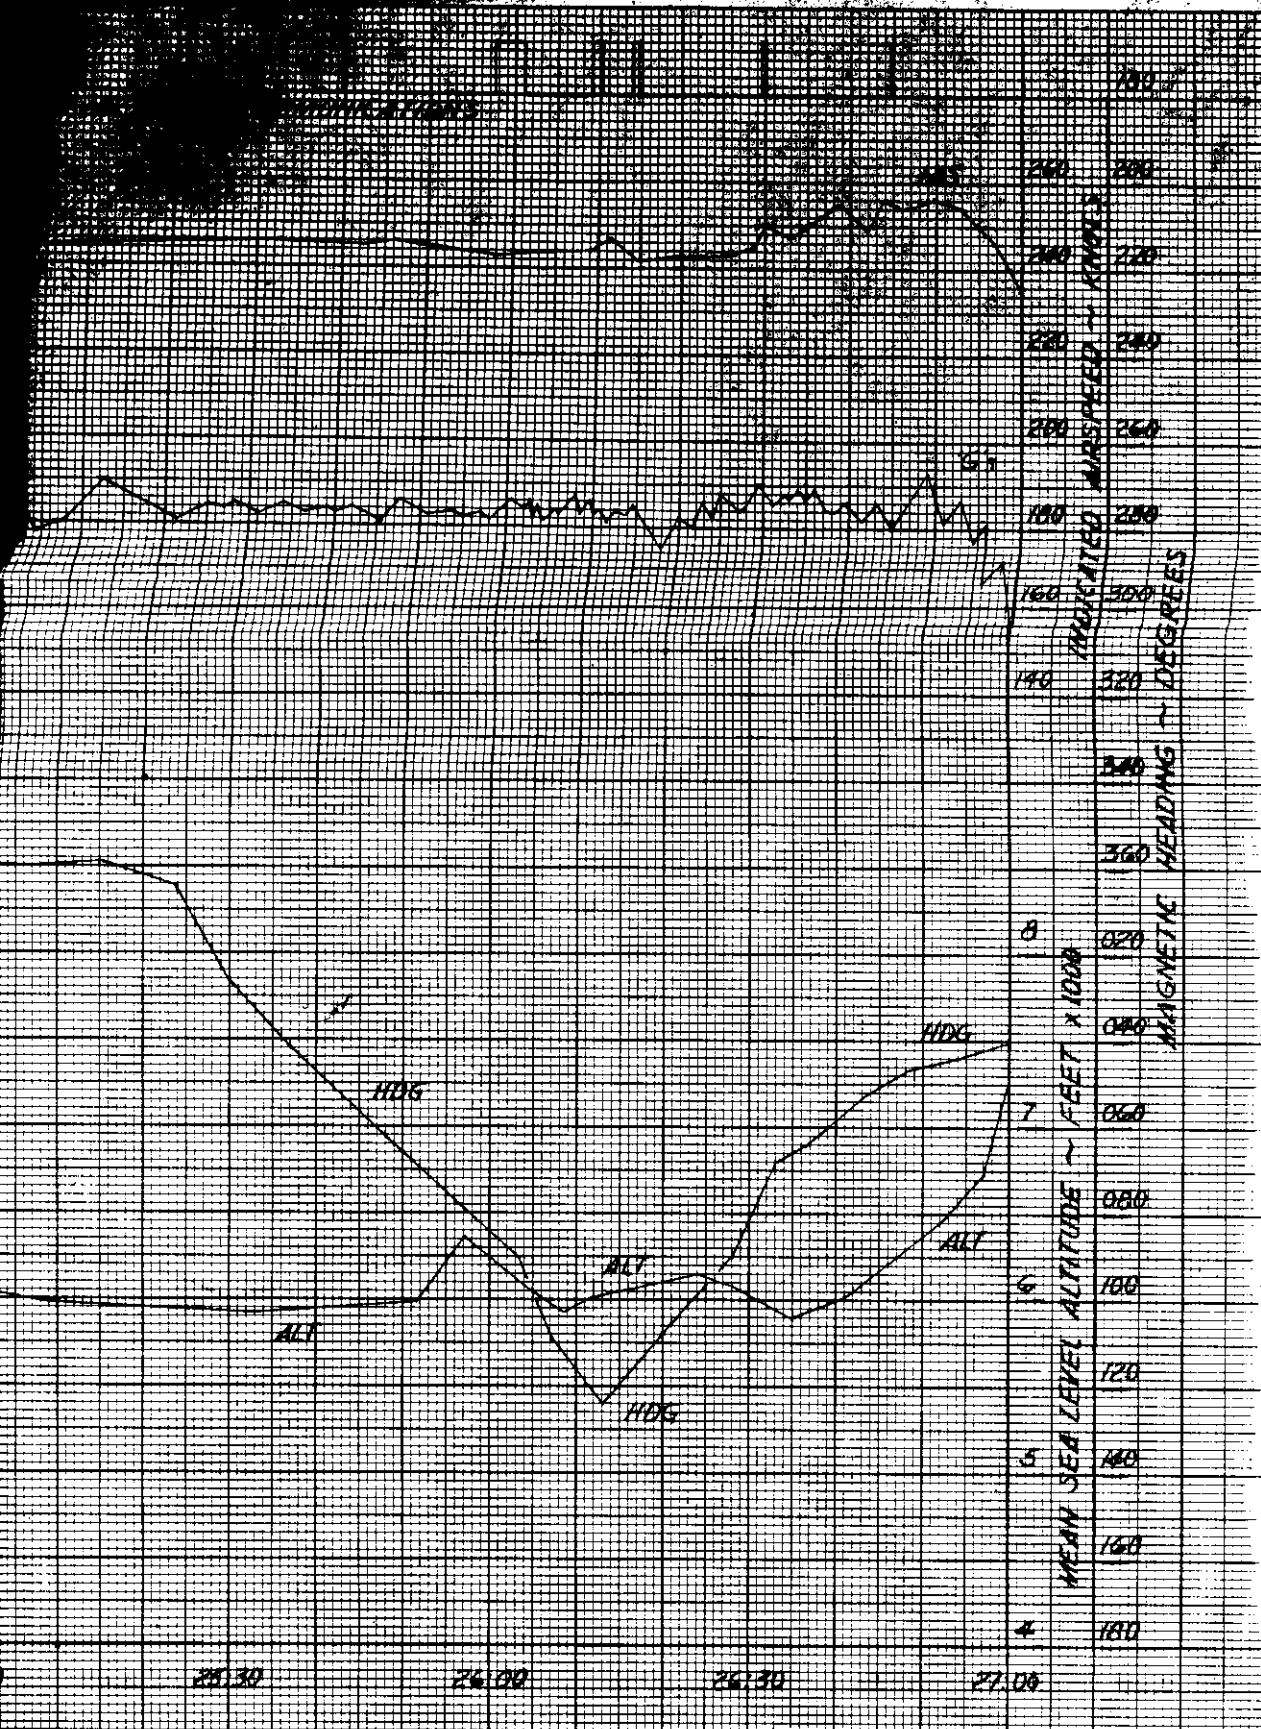
DCA 78-A-1005

NATIONAL TRANSPORTATION SAFETY BOARD
 BUREAU OF TECHNOLOGY
 WASHINGTON, D.C.
 UNITED AIR LINES, DOUGLAS DC-8B, MONTHLY
 FLT 2060, SULLY LAKE CITY, UTAH DEC 25, 1977
 CRASHED ON MOUNTAIN
 FLIGHT DATA RECORDER GRAPH
 FAIRFIELD STATION, ILLINOIS
