## Title: INVENTORY AND COMPLETION OF CASE STUDIES SURVEY

Date: January 2005

Project Title:
 IMPROVING THE SEISMIC RESISTANCE OF CULTURAL HERITAGE BUILDINGS

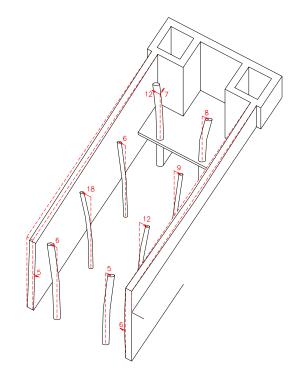
Figure 13 - Deformations, in centimetres, measured over the walls and columns of the Church (Monteiro, 1995).

Recently, studies to evaluate the verticality of the walls and columns were made (Monteiro, 1995). Longitudinally the columns' deformation has minor importance; in obliquely direction, were measured deformations with 30 centimetres of maximum relative distance (Figure 13). It's likely that the horizontal vault's thrusts are concentrated, above all, on the columns due to the lowered profile of the vault and the largest span of the central nave. Consequently, it is expected that the thrusts over the outlying walls will be, above all, vertical. In fact, these walls exhibit transverse deformations with light tendency to the interior (between 3 and 8 cm, values with a minor importance). So, supposedly, the South façade buttresses just have an apparent structural function.

The South and North façades present, in their upper edge alignments before the transept, close to the cornices, vertical depression and deformations.

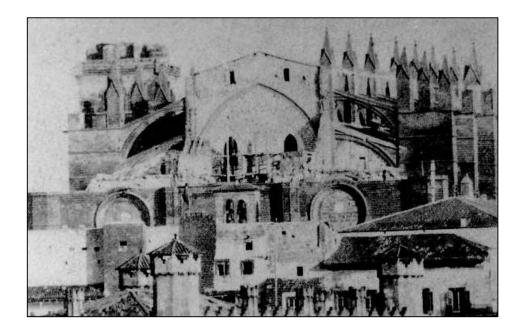
Figure 11- Dismantling of the western façade by 1855

1803-1851.- Numerous voices of alarm were raised declaring the precarious condition of the western façade. After two new reports on the condition of the west façade, dated in 1817 and 1841 respectively, it was the 28 of March of 1851 when a definitive report proposes to demolish the façade, the out-of-plumbing of it being already of 6 handspans (1,3 m) for an overall height of about 300 handspans (60 m).

The 15 of May from 1851 at 1:45 a.m. Palma de Mallorca was whipped by an earthquake of intensity between VII and VIII, causing probably the destruction of some part of already deteriorated main façade. Apparently, The movement did not have greater effect on the rest of the building.

In the summer of 1851 the works of disassembling of the façade began under the direction of architect Antoni Sureda (figure 11); they lasted six months. In August of the following year architect Juan Peyronnet Baptist was committed with the design and the reconstruction of the new façade.

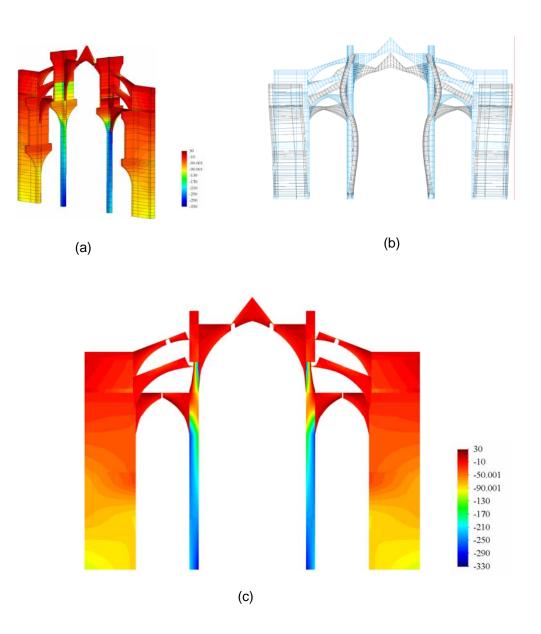
Figure 16 - (a) Model, (b) Deformation (x2000) and (c) distribution of normal stresses in chromatic scale (10\*MPa) and cracking (in white) for dead loading.

Figure 16,c shows the distribution of normal stresses (always parallel to the main axis of each structural component) for dead loading applied on a (theoretically) undeformed geometry. Cracking (and deep cracking associated to plastic hinges) predicted by the formulation is shown in white. At the base of the piers, the reaction is applied with significant eccentricity (in contradiction with Rubio's assumption and Mark's appreciation), causing a significant increase of the maximum compression. The maximum compression at the base of the pier reaches 3 MPa (the average compression being 2.5 MPa). Complementary analysis show that if the dead load is applied on the current deformed geometry, the maximum compression may increase about a 15%. The superior flying buttress experiences two hinges which indicate the exact place where the line of thrust is located. Similarly, the transverse arch of the central nave also shows the formation of two symmetrical hinges at the edges of the upper pyramid. These hinges may be produced by the need to make compatible the different movements of the pier and the abutment. This is patent in figure 16,b, corresponding to the deformed transverse section amplified by a factor 2000. it must be also noted that the displacements predicted for the dead load are 2 orders the magnitude smaller than the deformations actually observed in the building, although the deformed shapes are qualitatively similar.

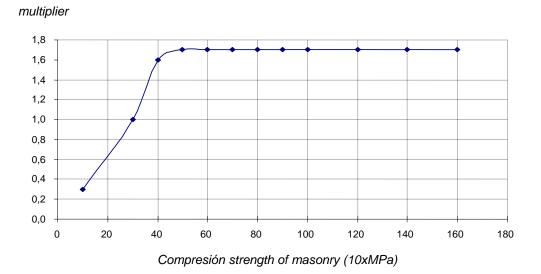
Figure 19 - Influence of the compression strength of masonry on the maximum dead load multiplier resisted by the structure

A complementary parametric study (figure 18) shows that the maximum multiplier is not influenced by the compression strength considered for the masonry except for values lesser than 5 MPa. The masonry actually existing in the piers, made of a stone having compression strength larger than 20 MPa, can be assumed to actually provide an average compression strength above this limit.

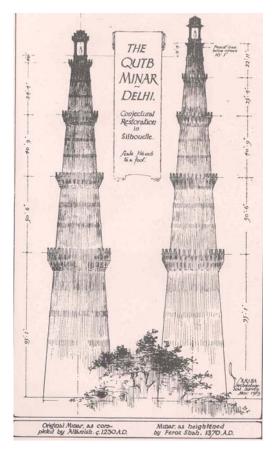
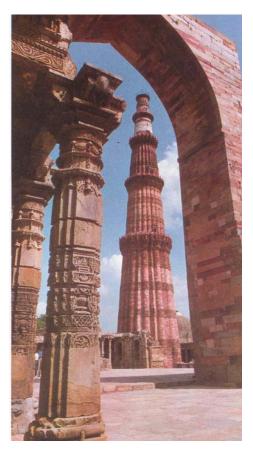
Figure 4 - The Qutub Minar before and after restoration.

The lower three storeys of the Qutub are made mainly of buff colored quartzite. But the upper two storeys, which were damaged and reconstructed, are made mainly of marble with a subordinate amount of quartzite; Quartzite of the Alwar Series of Delhi system (Pre-Cambrian) is available locally. The marble was brought from different parts of Rajasthan, India. Sculptured Vindhyan sandstone is reported to be brought after destroying the Hindu temples, was also used in the construction of the Qutub. From the Nagari and Persian inscriptions on the minar, it is evident that it was partially damaged in 1326 and 1368 by lighting and was promptly repaired by the Muslim rulers. While on the subject of the repairs executed to the minar, it is recorded that "On the first of August 1803, the old cupola of the Qutub Minar was thrown down and the whole pillar seriously injured by an earthquake." About two years later, the governor-General authorized the necessary repairs to be begun, and the work was entrusted to Major Robert Smith of the Engineers, who completed it by the beginning of the year 1828, at a cost of Rs. 17,000. All the forms of the mouldings were carefully preserved, but the rich ornamentation omitted.

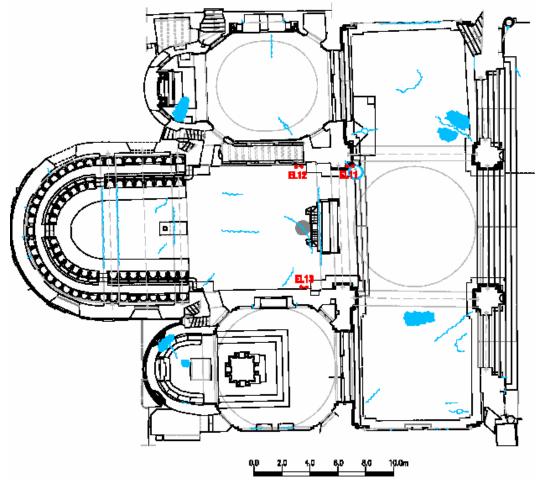
Figure 13:

In the following scheme, at the level of the church floor, the positioning and the number of the measuring devices are shown:

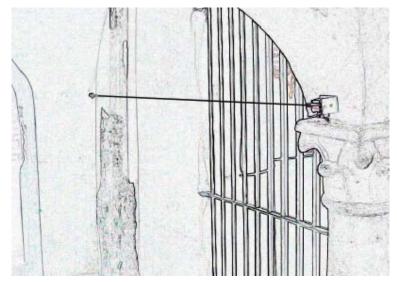
The cable extensioneters allow to check the variations, in terms of relative displacements, between two opposite vertical structures, at regular time intervals. The device is composed by an invar steel cable, kept in tension by a calibrated spring and by a potentiometric transducer, electrically insulated, ranging between 0,0 and 50,8 mm.

Figure 14: cable extensimeter

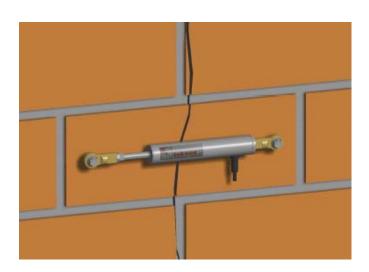
the fixed electric extensioneters, allow to detect an eventual variation of the opening of the main fissures. These devices are fixed to two stainless steel pins, positioned at the sides of the opening and fixed to the wall with epoxy resin. The coupling of the measuring device to the rigid pins is realized by ball and socket joints, that allow the movement of the instrument on three orthogonal axis avoiding any flexural stresses on the transducer.

Figure 15: electric extensimeter

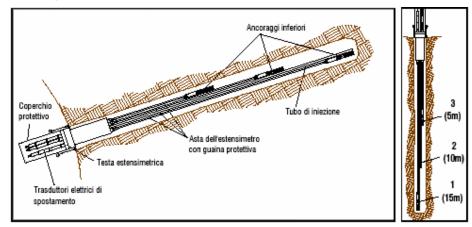
the multi base extensometers allow the measurement of the relative displacements (settlements) between points of the soil aligned on the same vertical at different depths. The measurement bases consist in fibreglass poles (diameter 6 mm) which are anchored at their lower extremities to the ground by a galvanized steel bar fixed to the ground itself by injections, while at the upper end are fixed to the displacement transducers connected to the foundation structure.

Figure 16: multi base extensimeter

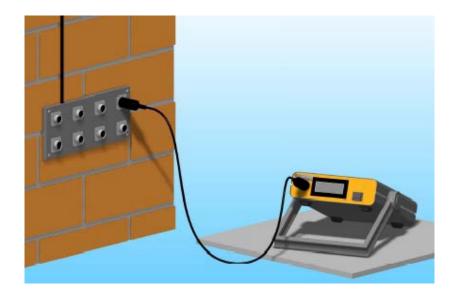
The digital read-out unit is composed by an electronic portable system with rechargeable batteries. The connection to the panel, to which arrive from the measuring devices the multipolar cables, is carried out by a 6 poles jack. The measure is shown on a 4 digit display.

Figure 17: digital read-out unit

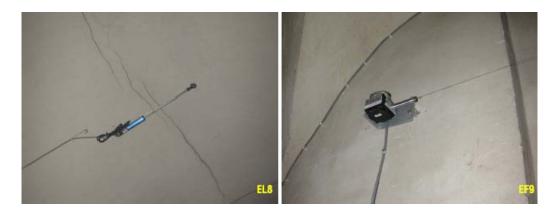
Figure 18: cable extensimeter EF9 and electric extensimeter EL8

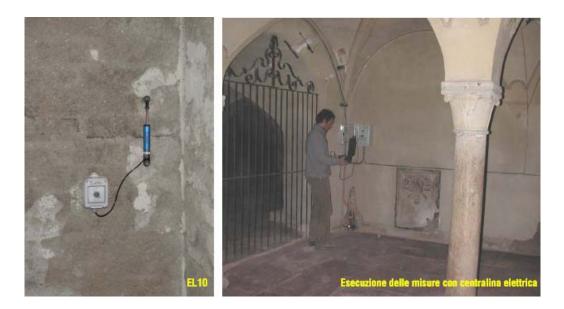
Figure 19: electric extensimeter EL10 and read-out of the displacements with the electronic switchboard

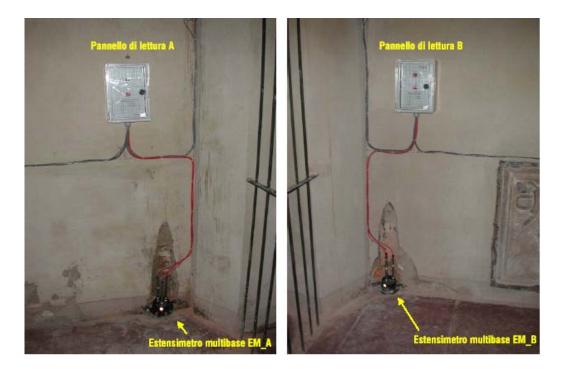
Figure 20: measurement panels A and B and view of the top of the multi-base extensometers
