### ***Preservation Assessment of Totem Poles***

**Preservation Assessment of Totem Poles  
Totem Bight State Historical Park  
Ketchikan, Alaska**

**May 11-21, 2008  
Ron Sheetz, Conservator**

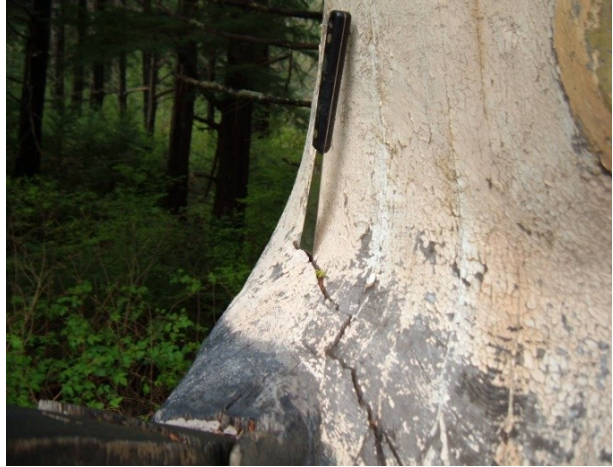
- The right shoulder has a serious separation  $\frac{1}{4}$ " wide X 12" across. There are previous repairs to the wings.
- A 70" long split starts at mouth and continues down to the right knee. The right side has six repair butterfly patches that help hold the deteriorating side together. A butterfly patch was removed and a 9" penetration into the decayed wood with a spatula was gained. Butterfly patch was replaced. A considerable amount of decayed wood was removed from the decayed knot on this same side.

**Separation at right shoulder**

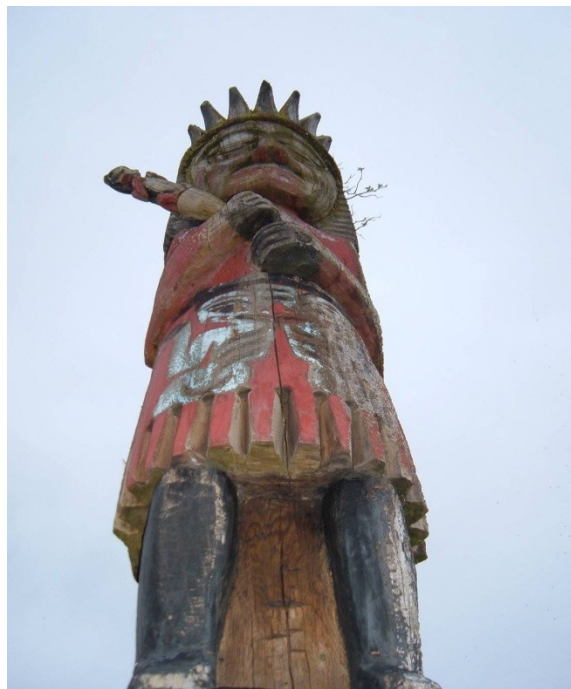
**Shaman with vegetation protruding from head**

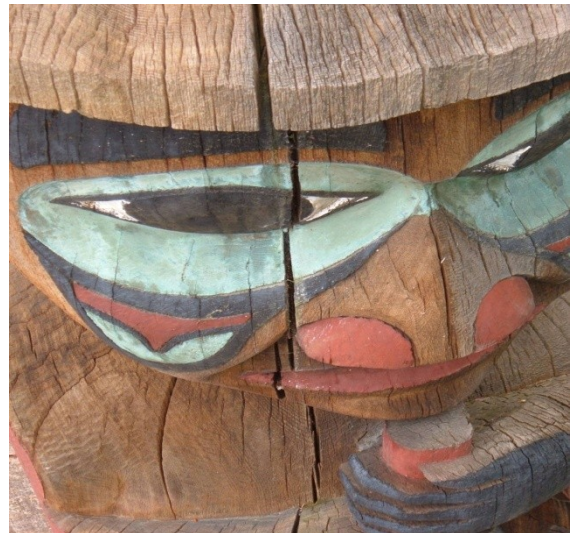
- Corner post is 22'8" tall with a 30" diameter base buried in the ground. It is a corner post and structured into the clan house.
- The end grain on top of hat is split four ways to the center. Remnants of a lead cap remain around outer edge.
- One of the more noticeable splits is 3/8" wide. It starts in the front rim of hat, continues down through right eye, right wrist, around right knee and foot to ground.
- There is graffiti carved into the right shoulder, hip and leg of the watchman.
- The left shoulder has a 1/4" crack.
- A piece 5" wide is starting to flake off on backside of watchman. There is less flaking occurring at base of watchman figure.
- A copper shield completely circles the totem at roof line.
- Located directly under the roof line is a repair patch, (10 1/2" wide X 24 1/2" high).
- Base of pole is atable.

**Split in rim of cap down through face**
