MINISTRY OF TRANSPORT AND CIVIL AVIATION

CIVIL AIRCRAFT ACCIDENT

Report of the Court of Inquiry
into the Accidents to
Comet G-ALYP on 10th January, 1954
and Comet G-ALYY on
8th April, 1954

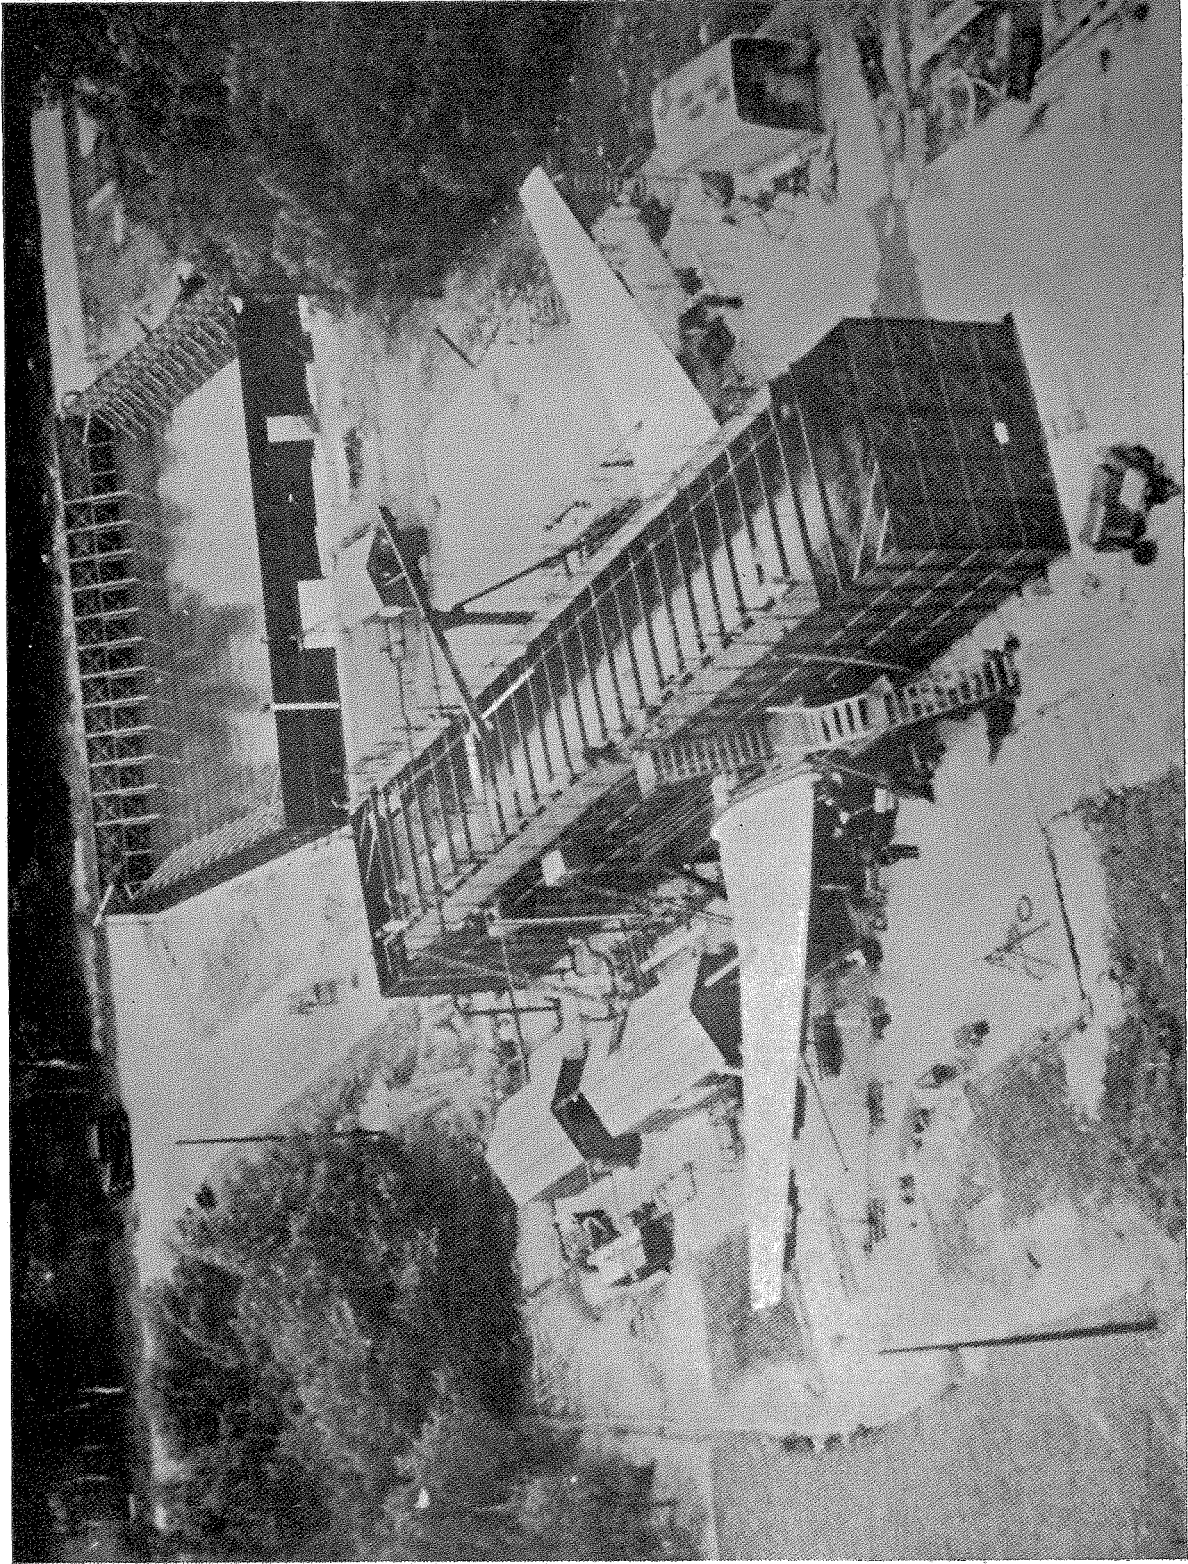
relate only to the external structure. Figure 4 is a photograph showing the reconstruction of the fuselage and tail unit from the wreckage and Figure 5 is a photograph showing the reconstruction of the front fuselage.

FORWARD EQUIPMENT BAY ACCESS DOOR IN PLACE AT WATER IMPACT

FIG. 5. FRONT FUSELAGE—VIEW ON STARBOARD SIDE—G-ALYP.
