Initial Report on 23 June 2001 Arequipa, Peru Earthquake

Observations from Locations Reporting Most of the Damage

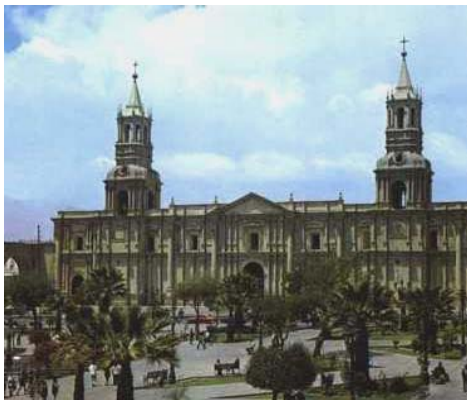
The city's historic Cathedral of Arequipa sustained heavy damage, mainly due to the collapse of one of its towers. The cathedral is situated on the Plaza de Armas in Arequipa's historic center, a UNESCO World Heritage site. The cathedral, founded in 1612, was damaged by previous earthquakes and fire and was substantially rebuilt in the 19th century. Both towers of the cathedral were apparently damaged in previous earthquakes and rebuilt most recently in about 1940. This cathedral is the symbol of Arequipa and an important part of the architectural heritage of Peru.

Figure 4. Cathedral of Arequipa, pre-earthquake file photo. (Source: personales.com)
