RCEM – Reclamation Consequence Estimating Methodology

Dam Failure and Flood Event Case History Compilation

**U.S. Department of the Interior
Bureau of Reclamation**

February 2014

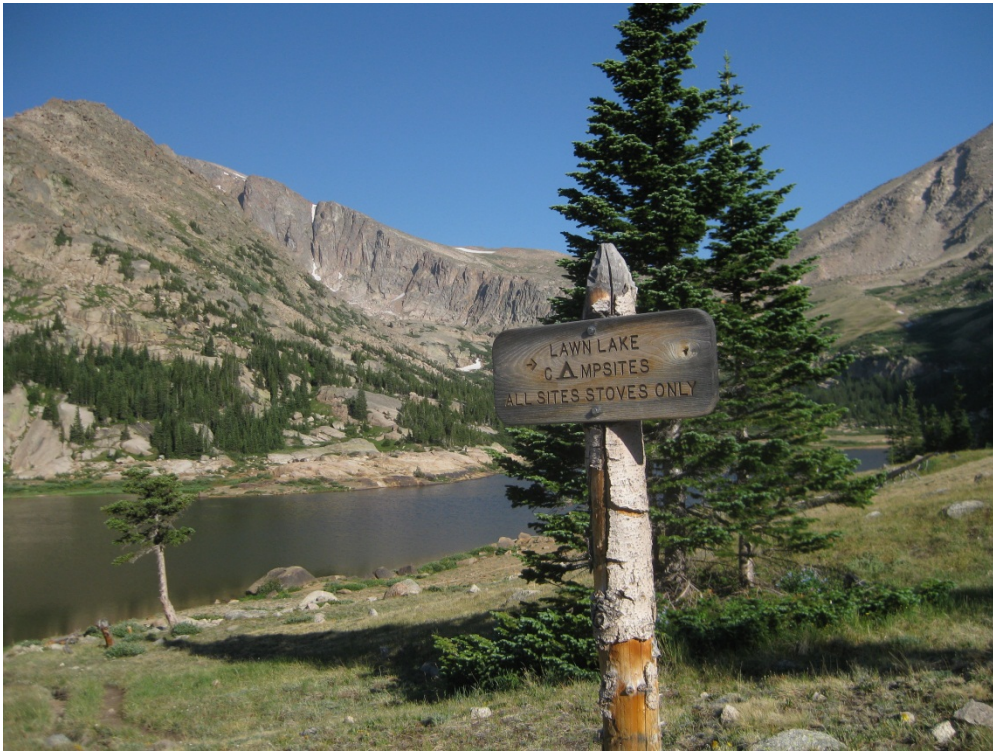
Lawn Lake, taken July 2012

Lawn Lake Dam was located at about an 11,000 foot elevation, in Rocky Mountain National Park, Colorado, just west of the town of Estes Park. Access to the dam was by way of a 6.3 mile hiking trail. The dam was an embankment structure which raised a natural lake, and stored water for irrigation. The twenty-six-foot-high dam held a reported 674 acre-feet of storage and was 79 years old at the time of its failure. Breaching of the dam was due to piping which was initiated along the outlet works conduit that ran through the embankment. Lawn Lake Dam failed at about 5:30 am, Thursday July 15, 1982.

The dam failure flood followed the path of the Roaring River for 4.7 miles to its confluence with the Fall River. No warning was issued along this reach and a camper, located in his tent, was swept away by the flooding and killed.
