Site Management Plan

Church Lane Flood Meadow Local Nature Reserve

North Weald Flood Alleviation Scheme
General Scheme Plan
6.5 Flood Alleviation Scheme (FAS)

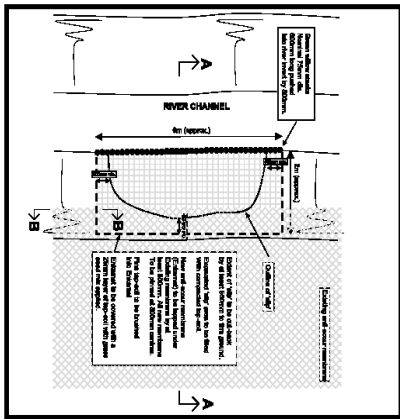
**PROPOSED DETAILS
RIVER BANK (Plan)**

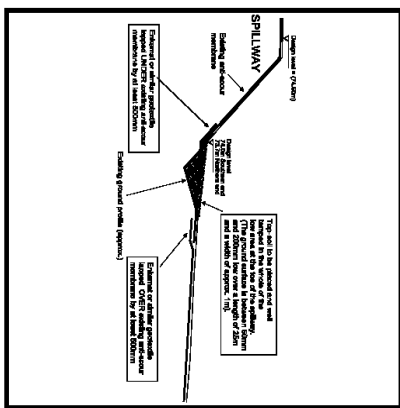
**PROPOSED DETAILS
SPILLWAY (Section)**
