# On the reddish, glittery mud the Inca used for perfecting their stone masonry

Research

Author: Helmut Tributsch

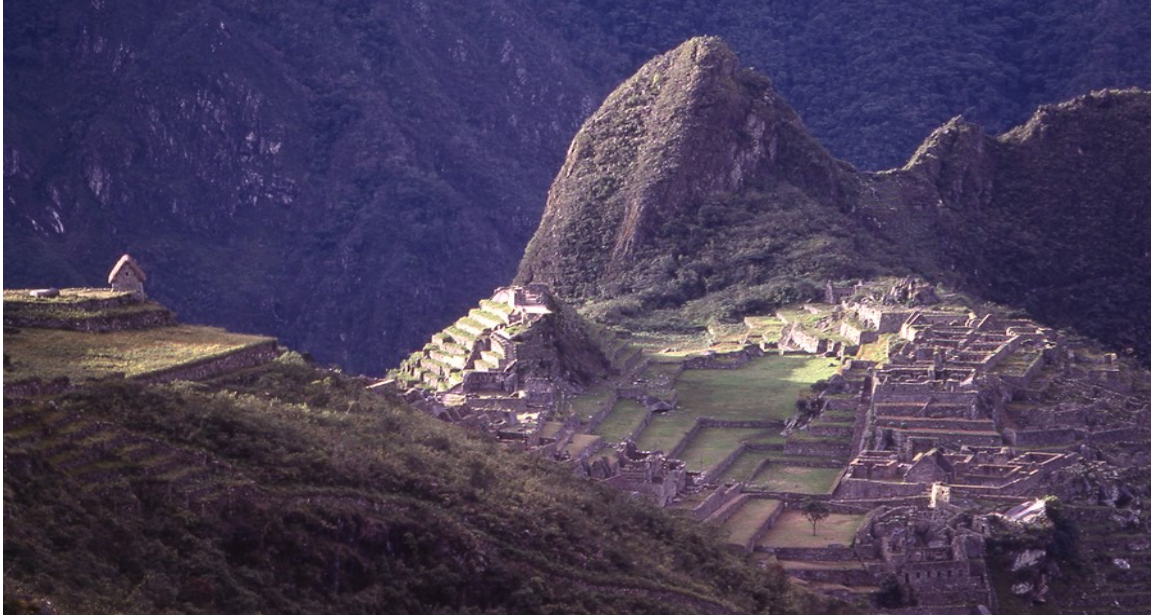
**Fig. 1.** Machu Picchu has become a symbol of the austerity, functionality and precision of Inca masonry and architectural style. It is really cut and fitted into the mountain rocks and contrasted by the playful integration of agricultural areas and the sight and sound of water streams, cascades and fountains (all photos in this paper are from the author)

Granite, as it was used in Machu Picchu (fig. 1), also contains mainly quartz and K-Feldspar ( $\text{KAlSi}_3\text{O}_8$ ) with some additional minerals. Rhyolite (porphyry) is the volcanic equivalent of granite and has smaller crystals. It has been mainly used by Inca builders for the construction of Ollantaytambo (fig. 3) besides of Andesit and Diorite.

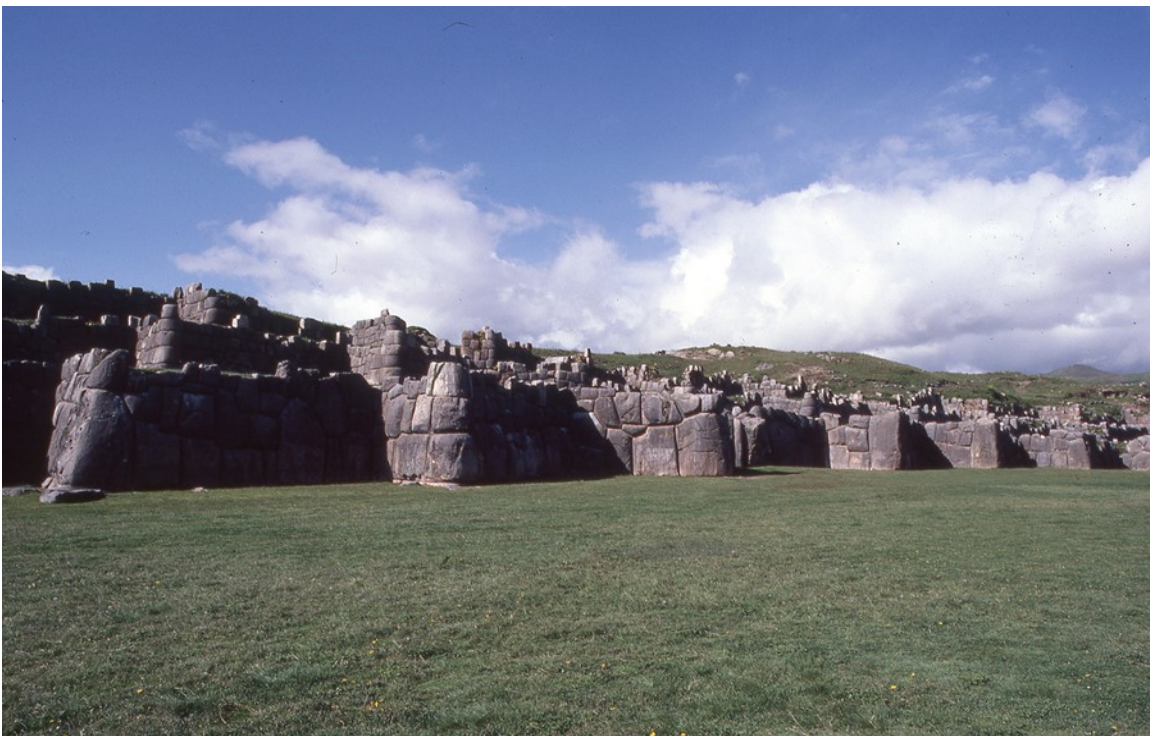
**Fig. 2.** The Sacsayhuaman fortress near Cusco became a symbol of power, expressed through impressive arrangements of huge fitted stone blocks. Polygonal stones show often convex faces and sunken joints providing attractive patterns in sunlight.

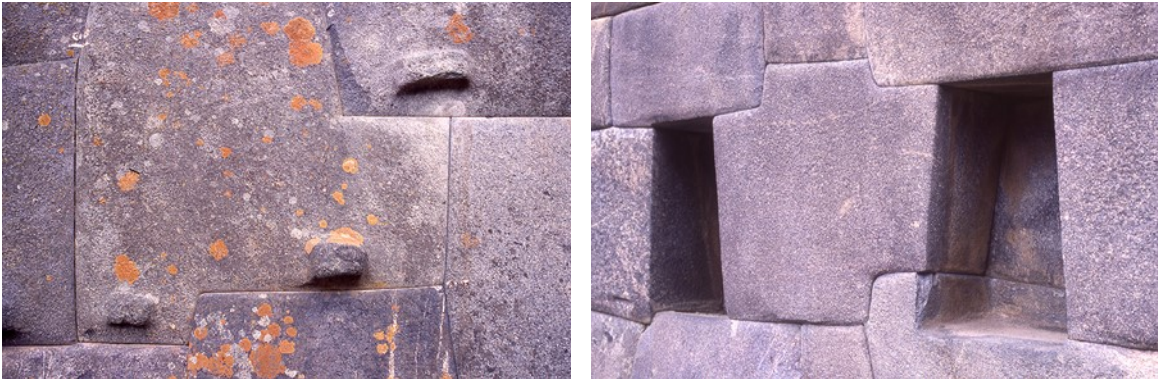
**Fig. 3.** Tightly fitted Rhyolite boulders in Inca walls at Ollantaytambo, additionally showing a characteristic uneven surface shape. The process of cutting them from solid volcanic rock and shaping them to such perfection with stone hammers and grinding movements, as presently explained, remains an admirable achievement.

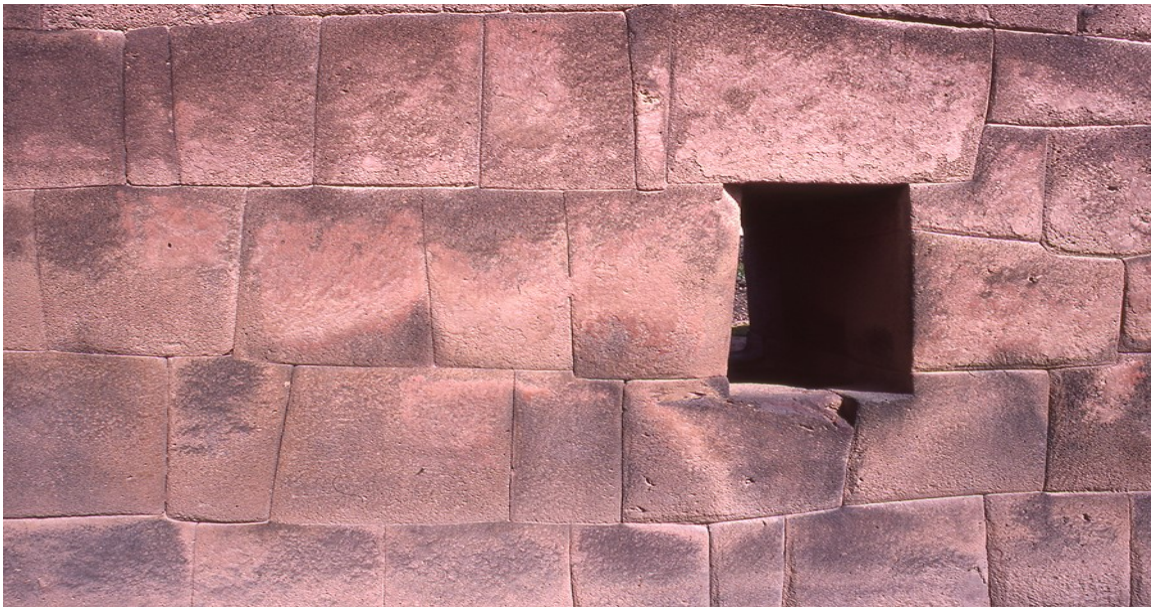
**Fig. 4.** This wall from the Pisac ruins gives a good impression of the apparent easiness and elegance, with which Inca stone blocks appear to have been laid down. They seem to have been soft, adjusting and settling themselves to perfect fitting via their weight.

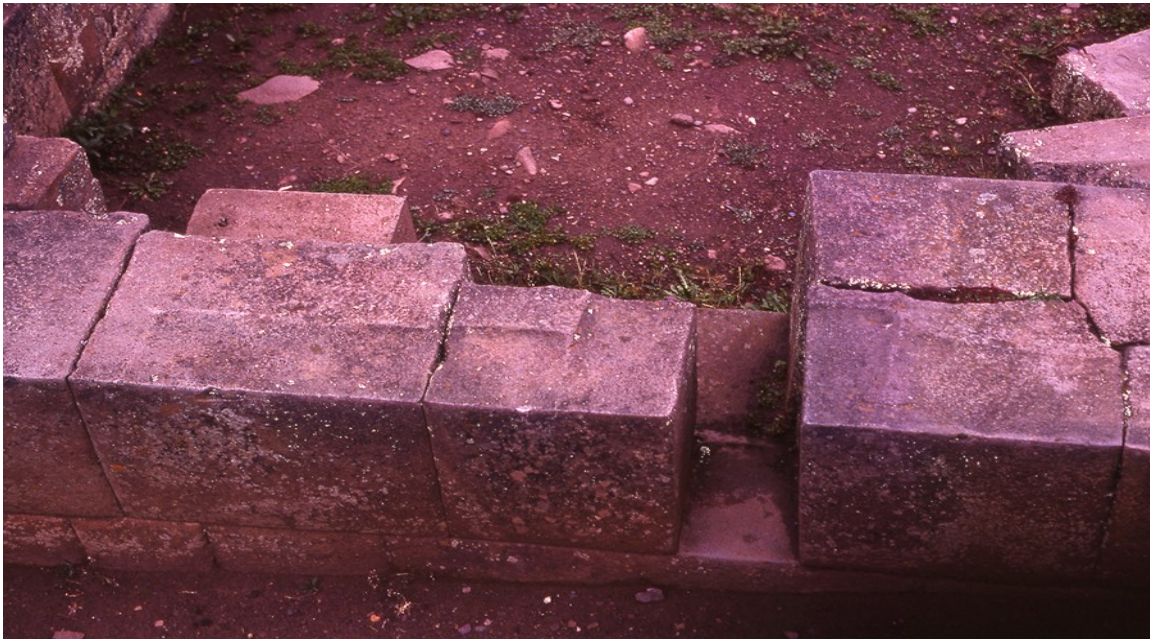
**Fig. 5.** This dismantled wall from Pisac clearly shows on the upper face of stones the irregular “impressions” of the overlying stone blocks taken away. How were they produced?

is Pisac (fig. 5).

In Inca stonework masonry the load-bearing faces are closely fitted throughout the surfaces (fig. 5). Vertical joints are typically fitted only to a depth of few centimetres. This may indicate that applying load was an important strategy towards obtaining optimized interfaces.

solved silicate particles for fresh crystallization. This would have helped modelling the shape of the weight producing stone onto the lower one (Fig. 5). Such chemically attacked and “softened” surfaces with irregularly distributed gel-type surface layers could also have been treated and modelled subsequently with mechanical tools. A similar, but modified strategy could have been applied to vertical interfaces between stone blocks.

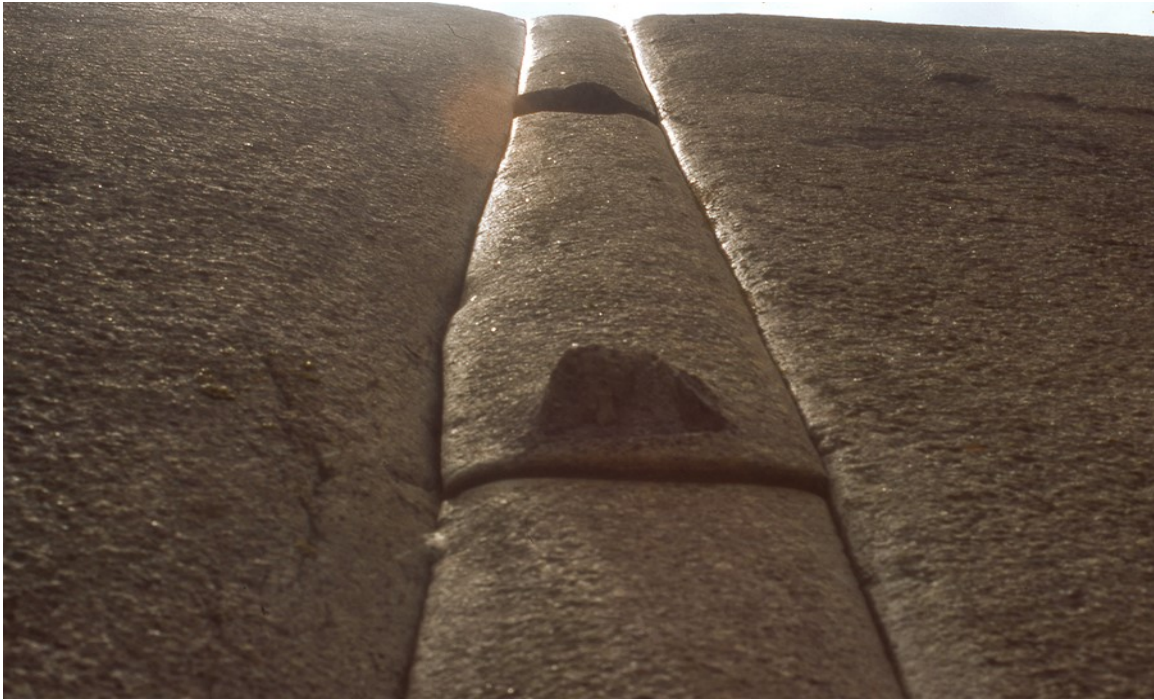
**Fig. 6.** When looking up the nearly 4 m long stone joints between the standing stone blocks of the Wall of the six Monoliths in Ollantaytambo one recognizes, that only these joints seem to have received a special treatment, which is generating a high light reflection.

Fig. 6 shows such a glaze appearance from the Ollantaytambo site in the stone junctions of the

wall of the 4 meters high, six standing monoliths within the unfinished Sun Temple, when looking upside against the sky. Only the joints are highly reflecting and seem to be vitrified. The surface of the monoliths and the connecting junction stones themselves appear only to be hammered. This suggests that there was a special treatment of the joints and an intention behind.

An important phenomenon which Inca builders apparently empirically applied in their wall technology was “pressure dissolution” and “viscous compaction”. These phenomena were studied in some detail in relation to geochemical and geological processes. Pressure dissolution concerns the dissolution of minerals into an aqueous pore fluid at grain- to -grain contacts in presence of high stress. Where pressure between grains builds up the rock material cracks and degrades. It is compacted because material is consequently dissolved and chemicals and particles are transported away to induce new material growth at stress free locations (Rutter, 1976,1983). The so-called Fowler-Yang equations give an adequate description of this phenomenon (Fowler & Yang, 1999). This phenomenon has also been studied with Biotite and Feldspar (Barnett & Kerrich, 1980) and with quartz Arenites, which can serve as appropriate models for the highly quartz containing volcanic and magmatic stone material used in Inca walls. Pressure solution occurs at stressed individual grain contacts. Dissolved quartz then precipitates on free adjacent grains. Pore fluid migrates and porosity is significantly reduced (Angevine & Turcotte, 1983). This is exactly what one would expect to have happened, when looking at smooth, shiny, “vitrified” interfaces or surfaces of Inca stone blocks (Fig. 6, 8)

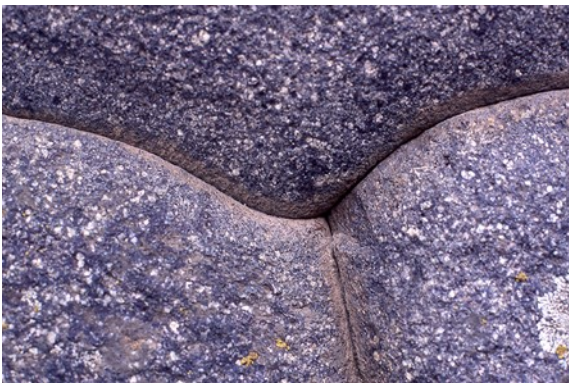
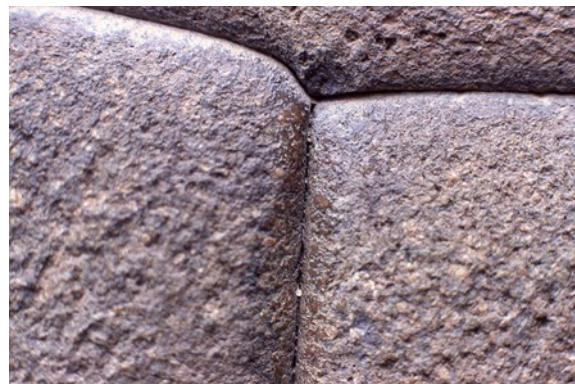
**Fig. 7.** These joints of stones from Inca walls in Cuzco clearly show, that in their neighbourhood the surface properties of the stone material is different in colour and structural composition from the rest of the stone material.

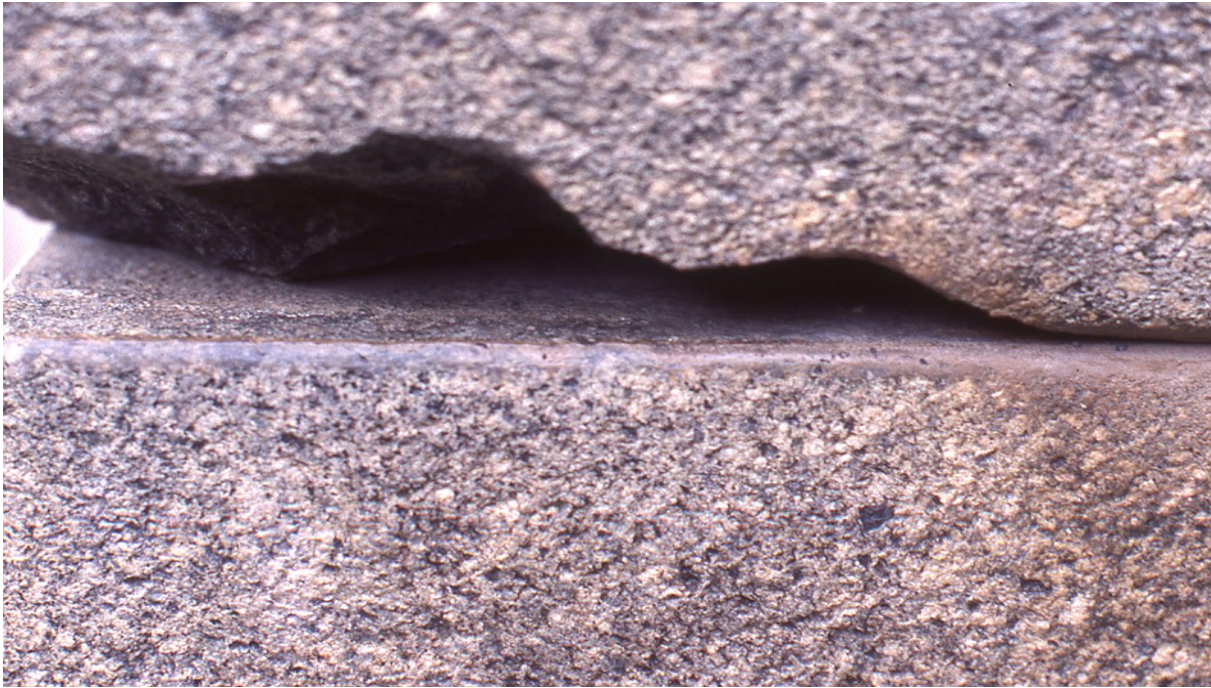
**Fig. 8.** In this stone junction from Sacsayhuaman (compare fig. 2) part of upper stone is missing and this gives visual access to the surface of the original stone junction, which is much more elaborate and shiny, compared to the rest of the stone surfaces, which were hammered or maybe also polished.

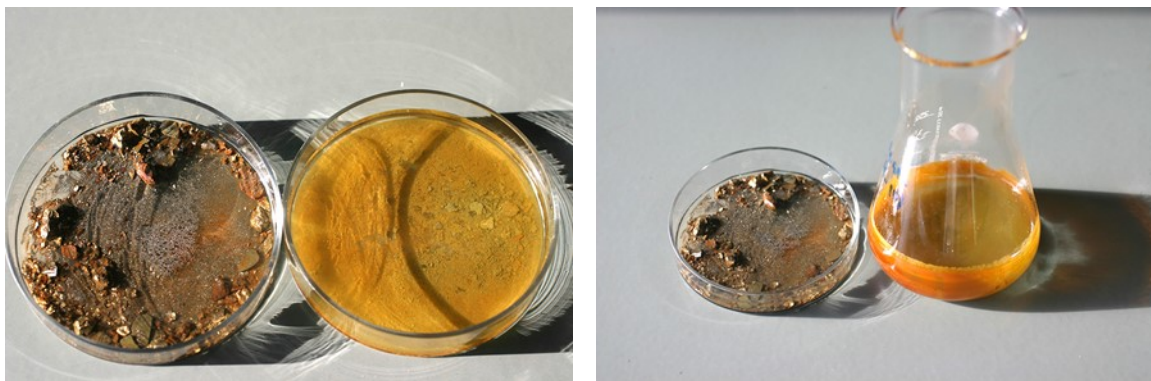
**Fig. 10.** Laboratory made, bacterially oxidized pyrite ( $\text{FeS}_2$ ) mud and mine water. As long as the not yet completely dissolved pyrite (fools gold) crystals are visible, they glitter like gold (left side of individual pictures). The Quechua term "allpa" is a perfect word for describing such crushed metal sulphide particles. The describing word "llancac", sticky, not pleasant for touching, may refer to the high sulphuric acid content. When dissolved a brown-red mud is obtained (the colour depends on volume of solution and optical conditions, compare left and right). It can well be described with "reddish".

From this formula it can be seen that acid is generated while  $\text{Fe}^{3+}$  and sulfate are the final oxidation products. Many details of the complicated interaction of sulfide oxidizing bacteria with pyrite (fig.9, right) during this biological leaching process have been published (Tributsch & Rojas-Chapana, 2000, 2006 ) (Rojas-Chapana & Tributsch, 1999, 2000, 2004). Acid production is a side product of the bacteria's strategy to harvest chemical energy from solid pyrite for carbon dioxide fixation at environmental temperatures. During that process crushed metal sulphide particles are transformed into a reddish mud containing oxidized metal complexes (fig. 10).

And the possible explanation is simple. Witnesses of Inca masonry work may have seen that crushed plant material was added to the reddish clay, the acid pyrite mud (fig. 10), used for treating Inca stone surfaces. And there would have been a reason for doing this: published experimental work shows that silicate mineral dissolution works via a combined action of chemical complexation and acid attack (Barman et al., 1992) and that organic complexation can significantly increase dissolution (Bennett & Casey, 1994). Below pH 5 dissolution of silica containing rocks itself increases with decreasing pH value and thus increasing acidity. Organic complexing acids accelerate this process. When interacting with aluminosilicate minerals organic acids can complex aluminium, and to a lesser degree silica. This decreases their chemical activity. The result is an increase of dissolution rate independent of solubility constraints. Oxalate is especially active because it efficiently complexes aluminium and increases silicate dissolution by a factor of 15 for a concentration of 1 mM oxalate (Drever & Stillings, 1997)(Drever, 2005). Oxalate,  $C_2O_4^{2-}$ , is a very frequently encountered chemical agent in green plants. It is in fact, as calcium oxalate, distributed among all taxonomic levels of photosynthetic organisms and the level of accumulation can be substantial (Franceschi & Nakata, 2005). Examples are spinach, buckwheat, parsley, beets, chart, poppy, beans, fat hen, or rhubarb, amaranth, beets, potatoes, tomatoes, cereal, celery, chicory.
