# INDUSTRIAL HEMP GRAIN PRODUCTION

## Lessons learned from a large-scale field study

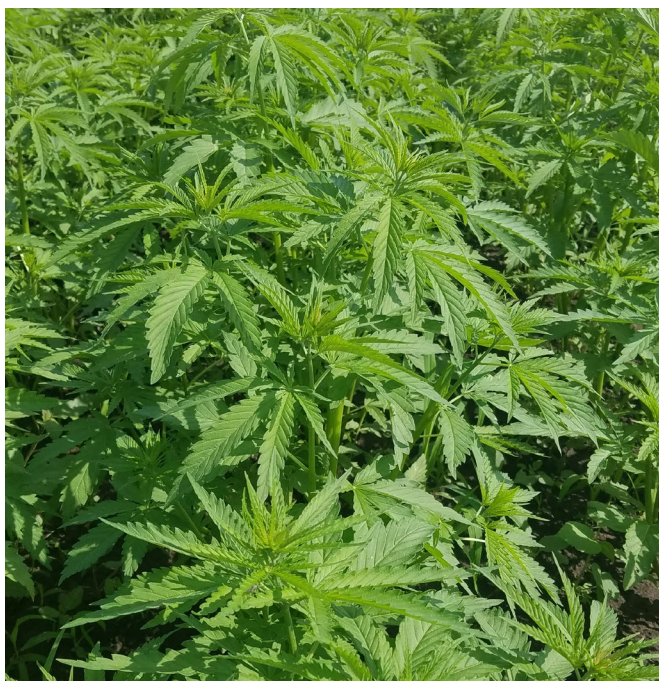
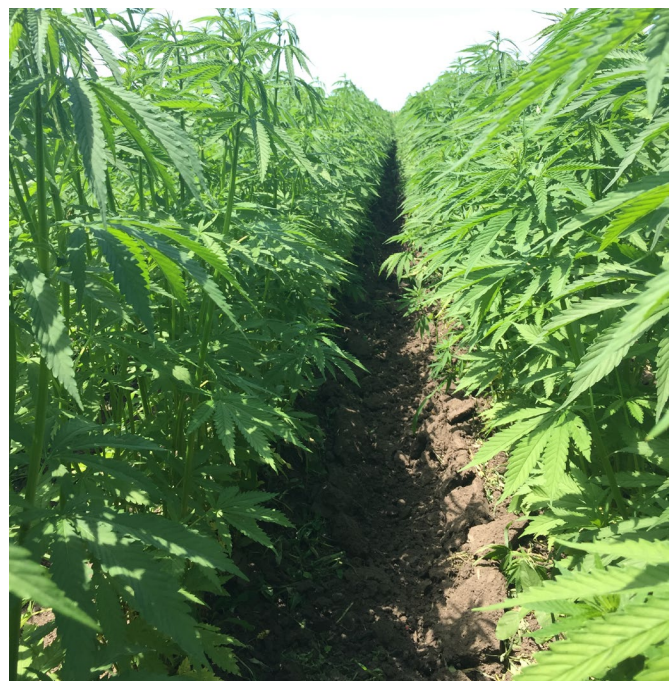
**FIGURE 1.** Industrial hemp crop growth in early July 2019. Mechanical cultivation applied (right) to control weeds in the 30-in. row spacing treatments. No weed control was applied to the 15-in. row spacing treatment after planting.

Weed pressure within the industrial hemp crop was high throughout the growing season. Currently, there are no synthetic herbicides labeled for use in industrial hemp, so weed management presented limited options within the different row-spacing treatments. Due to the burn-down application of glyphosate and multiple tillage passes at planting, the field was free of standing weeds at the beginning of the growing season. Figure 1 shows the industrial hemp crop in early July 2019 with the 15-in. row spacing on the left and the 30-in. row spacing on the right. Mechanical cultivation was applied on July 8, 2019 to suppress weed pressure in the 30-in. rows while no weed management was applied in the 15-in. rows. Canopy closure occurred around the second week of July for the 15-in. rows while the canopy did not close until late July for the 30-in. rows. It was observed that weed pressure in the 30-in. rows was reduced by the mechanical cultivation. Although there was no weed control in the 15-in. row treatment, the crop grew vigorously and was observed to achieve similar height to the 30-in. plants. Plant height and canopy closure suppressed weed growth, observationally, in the 15-in. row treatment. Weeds were present at harvest in both the 15- and 30-in. row treatments. Some weed seed was present in the clean grain tank of the combine, however, the height of the industrial hemp seed heads excluded much of the weed seeds from entering the harvester due to the grain platform being above the height of the weeds.

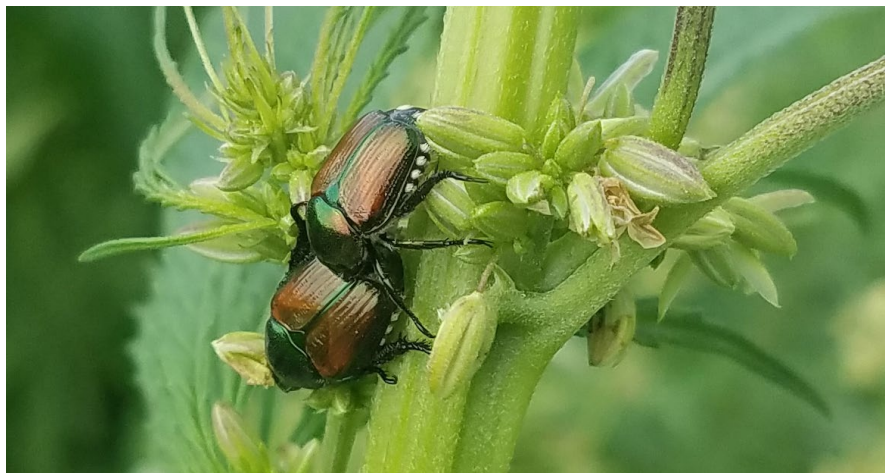
**FIGURE 2.** Japanese beetles located in the industrial hemp field in 2019. Insect pressure existed within the field, but damage to the plants was observed to be minimal and not a concern for grain production.

Insect pest pressure in the industrial hemp crop appeared to be minimal during the growing season. Japanese beetle (figure 2) and tarnished plant bug were observed during the growing season, but the damage did not appear to decrease yields. No synthetic pesticides are currently labeled for treating industrial hemp for insects, so mitigation or management strategies were not implemented.

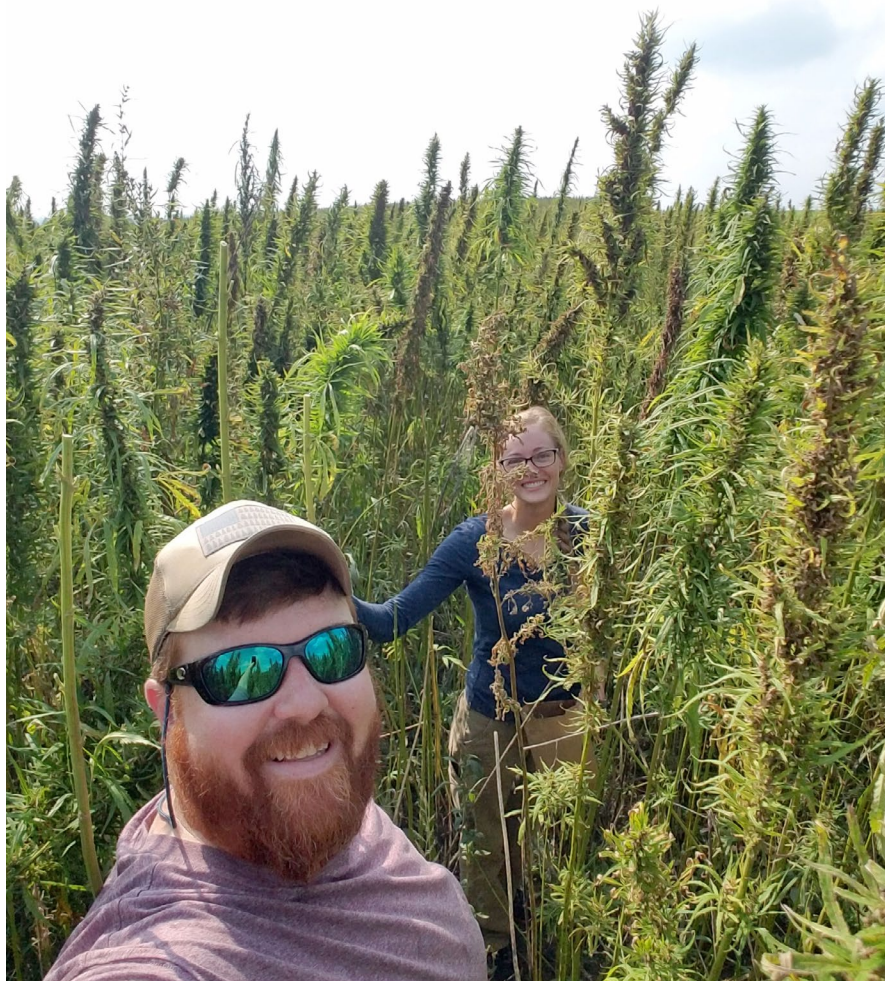
**FIGURE 3.** Badger Ag. Tech. Lab Director Dr. Brian Luck (left) and Faculty Associate Dr. Jessica Drewry (right) hand harvesting industrial hemp heads for yield estimation. Five random locations in both the 15-in. and 30-in. row spacing treatments selected for assessment.

Yield estimation was completed within both row-spacing treatments (figure 3). The heads of hemp plants were harvested at five randomly selected locations within each treatment. One row was harvested at each location for a distance of 17.5 ft. The heads were dried in a forced-air oven at 131°F for 72 hours. An Almaco stationary thresher was used to separate the seeds from the head and the collected seeds were weighed to estimate yield. Results showed a statistically greater yield for the 15-in. row treatments (table 1). Total yield estimation was calculated assuming the mean yield for each treatment was applied over the entire five acres allocated to each treatment.

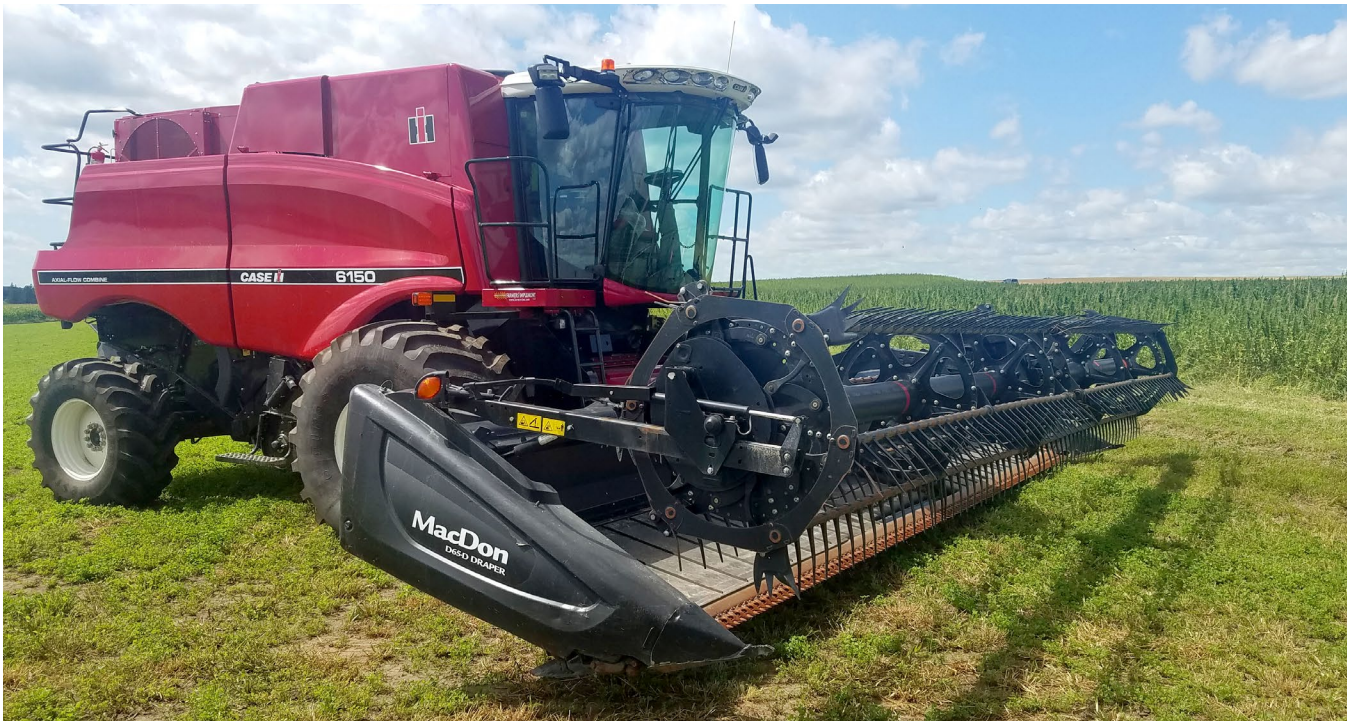
**FIGURE 4.** Combine harvester and MacDon header parked next to the industrial hemp field in August 2019. Harvest date for the industrial hemp field was September 25, 2019.

A Case IH 6130 (model year 2012) combine fitted with a MacDon Industries D65 draper platform (30-ft. cutting width) was used to harvest industrial hemp grain in 2019 (figure 4, Case IH 6150 pictured). Header

reel rotational speed was initially adjusted to match ground speed. At this setting poor crop delivery across the cutter bar assembly was observed. Based on this observation the reel speed was adjusted to slightly greater than ground speed, which yielded better crop delivery across the cutter bar assembly. The reel remained in the aft position for the duration of the harvest. Forward reel positions caused the crop to stall on the cutter bar assembly and generated poor cutter bar performance. It was difficult to find the best reel height

setting because the crop varied greatly in height. Reel height remained in the fully down or near to the fully down position. In this position the best crop delivery and cutter bar performance was observed. However, low reel height settings caused the taller plants to be displaced forward or under the cutter bar causing yield losses. Furthermore, taller plants had the tendency to become lodged in the reel and subsequently dropped to the ground ahead of the harvest platform causing further yield losses.

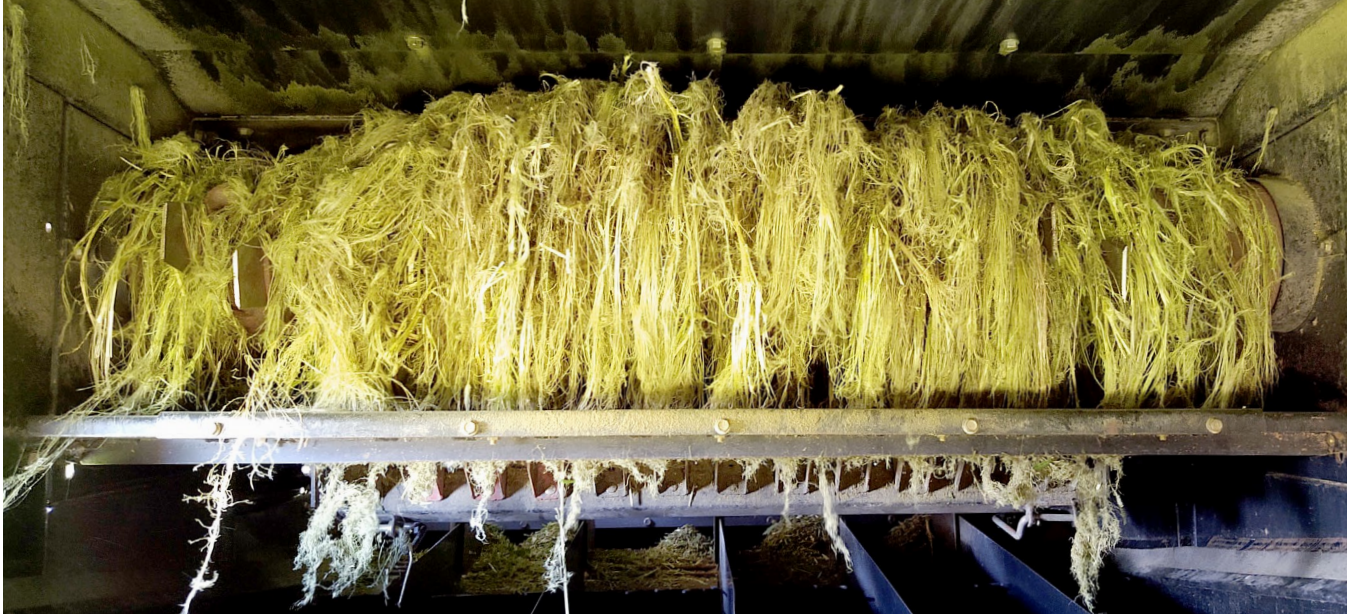
**FIGURE 5.** Fibers wrapped around the straw chopper rotor at the exit of the threshing rotor when operated at the low speed setting. Increasing the speed from low to high eliminated this issue.

Fiber wrapping occurred in several locations on the combine. The most significant fiber wrapping was observed at the residue chopping rotor at the exit of the threshing rotor (figure 5). Changing the chopping rotor to high speed eliminated this issue. The feeder house slats and drive drums were additional locations where fiber wrapping occurred. Minor wrapping occurred at the cleaning fan shafts inboard of the support bearings and inboard of the lower cleaning fan drive sheave. Minor fiber wrapping inboard of the feeder house drive sheave was also observed. Overall fiber accumulation over the harvested area was not excessive, however, fiber wrapping should be assessed often if harvesting more than 10 acres. Where fiber wrapping occurred, the fibers remained loose until large amounts of fiber accumulated. It is important that when wrapping of fibers is observed that the problem be dealt with immediately. Plant stubble often became lodged in the framework on the underside of the combine and dislodged a shaft speed sensor for the clean grain elevator

once. Wrapped fibers can damage bearing seals or cause enough friction to create a fire hazard.

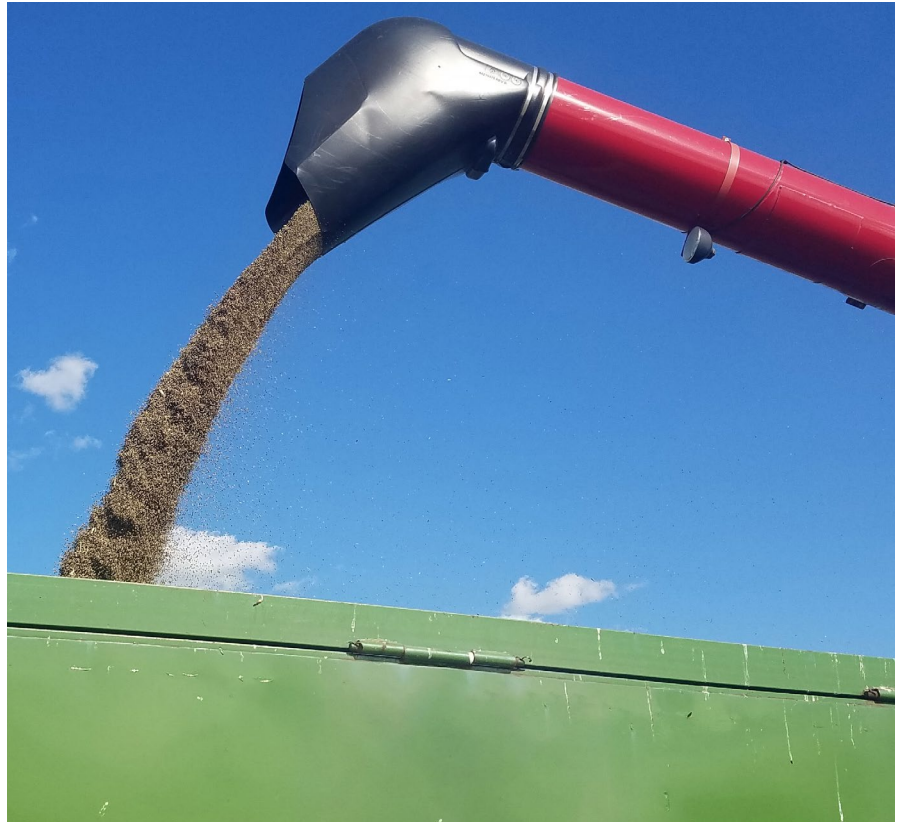
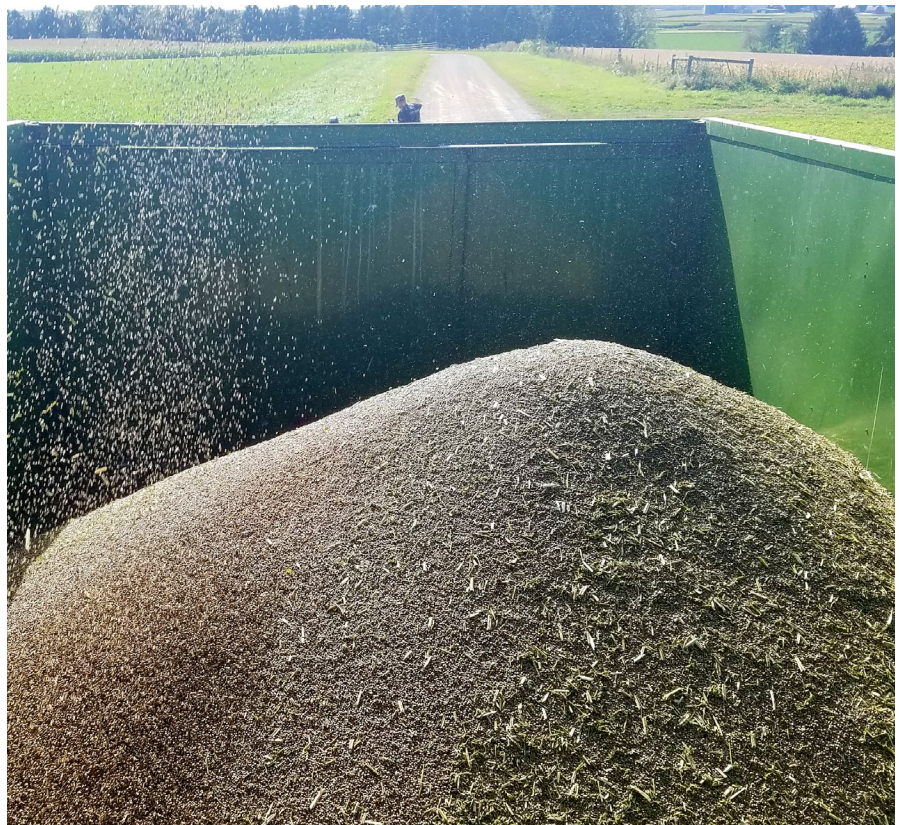
**FIGURE 6.** Industrial hemp seed is unloaded from the combine (top). Industrial hemp seed after harvest and unloading into a wagon (bottom).

Unloading the harvested hemp seed from the clean grain tank and through the unloading auger was done at low engine speed to minimize seed damage. The grain harvested was well cleaned at the final combine settings and was determined to be in good condition at harvest (figure 6).
