**ARCHAEOLOGICAL ASSESSMENT OF THE PROPOSED
CAPE TOWN INTERNATIONAL CONVENTION CENTRE 2
ON ERWEN 192, 245, 246 AND THE REMAINDER OF ERF
192, "SALAZAR SQUARE", ROGGEBAAI, CAPE TOWN
FORESHORE**

October 2012

ACO Associates cc

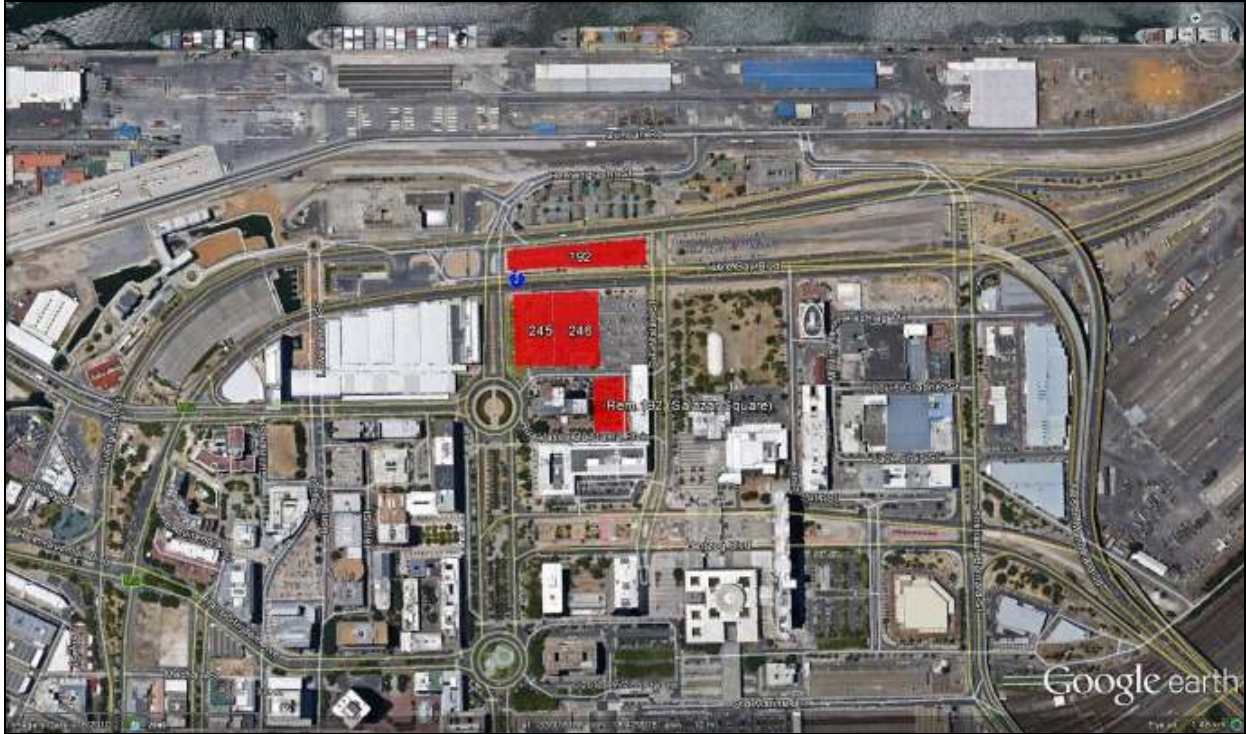
Figure 1: The location of the proposed CTICC 2 on Erwen 245 and 246. Additional parking will be provided on Erf 192, and the remainder of Erf 192, Salazar Square.

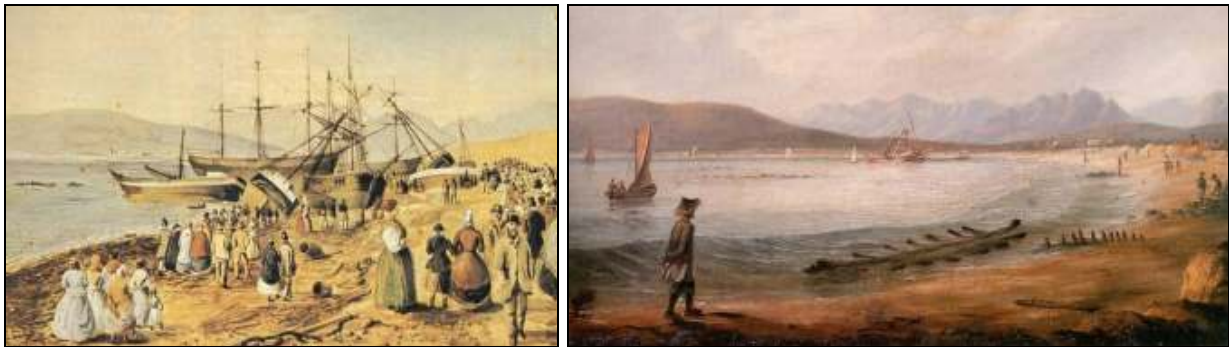
Plate 3: Ships stranded during the “great gale”. Watercolour by Otto Landsberg (in Veitch 1994). **Plate 4:** The remains of ships on Woodstock Beach. Probably a common sight at certain times of the year.

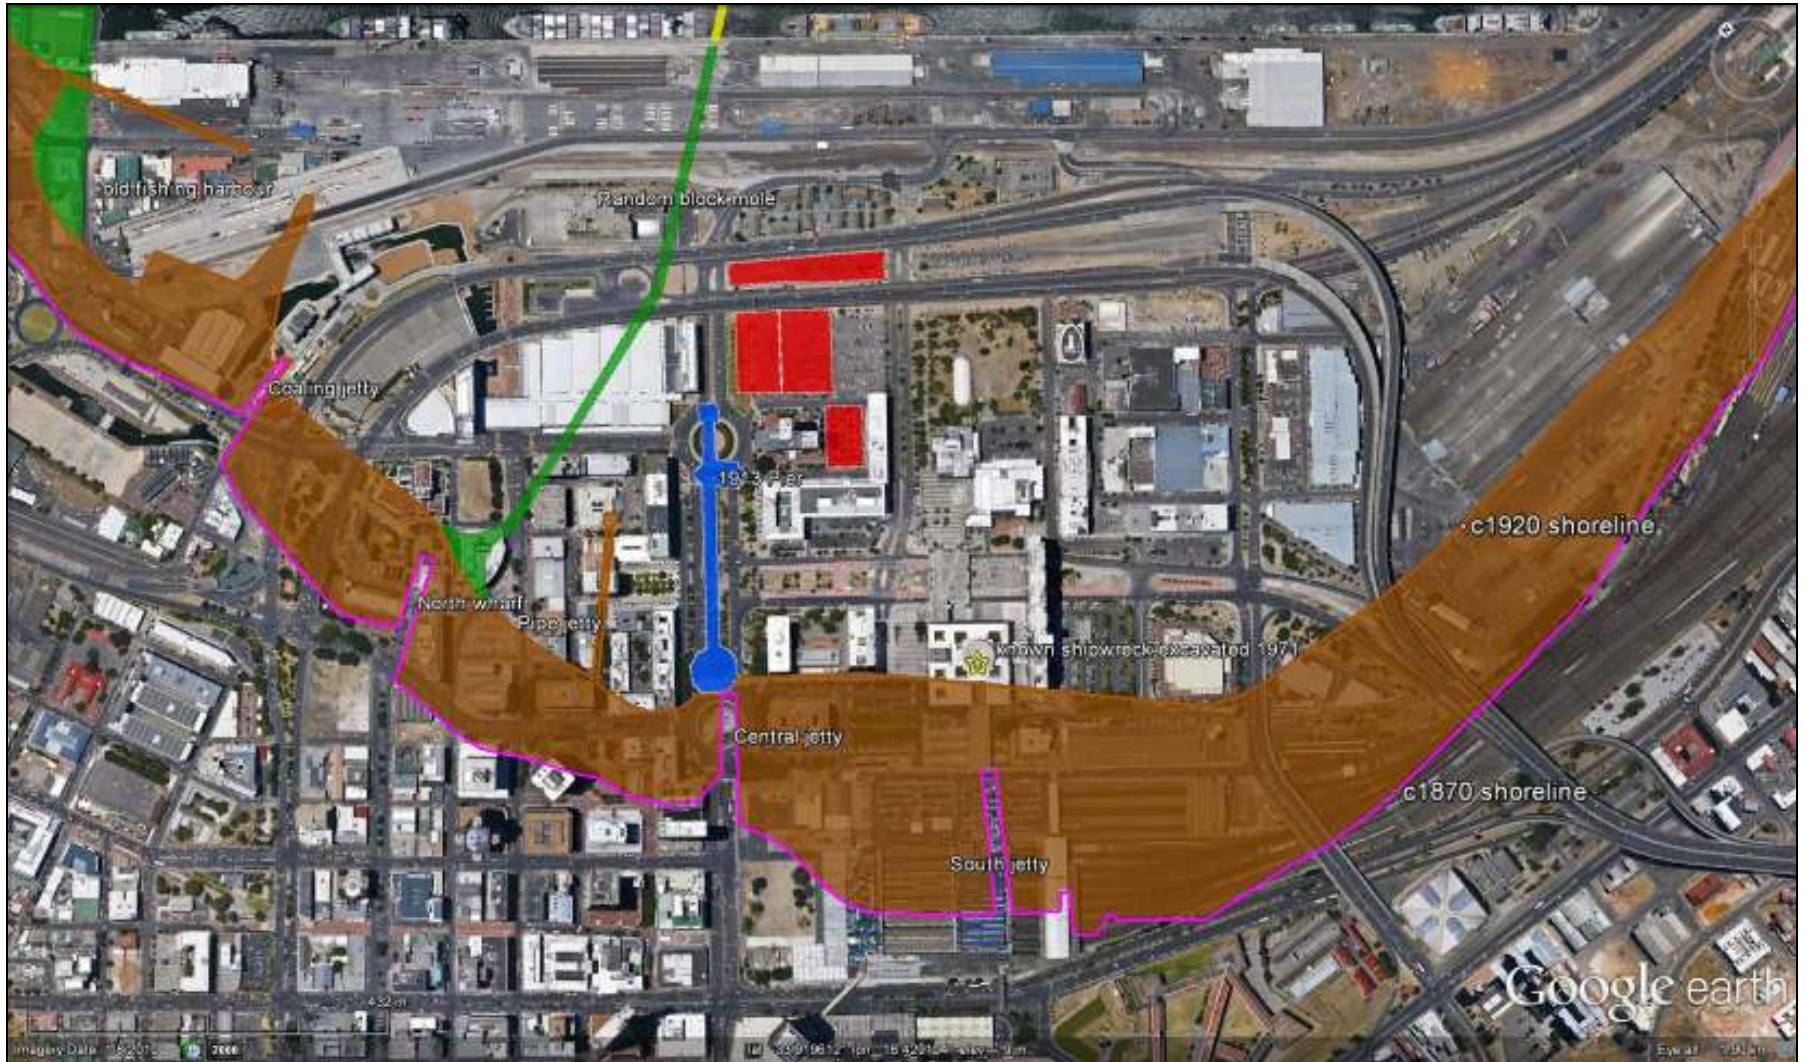
Figure 2: Table Bay harbour - historical development 1870-1985 (based on: South African Transport Services Drawing TBH 106 (1985): A-374). Proposed development sites shown in red. The area between the 1920 shoreline and the existing harbour was reclaimed between 1938 and 1943. Comparison with the 1926 aerial photo in Figure X shows that the information with regards to the 1920 shoreline omits certain features such as the Rogge Bay fishing “harbour”.

The tipping of gravel for the breakwater marked the beginning of the large civil works programs to improve mooring and harbour facilities in an attempt to cut the loss of ships during the winter storms. Over the years a number of jetties had been constructed at strategic places along the shoreline to provide loading and offloading facilities for visiting ships. A number of those are shown and identified on Figure 2.

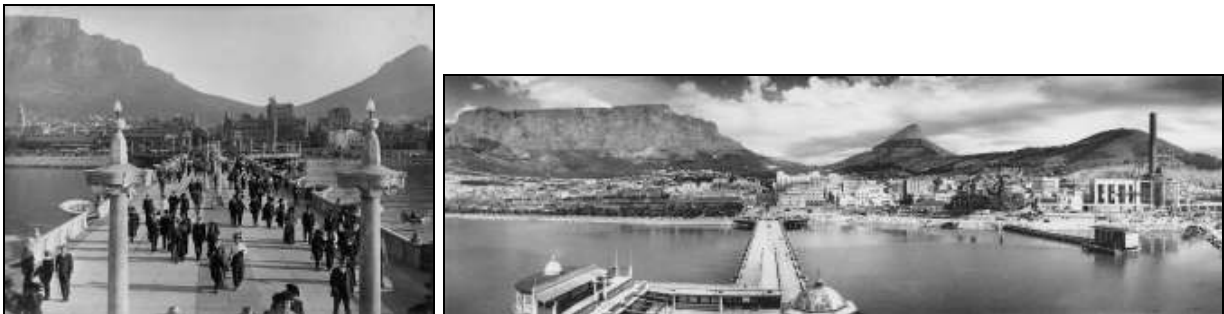
Plates 8a & b: The Pier was a popular social gathering place and concert venue. The panorama at right captures the changing coastline and cityscape.

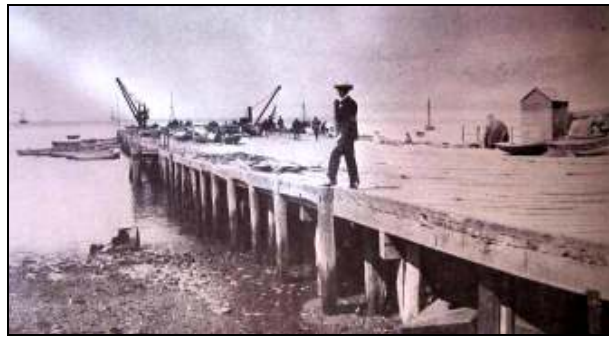
Plate 11: Photograph of the wooden jetty (Central jetty) at the end of Adderley Street c1902 (Picard 1969:118). The central jetty was constructed in the 1850's and became the central hub of harbour activities. In 1907 the jetty was extended to create a central pier and promenade. The pier was demolished in 1938 to make way for the Foreshore Reclamation Scheme (Patrick et al 2010).

In 1913, the Cape Town Municipality built a public pier (Plates 7 - 10) at the foot of Adderley Street at the western end of the promenade. This may in part have been motivated by the desire to replace the old Central Wharf⁶ (Plate 11) which was by now almost completely buried by reclamation. Part of this old wharf and the associated earthworks is likely to have been what was excavated by archaeologists

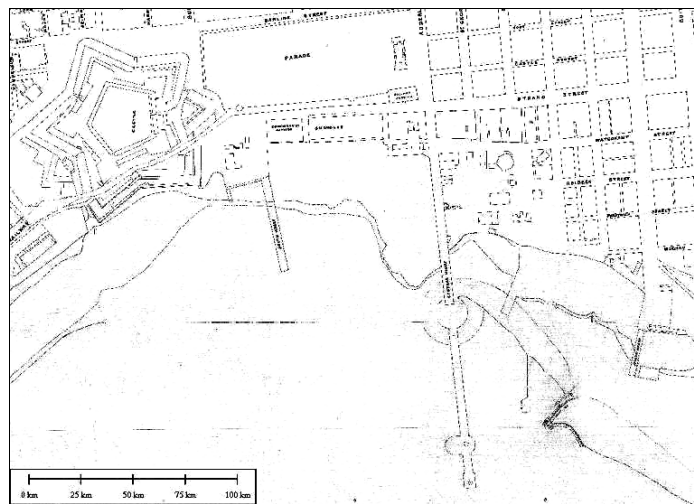
Figure 5: Detailed overlay showing c1862 and 1938 shorelines showing the proposed location of the new pier at the end of Adderley street, and the location of the old Central jetty. The earlier landfill between the Castle and Central Wharf is prominent and the later fill and sea wall (promenade) show as a faint line. (ACO map collection)

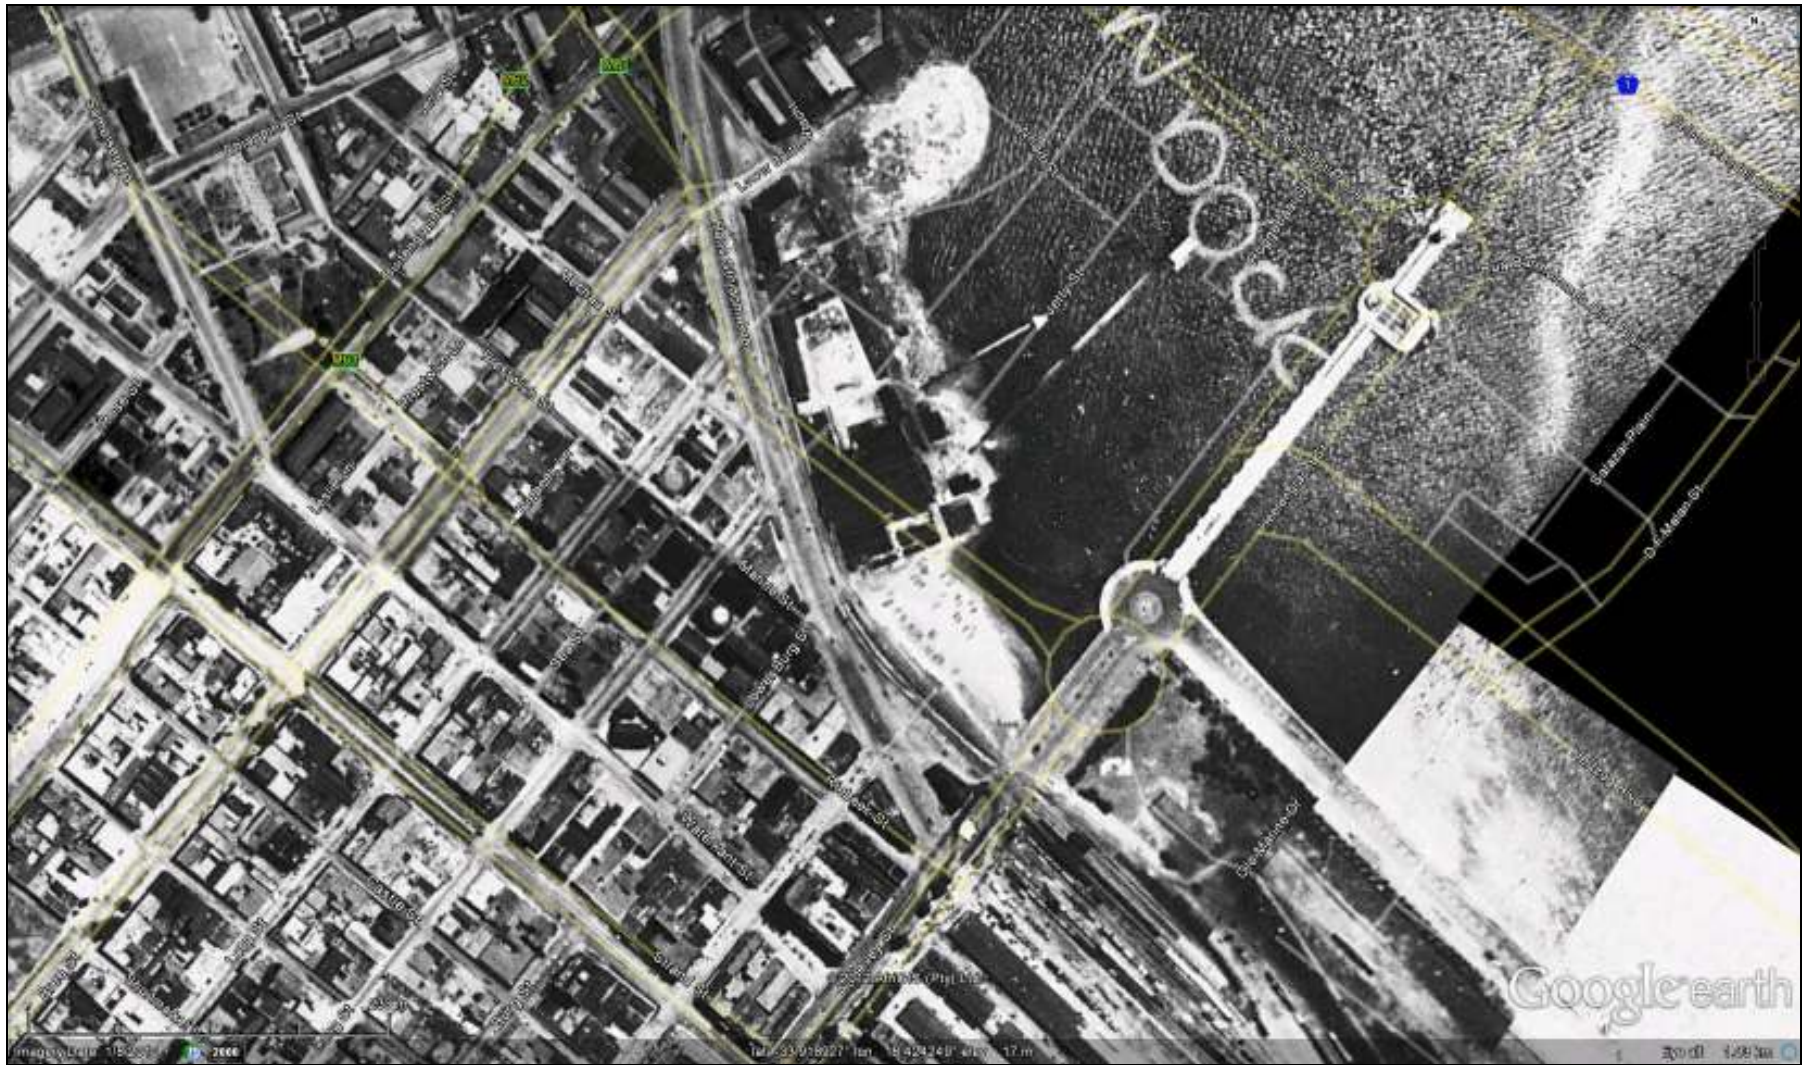
Figure 7: An extract from the 1926 aerial photo of Cape Town showing the 1913 pier (source: Jordan 2003) with current street map superimposed via Google Earth. The old Roggebaai fishing boat harbour and beach clearly visible at center The old promenade running south east from the base of the new pier at the foot of Adderley Street.

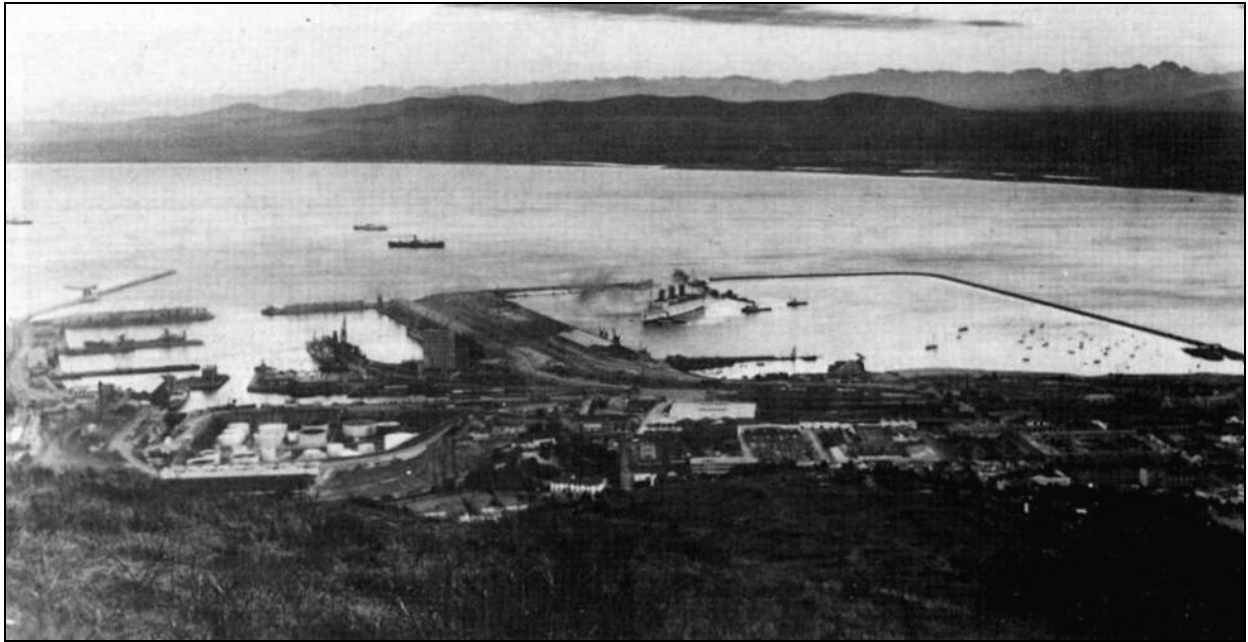
Plate 12: The new southern basin in 1934 with the random block mole at right (in Newall 1993)

From 1926 to 1932, as a result of the need for docking space for more and larger ships, a mole (the so-called “random block mole”) was constructed just northwest of the municipal pier to form a large sheltered basin. It extended in a north-easterly direction before angling to the north-west towards the end of the Victoria Basin (Spies & Du Plessis 1976, quoted in Durden 1992. See Plate 12 & 13 and Figure 2).

The mole was originally built by first dumping rubble on the seabed and then placing large six-ton concrete “wave-breakers” on top. When dismantled, the wave-breakers were removed by a crane equipped with a grab-claw and were subsequently stacked ashore (although some were found during the construction of the CTICC 1). The Municipal Pier was demolished to just above the high-water mark and the remains were buried in the fill (de Kock 1999).

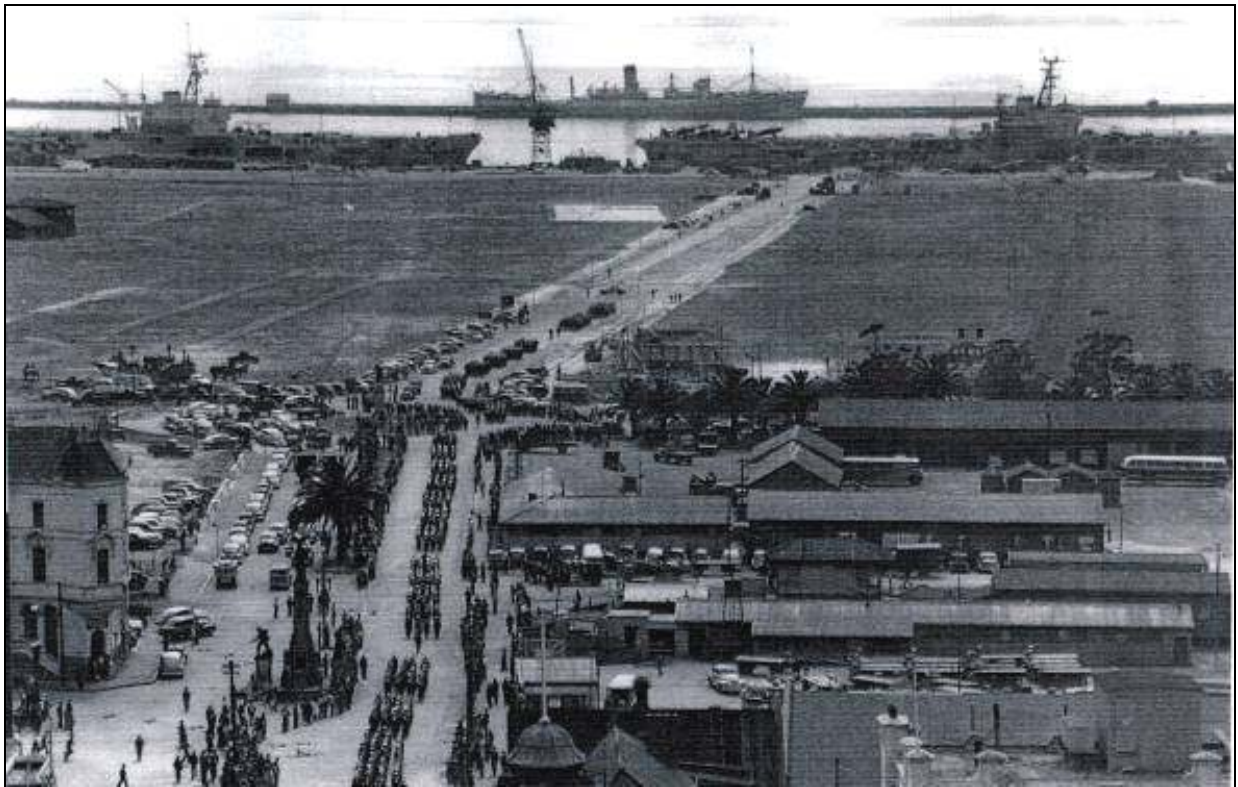
Plate 14: Troops parading in Adderley Street shortly after completion of the reclamation. Two aircraft carriers can be seen berthed in the newly constructed Duncan Dock. The reason for the deviation of the road to the right is unknown (South African Library).

Dredging began on 10 May 1935 and, although scheduled to be completed by 1941, intervention of the war meant that final completion was delayed until 1945. Despite this the harbour was in use as early as 1943 (Plate 14).

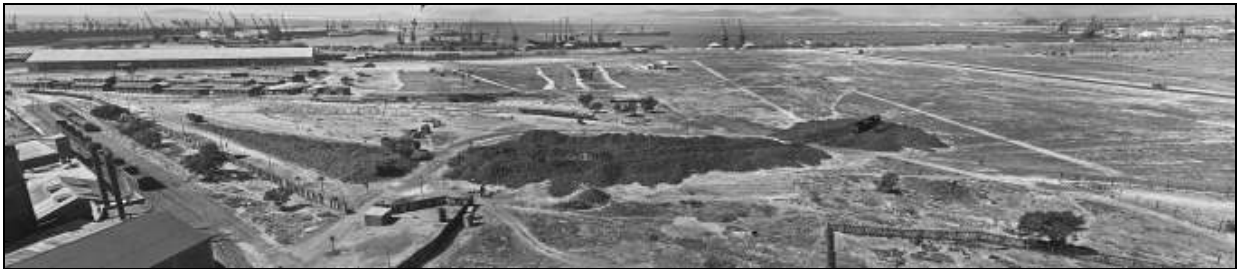
Plate 19: Broad panorama over the landfill area (City of Cape Town: Heritage Branch)

A number of views of the newly reclaimed land are shown in Plates 15 -18 with the proposed development sites marked in red on some. A panoramic view of the area from the old Power Station is shown in Plate 19.

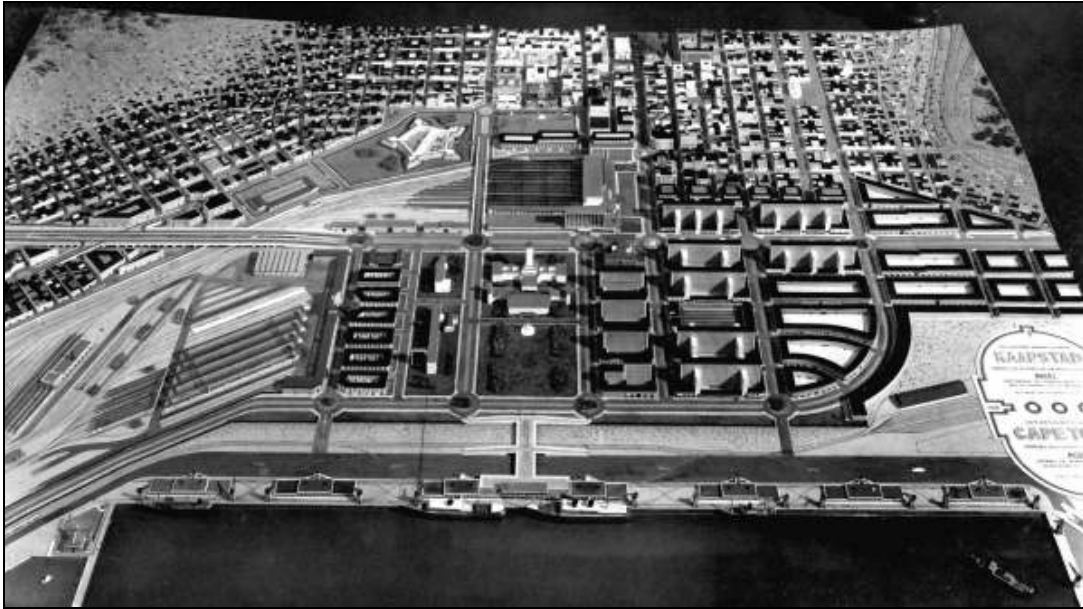
Plate 20: A photograph of the model of the proposed layout of the foreshore (source unknown - included with a number of loose photographs in a second hand copy of the 1940 Foreshore Scheme report in ACO possession)

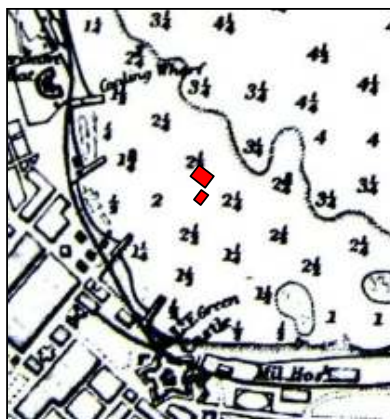
Figure 8: An extract from a plan showing the bathymetry of Table Bay in 1858, as surveyed by F. Skead R.N (see also Figure 2). Although the date on the chart suggests that it was prepared in 1858, some of the landmarks that have been included indicate that the map is probably from sometime after 1860. Depths in fathoms (1 fathom = 1.8288 meters). Sceptre Reef appears in front of the old Military Hospital at Woodstock.

The analysis of available historical information has indicated that the proposed development lies on reclaimed land above a part of the bay that would have been between 500 meters from the old shoreline (in about 1870). The approximate position of the development sites are indicated in red on the depth chart below and suggests that sea depth in the area of erf 245 and 246 would have been in the order of 4 – 4.5 meters (2 - 2.5 Fathoms). It is worth bearing in mind when building/foundation depth is discussed as it will be in that range where material may be found on the old seabed.

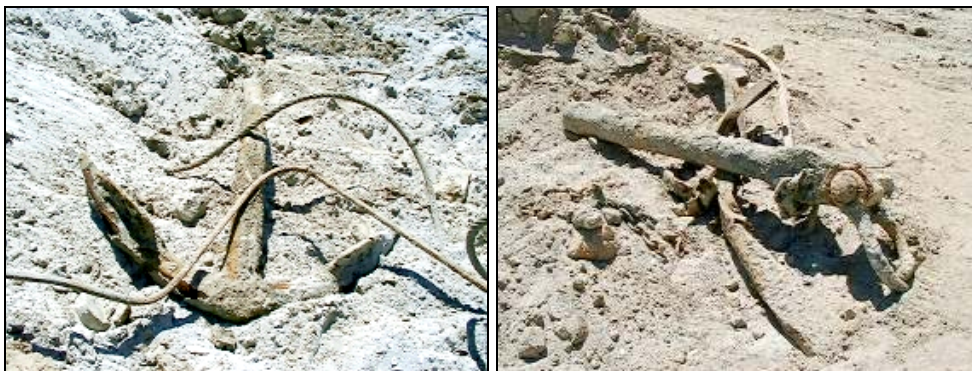
Plates 21 & 22: Two anchors were recovered from the lower rubble fill during bulk earthworks at the CTICC 1 site. The admiralty pattern anchor shown at left is made from wrought iron and has curved arms tipped with flukes. These were used throughout the 19th century. The anchor at right had lost its arms although the mechanism at the top of the shank was well preserved. Neither anchor had a stock (an “L” shaped iron bar that passed through the shank just below the chain ring at right angles to the arms. This device prevented the anchor from lying flat on the seabed and ensured it dug into the sandy bottom).

It is difficult to determine what may be found on the old seabed. Anchors, cargo and fragments of vessels are probably most likely (anchors were found previously on the *Arabella Hotel* (now the *Westin*) site during bulk excavations (Halkett 2002, and at the Silo 1 site at the Waterfront Schietecatte in prep). Significance would be determined on a case by case basis. The recovery of such items is unlikely to result in significant delays. We believe it to be highly unlikely (although they cannot be ruled out) that individual human remains will be found on the old seabed.

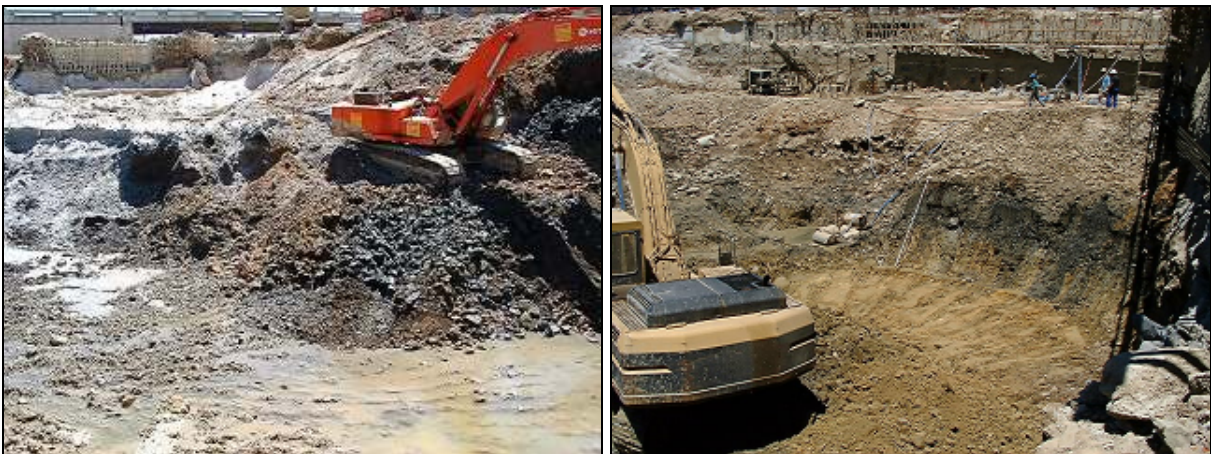
Plates 23 & 24: At left two types of fill consisting of the lower rock rich deposits (from the base of Duncan Dock?) and sea/dune sand above. A thick dark layer in the photograph at right, was interpreted as the old seabed, upon which was a build up of organic debris and coal residue (Photographs: ACO Associates archive).

- Upper rubble: this is a landfill made up largely of building debris and from the smell in places, also industrial waste;
- Dredged sand: landfill consisting of dredged seabed material, white in colour and rich in water rounded marine shell. Clearly of marine origin, this cannot be the dune sand reported to have been brought from near the airport and it must have been used elsewhere (see Cox 2000 and Sharfman & Mavradinov 2000);
- Lower rubble: earlier landfill containing much rocky material and other debris. This appears to have been submerged or waterlogged and had a strong sulfurous aroma;
- Old seabed: this was marked by a relatively thin deposit (on average 80cm thick) of black/grey clay also having a strong sulfurous aroma;
- Bedrock: Malmsbury Shale.
