### ***Preservation Assessment of Totem Poles***

**Preservation Assessment of Totem Poles  
Totem Bight State Historical Park  
Ketchikan, Alaska**

**May 11-21, 2008  
Ron Sheetz, Conservator**

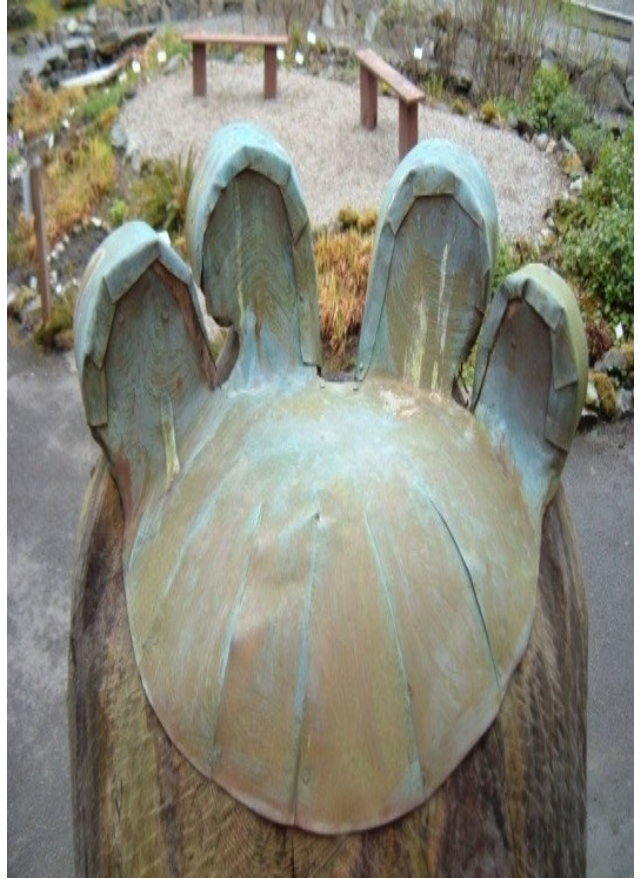
- Totem pole is 9' tall with a 34" diameter base that is buried in the ground. The pole is in good condition.
- The top of thunderbirds head and curly projections have a well constructed copper cap applied.
- There are vertical natural drying cracks in the center of beak and on right side of face.
- A vertical natural drying crack, 1/8" at widest point runs from under the chin down to the feet. Another natural crack is located between whales head and the fin 1/8" at widest point.
- Very small, less than 1/16" opening, natural cracks run the length of the back of totem.
- A small amount of vegetative growth and mold are located inside of each wing next to the thunderbirds body and around the base of totem.

**Copper cap**

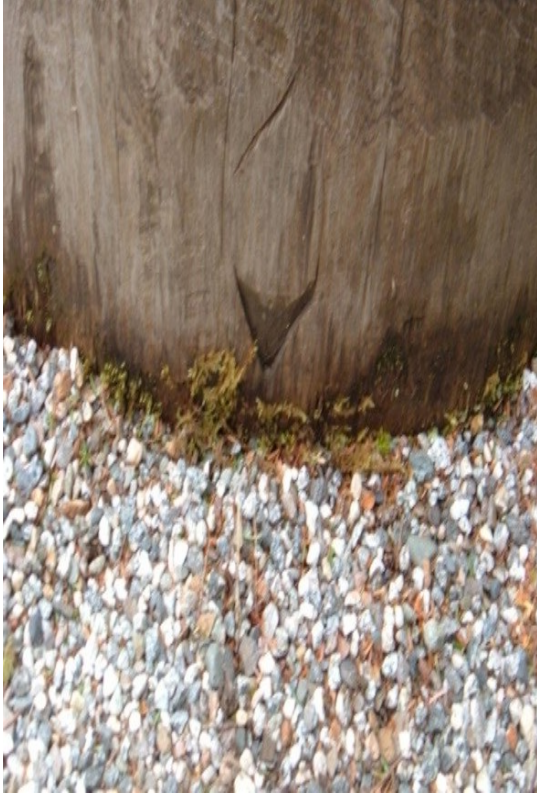
**Vegetative growth around base**

- Remove the vegetative growth on thunderbird with water and fiber brushes. Roundup or similar herbicide could be used to kill the vegetative growth around base of totem.
- Apply Bora-Care, a sodium borate based fungicide/insecticide to kill fungi and wood boring insects and to prevent re-infestation. Application can be made by spraying, brushing or both to all wood surfaces to a point of saturation, giving particular attention to end grain surfaces.
- Apply X-100 Natural Seal water repellent or similar paraffin oil based water repellent to retard water infiltration and slow leaching of the Bora-Care. Application with can be made by spraying or brushing. Re-apply both the Bora-Care and water repellent on a five year cycle.

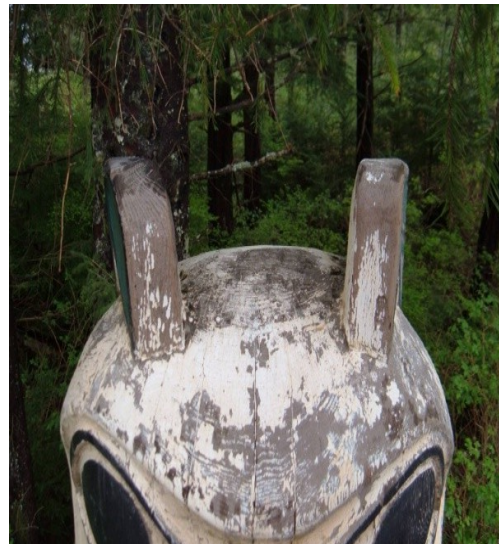
**Location of previous cap**

- A sheet lead or copper cap should be re-attached on top of head.
- The tongue can be adhered with an epoxy.
- Remove as much of the decayed wood as possible from behind the patches, in knot holes and splits, that can be removed with out causing further damage to totem pole. An air compressor fitted with a narrow nozzle works well to blow out debris from the cracks and splits.

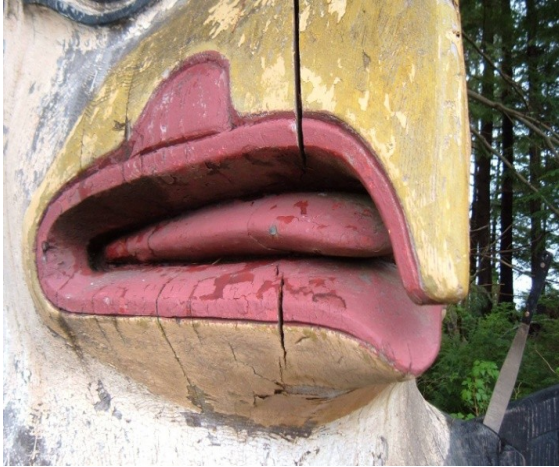
- The tongue is split, with the grain, 5" back from the tip of tongue. Tongue is loose but held in place by two nails one on each side. There is a wedge shaped segment  $1\frac{5}{8}$ " wide x 1" deep missing from left side of tongue behind split.

**Split in beak and tongue. Note nail head**

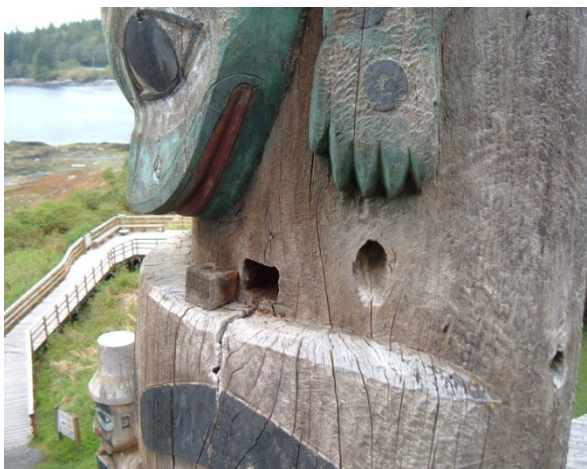
**Wooden removable plug below frog**

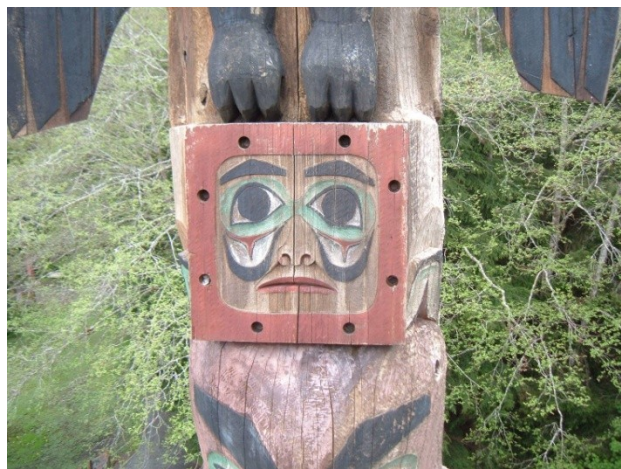
**Bent wood box attached with 8 spikes**

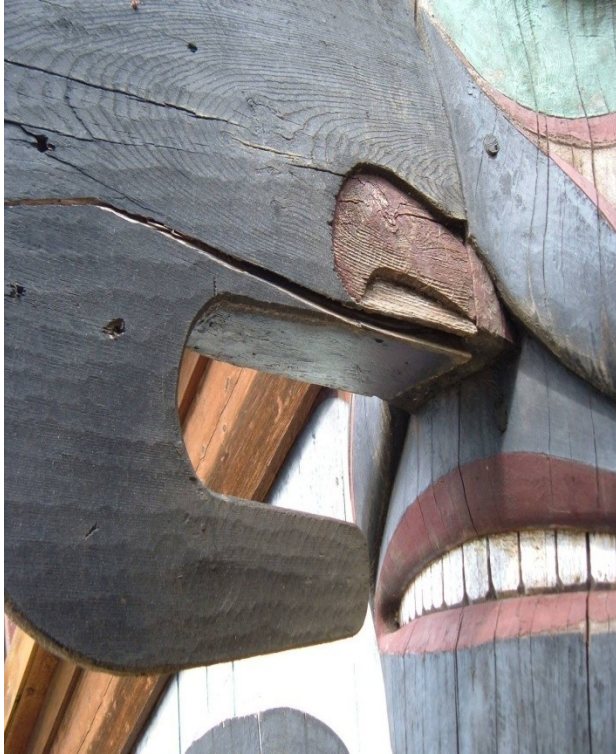
- The beak is hanging loose, appears to be attached only by wooden dowels that are going through the mortise and tenon joint. The wide split, through ravens head and face, follows beside the beak and through the mortise joint leaving a very loose fitting joint. The beak could fall.

**Raven-at-head-of-nass separating beak**

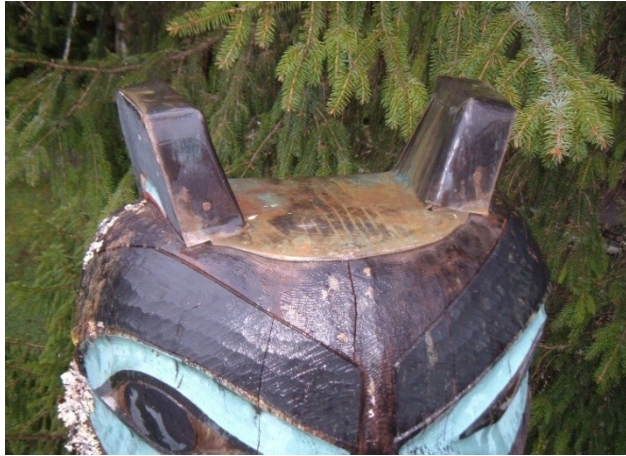
**Copper cap and lichen growth**

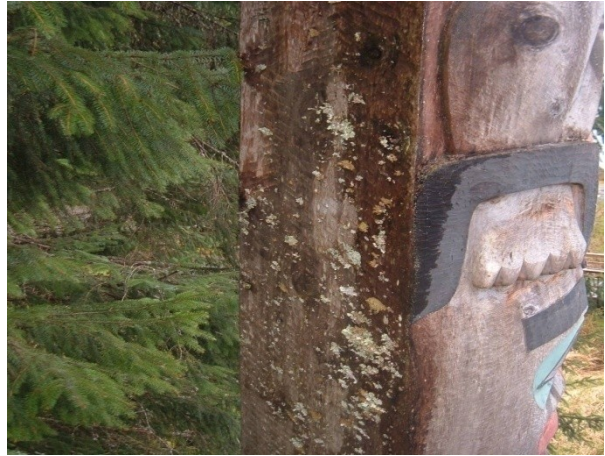
**Lichen growth on back of totem**

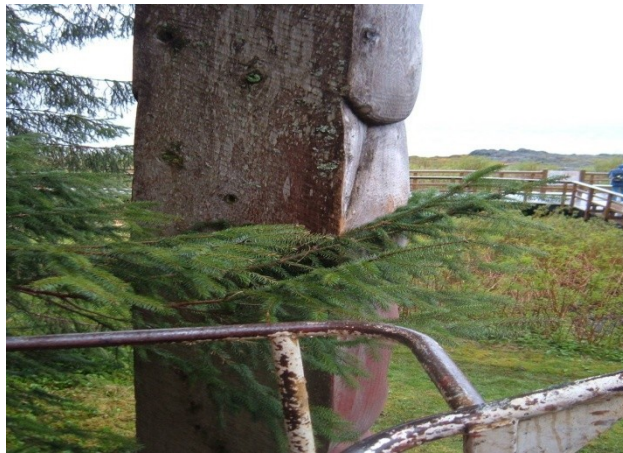
**Tree limb rubbing against totem**

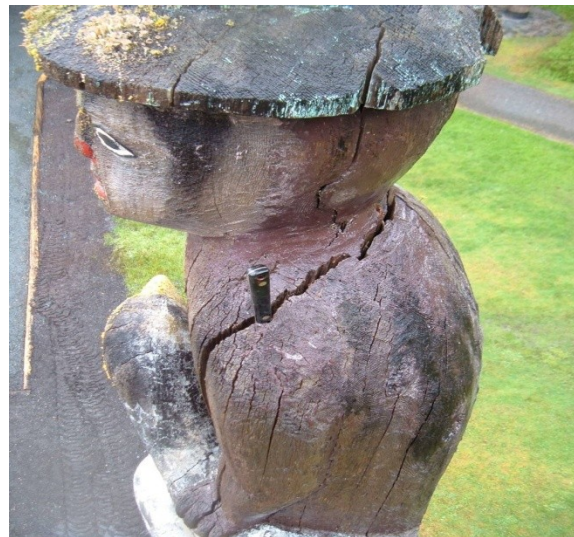
Split along back of village watchman

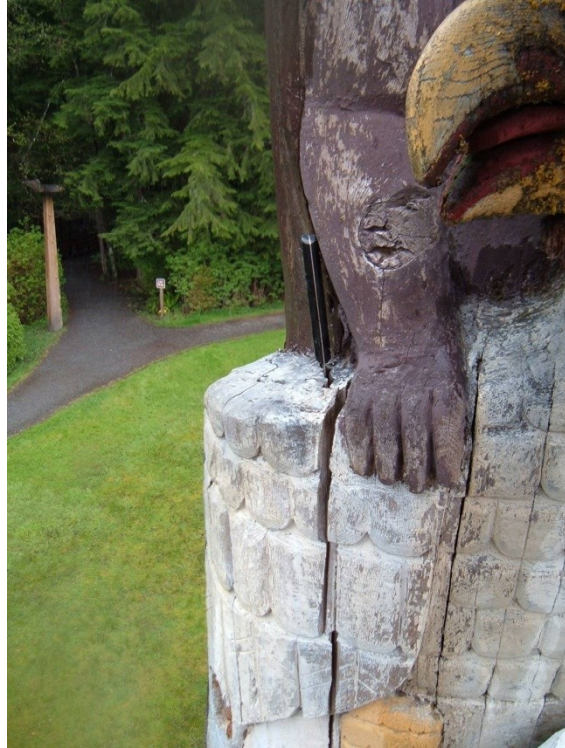
**Split in left wing of immature eagle**

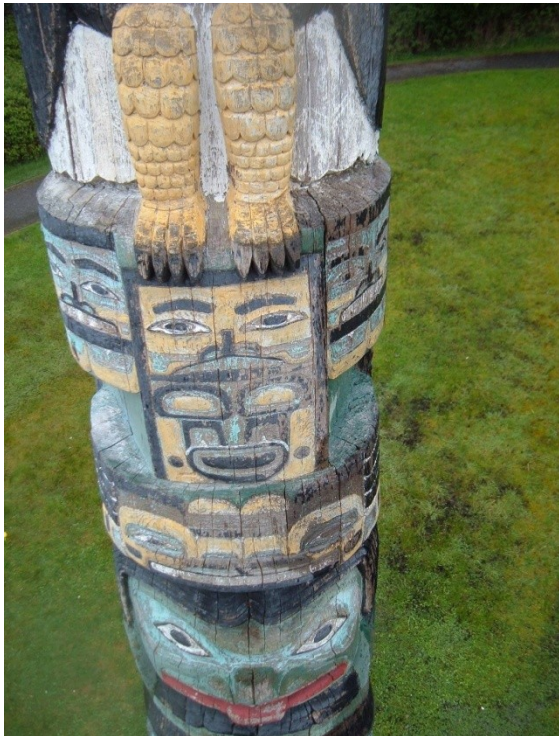
**Split along left side of painted faces**

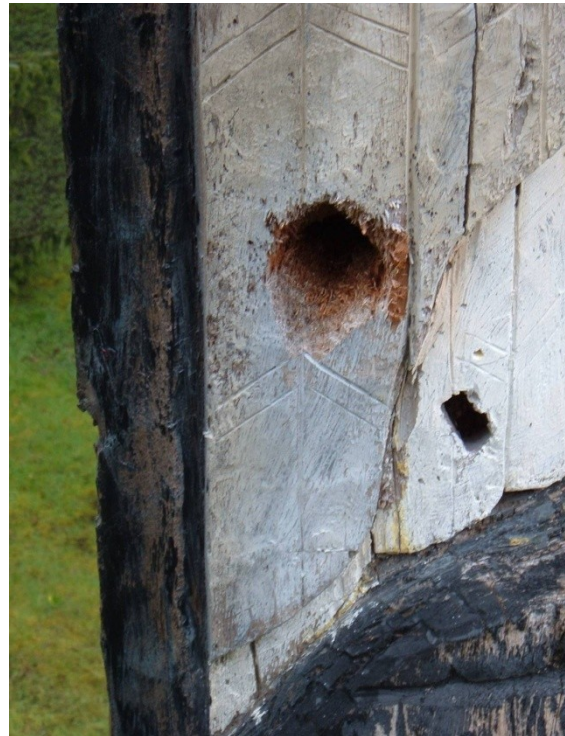
**Hole made in left wing by a woodpecker**

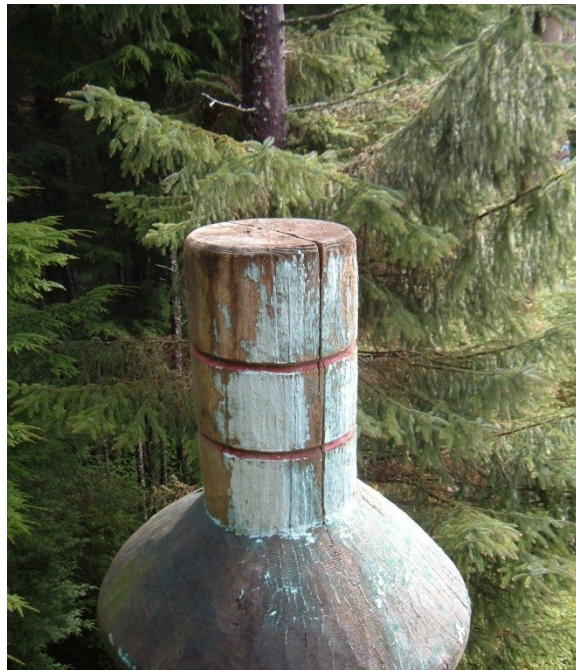
**Split in hat**

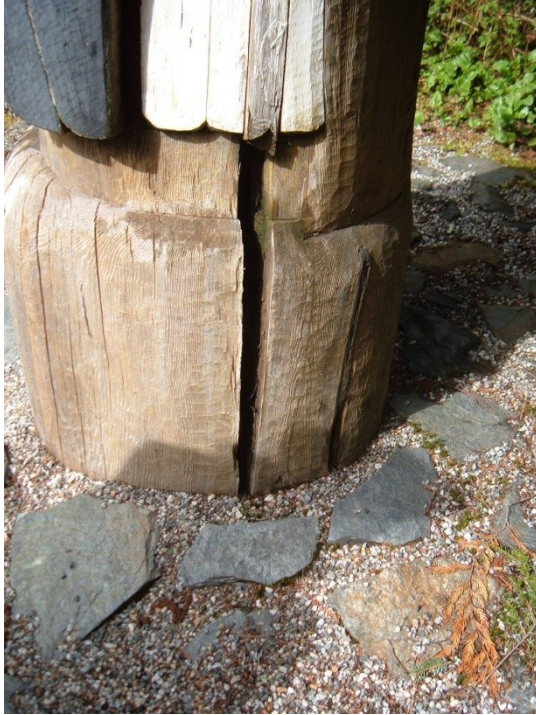
- Log defect crevasse are located on back of totem at the base. They were formed when the bark fell out of a crease in the log. Some debris was removed from several of these openings.

**Crevasse at base of totem**

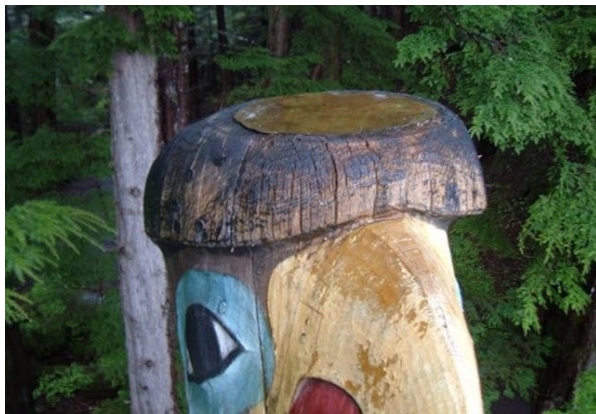
Small copper cap

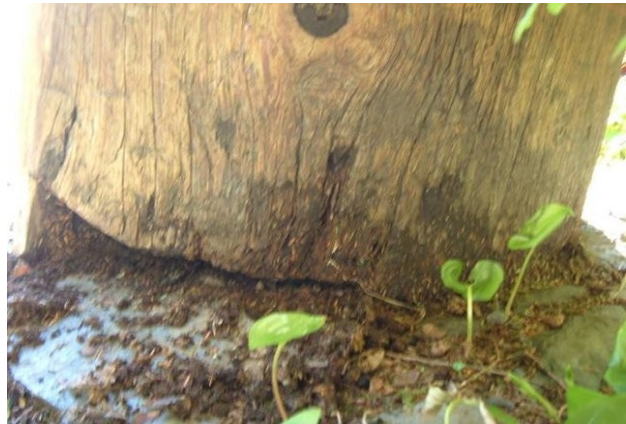
- The totem is leaning at least a foot off plum to the left and backwards. There is extensive fungal decay in the interior of pole at the base. A segment, half the width of pole has been cut out of the back at grade level. The blade of a spatula penetrated eight inches at this location.

Segment cut from base and vegetative growth

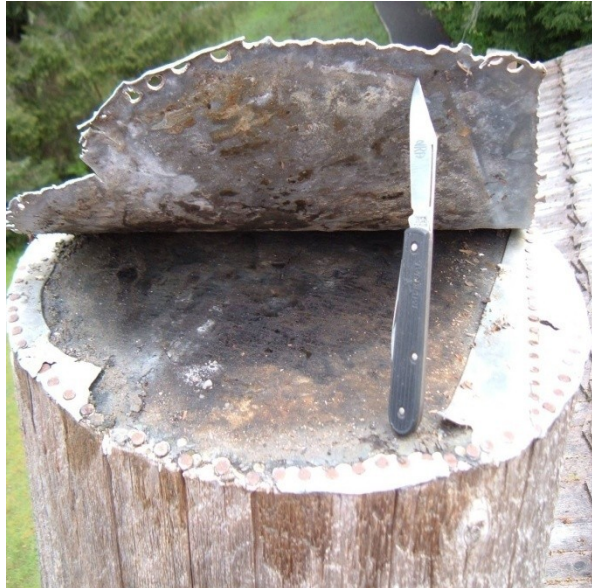
- Corner post is 22'8" tall with a 30" diameter base that is buried in the ground. It is a corner post that is structured into the clan house.
- The top of watchman's hat has a lead cap that is separating around the edge. Located under the cap is a layer of felt paper. The end grain wood under cap is in good condition.

**Revealing layer of felt paper**

- Remove the separating lead cap and replace with one that will bend down over outer edge of hat.
- Adhere with epoxies the loose repair patch in back of hat and the loose replacement leg.
- Clean the totem and apply Bora-Care. Application can be made by spraying or brushing to all wood surfaces to a point of saturation, paying particular attention to end grain surfaces.
- Apply X-100 Natural Seal water repellent over the borates with a spray or brush. Re-apply both the Bora-Care and the X-100 on a five year cycle.
